# CULTURAL RESOURCE MANAGEMENT PLAN

## Fayette Historic Townsite

Delta County, Michigan

Final Submission  
December 1996

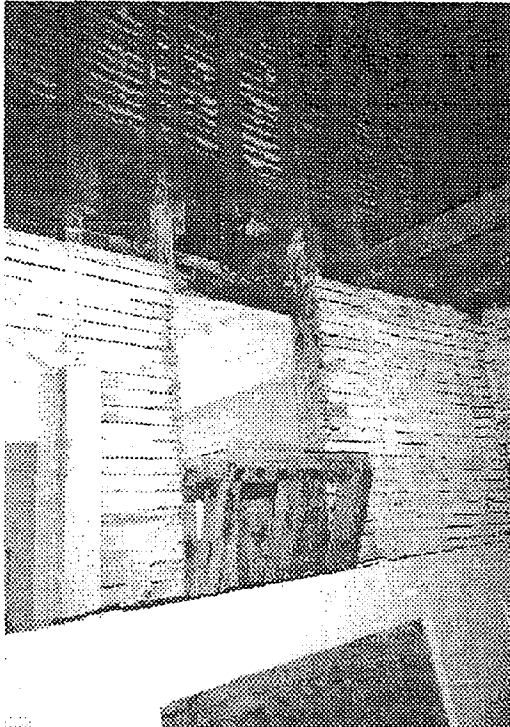
Figure 28

*Detail view of the wood framing that previously supported the former chimney, 1996. Note that the entire ceiling / floor structure above is missing.*

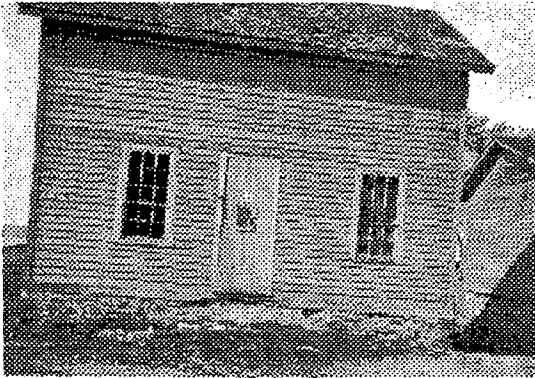
Figure 34

View of the north elevation in 1907. Note that the porch is missing and the foundation has deteriorated. Note the (presumed non-historic) plank door.

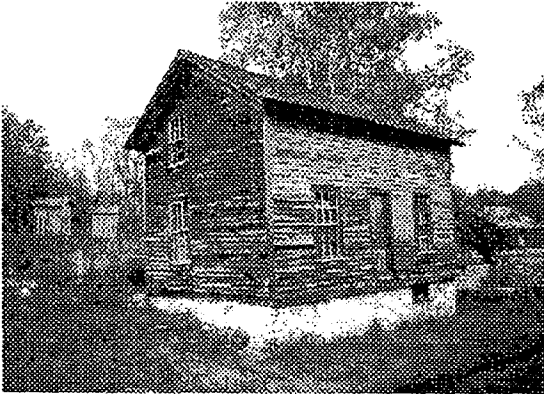
Figure 41

View of the north and west elevations. Note the several areas of deteriorated clapboard and the missing front steps. Also note the contemporary pit toilets located in the left background.

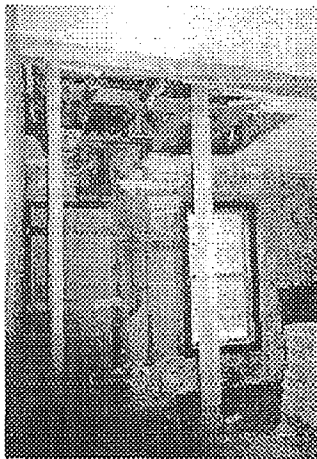
**Figure 47**

*View of the interior looking west, 1996. Note the broken ceiling joists and temporary shoring.*

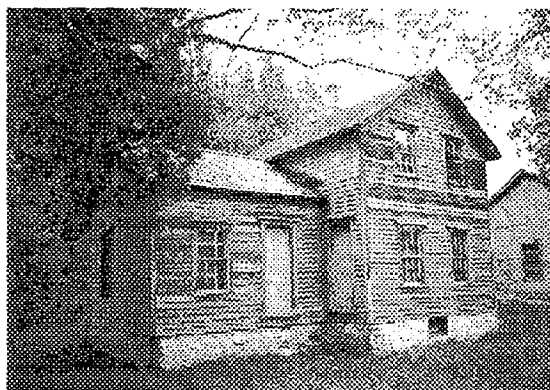
Figure 51

View of the west elevation, 1996. Note that the porch is has deteriorated and is completely gone. Also note the areas of clapboard replacement evidenced through a contrast in color.

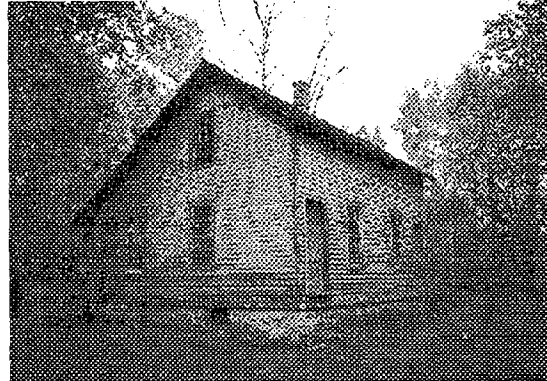
Figure 61

View of the west and north elevations, 1996. Note the areas of deteriorated clapboard siding and that the wood steps at each of the entrances are gone.
