Preliminary Report:
Archeological and Engineering Expedition
Monitor Marine Sanctuary

August 1-26, 1979

Gordon P. Watts, Jr.
Roger W. Cook
Kenneth Morris

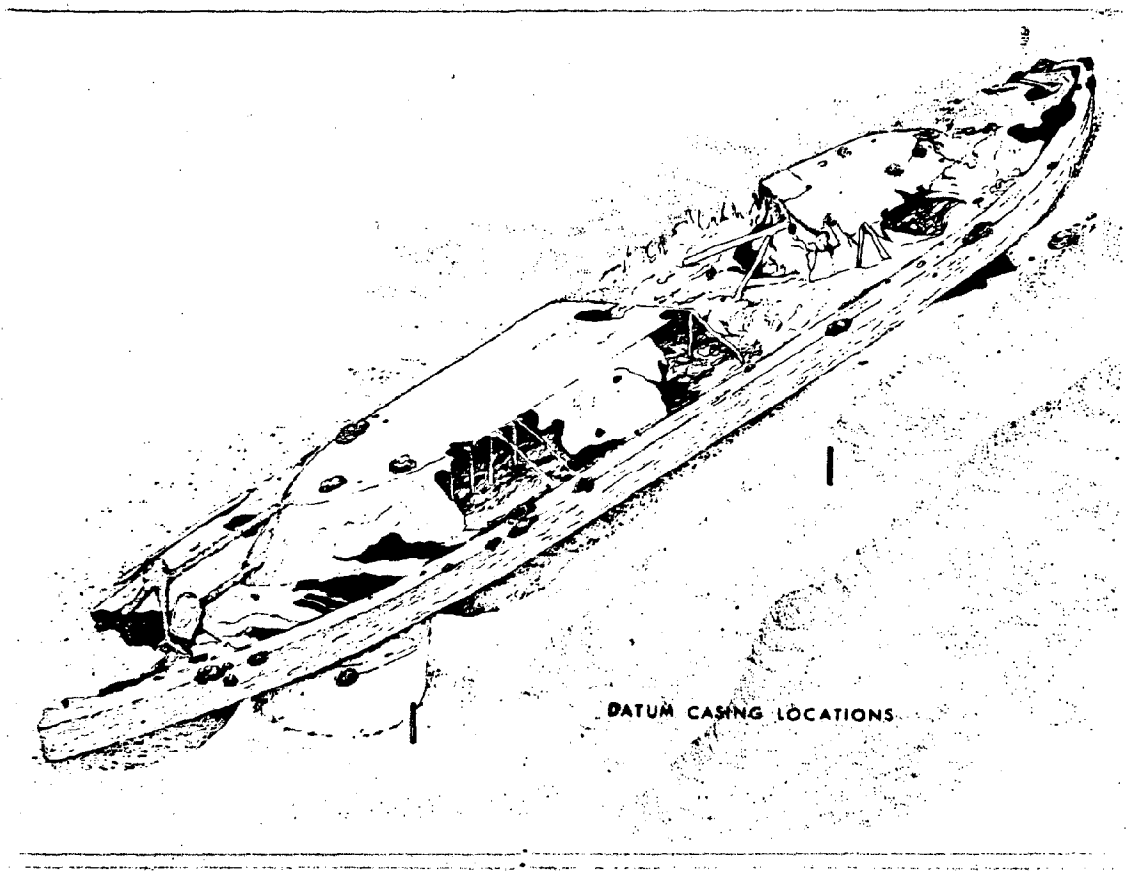
Figure 1.

The project began on August 1, 1979, with a non-lockout reconnaissance dive to examine the site. In the afternoon the first lockout was made to locate a positioning harness for the baseline datum stations and jet the first casing into the sediment adjacent to the amidships bulkhead. An electrically powered water pump mounted on the bow of the submersible provided water pressure sufficient to jet the first casing into a position identified by the harness. A leveling collar attached to the 3 inch casing provided the control necessary to assure a vertical orientation. While the first and second datum casings were easily jetted into the sediment to a depth of 5 feet, the remaining two located forward of the amidships bulkhead proved to be more difficult. At a depth of 3 feet an extremely compact stratum of sediment frustrated efforts to sink casings to the desired 5-foot depth. During the course of the project both of the forward casings were dislodged by the current. While it is possible that the stratum represents a natural formation, the discharge of calcareous material and black oxide from the casing indicated that the layer may be related to material associated with the Monitor (Figure 1).

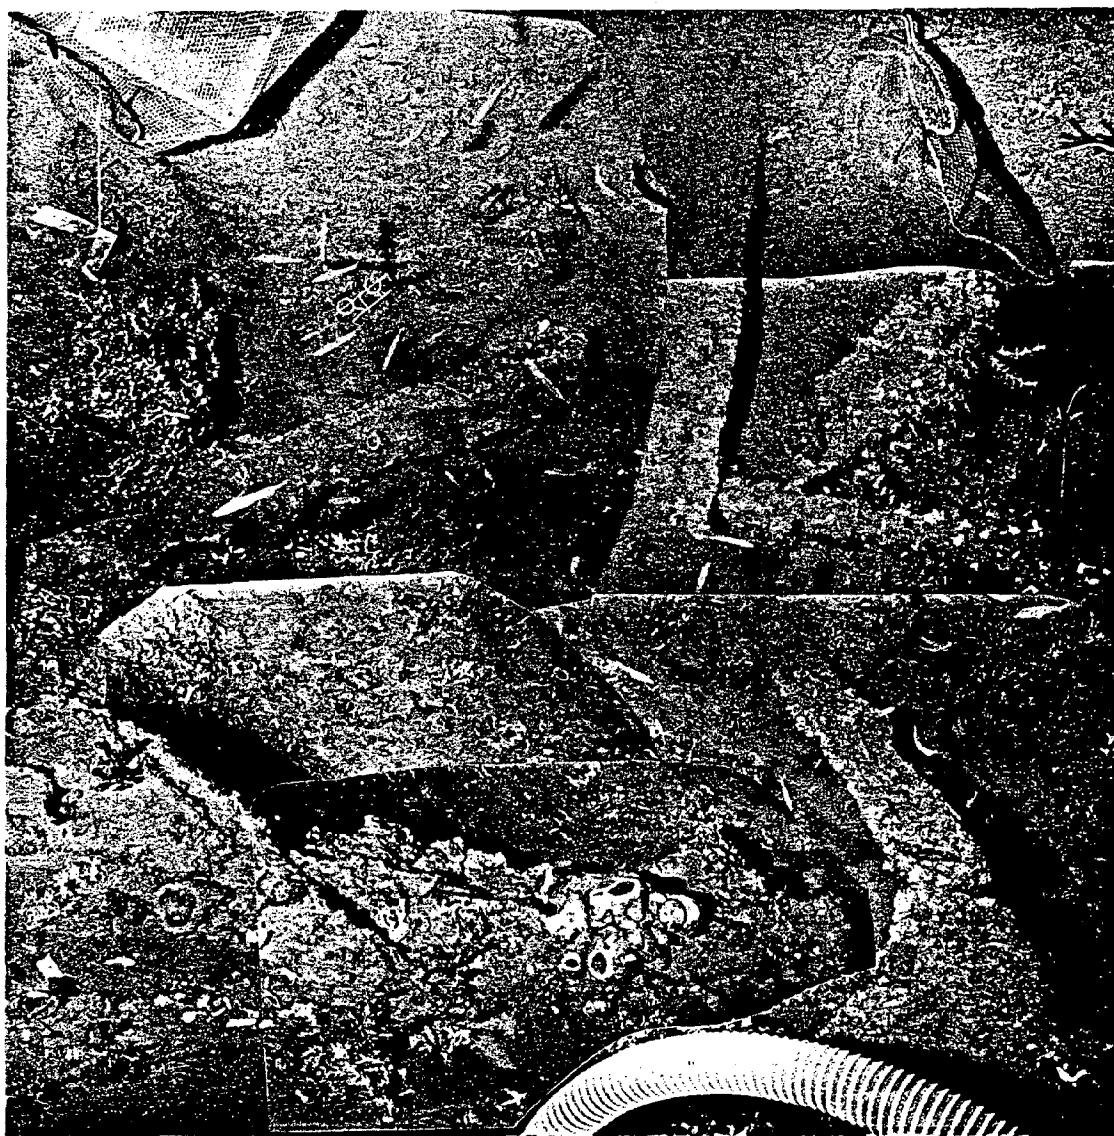
Initially the test excavation was carried out in a 5-foot square within the control frame (Figure 4). Because of the presence of structural material, it was necessary to reduce the scope of the excavation to a 2-by 5-foot rectangle in the southern end of the original excavation. In spite of additional structural material, it was possible to carry the excavation to deck timber and planking. Removal of the sediment was accomplished with the assistance of a hydraulic induction dredge powered by an electric pump mounted on the submersible. Discharge from the 3-inch dredge was routed over the armor belt to assist in keeping the water in the excavation area as free of sediment as possible (Figure 5).

Figure 4. Photomosaic documentation of material exposed after excavation of the first 6 inches of sediment.

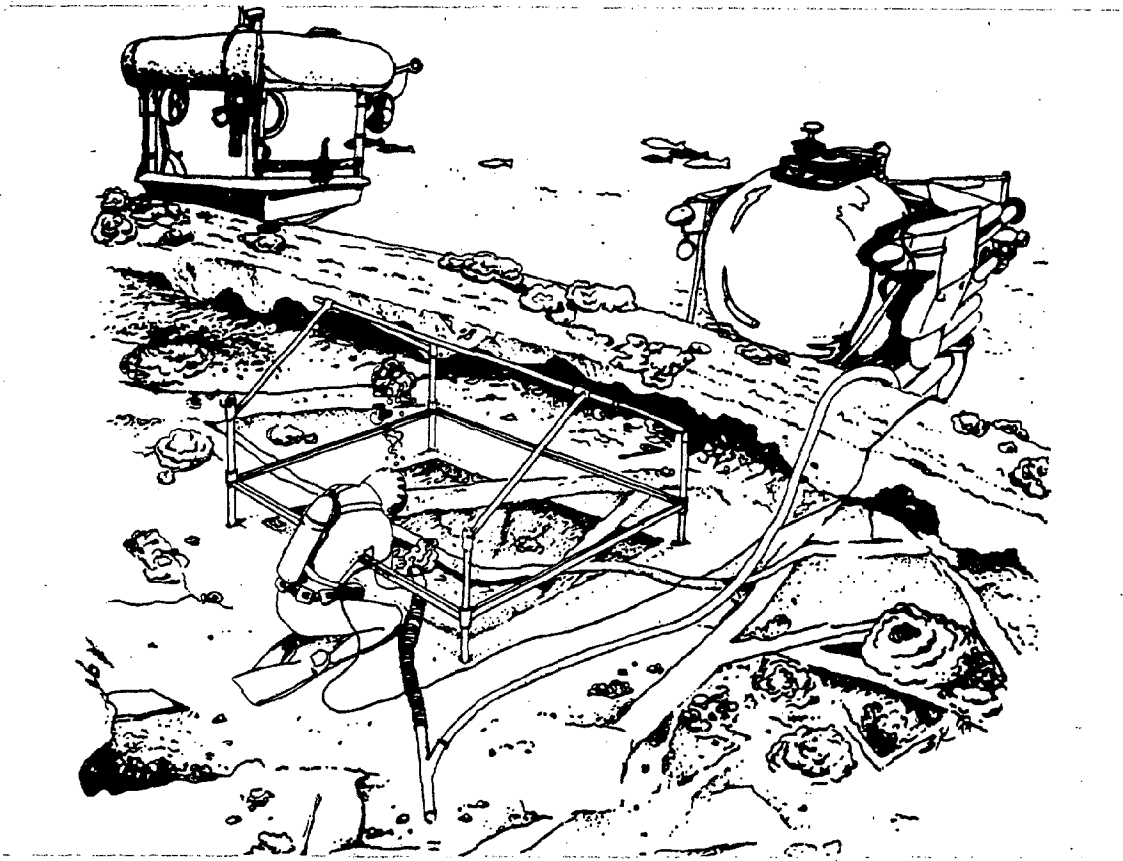
Figure 5. Artist's rendering illustrating the test excavation in progress.

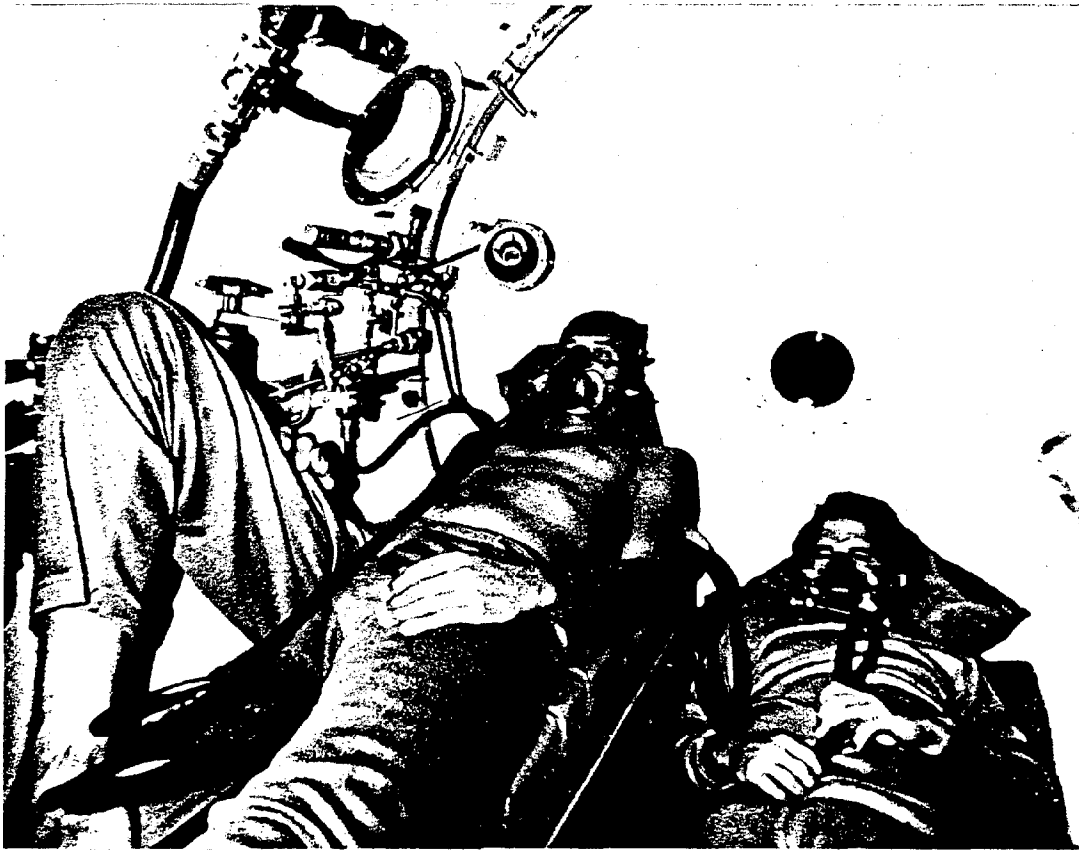
delivery systems, it is obvious that saturation mode operations represent a distinct advantage. Every hour on the site required approximately four and one half hours of decompression in the chamber aboard the support ship. This schedule automatically limited daily on-site operations to a maximum of 2 hours. While the lengthy decompression schedule provided an abundance of time for evaluating and assessing each dive, the schedule became taxing both mentally and physically for the divers after the first two weeks (Figure 8).

Figure 8. Decompression schedules provided ample opportunity to record and reflect on the activities of each lockout.
