SHORE EROSION STUDY

**SHORELINE EROSION AND BLUFF STABILITY ALONG LAKE MICHIGAN
AND LAKE SUPERIOR SHORELINES OF WISCONSIN**

SOUTHERN AND CENTRAL MANITOWOC COUNTY

APRIL 1977

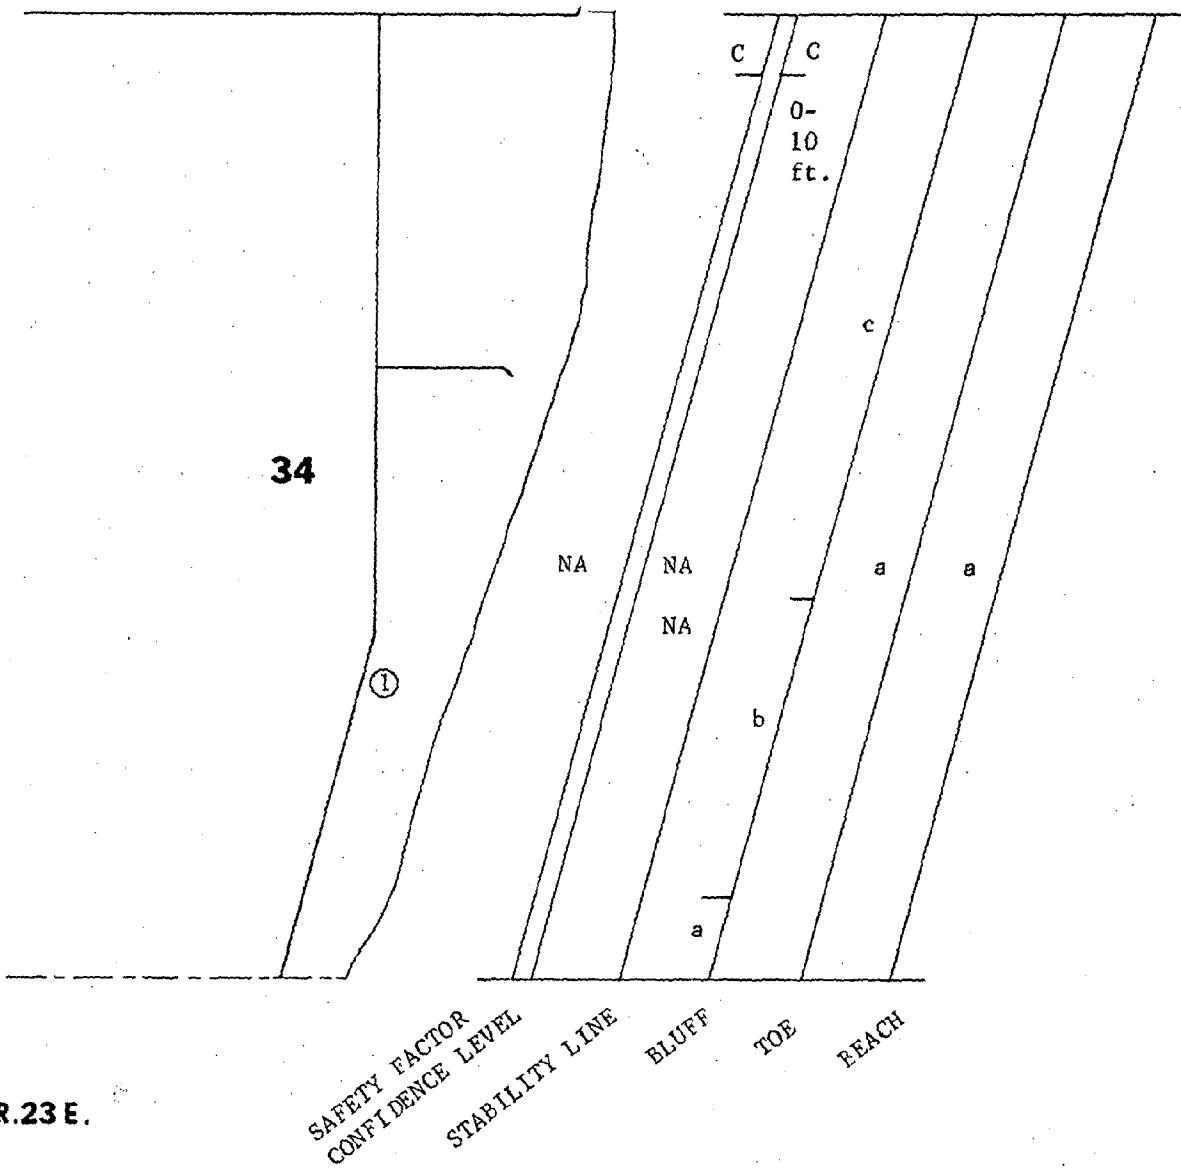
1. BLUFF	a-large scale sequential slumping	b-minor high angle slumping, some flows	c-large scale sequential slumping
2. TOE	a-slumped till '3C' and lacustrines, some exposures of till '3A'		
3. BEACH	a-20-35 ft. sand and cobbles

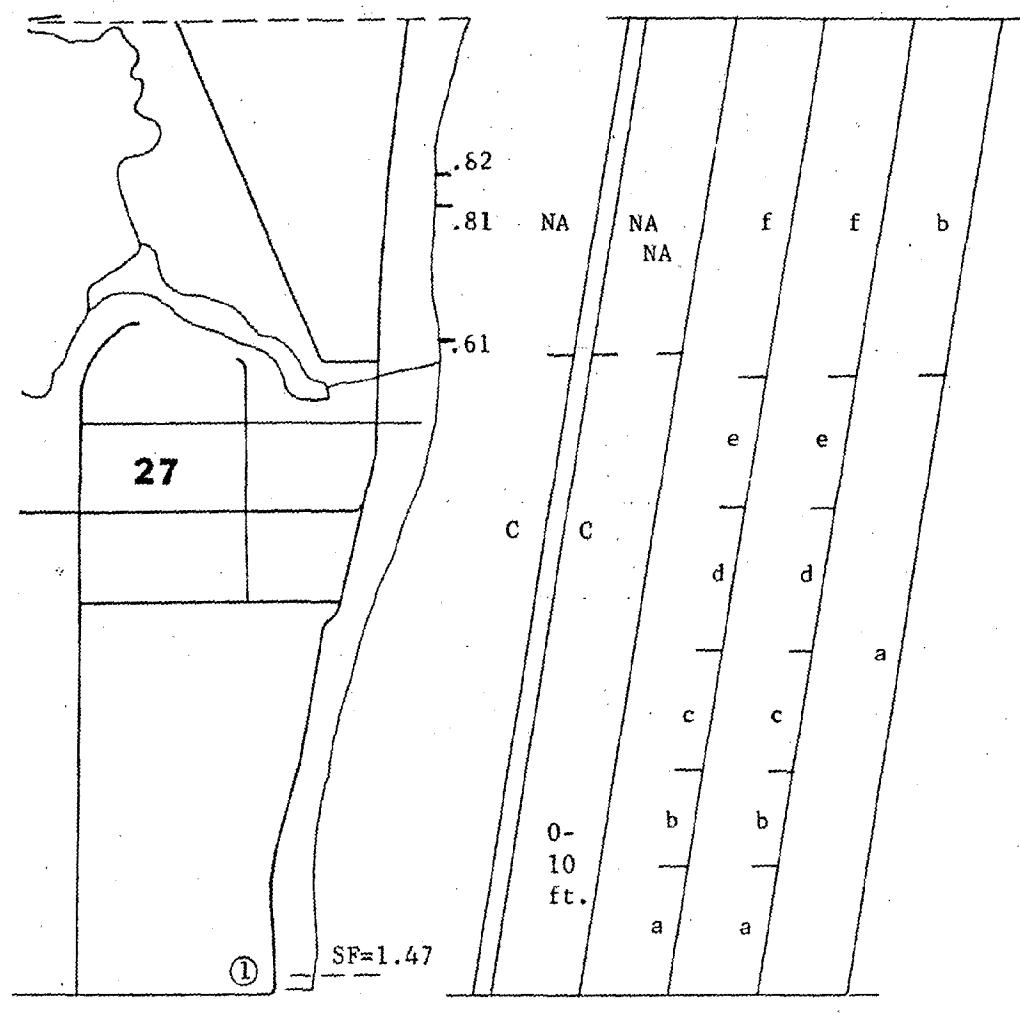
1. BLUFF	a-large scale sequential slumping; some exposures in scarp zone	b-rapid erosion, slope failures primarily by soil fall and high angle slumping	c-slumped and covered, entire bluff face involved	d-steep rapidly eroding bluffs, sapping and soil fall
	e-covered and vegetated; gentle slopes	f-terrace		
2. TOE	a-slumped till, clay, and silt	b-till 3A and slumped silts and clays	c-slumped silts and clays	d-till 3A
	e-sand	f-terrace sands		
3.BEACH	a-10-40 ft. cobbles	b-10-30 ft. sand and cobbles

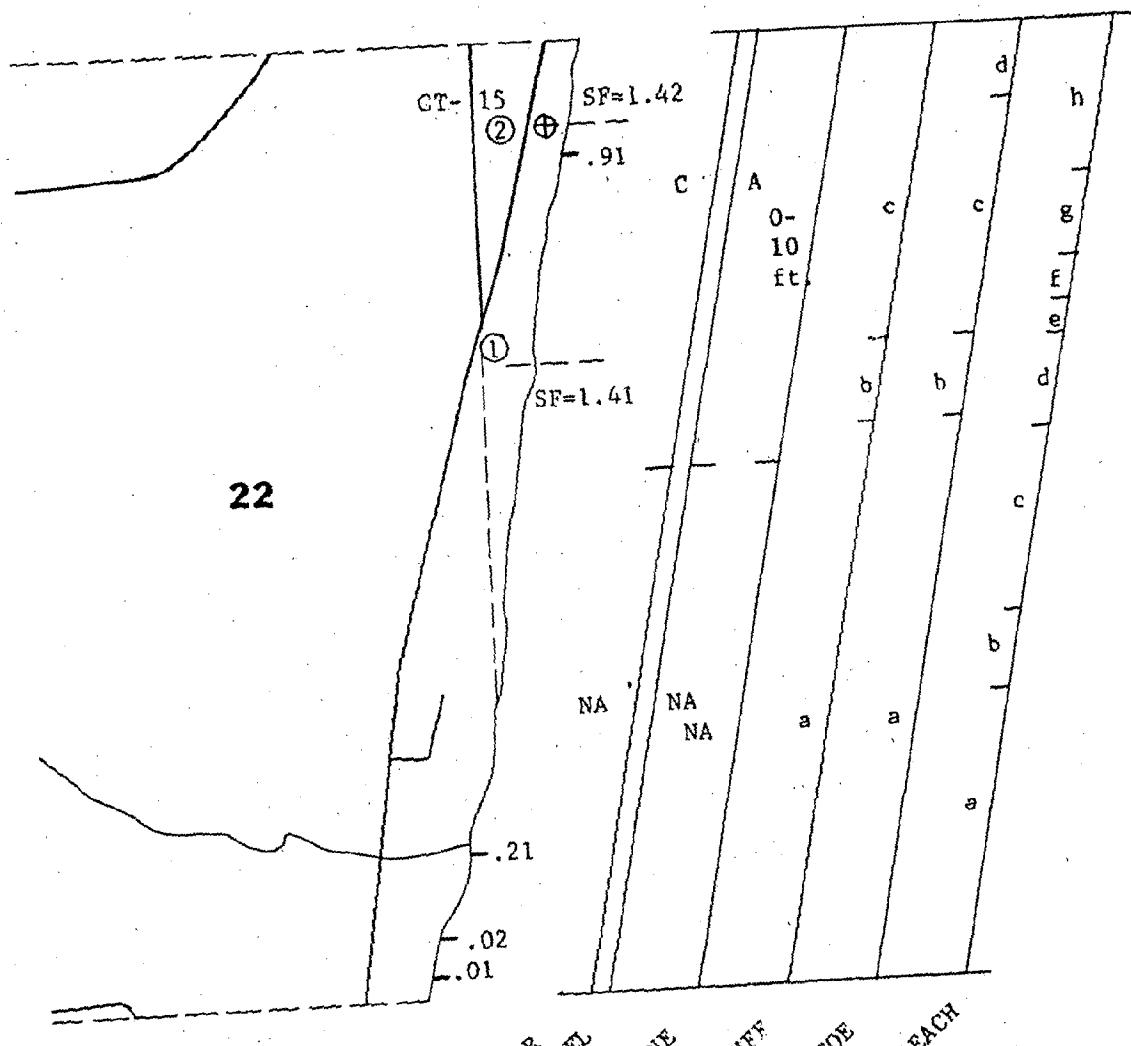
1. BLUFF	a-stable, fully vegetated bluff protected by terrace	b-2-15 ft. near vertical cut face in very stiff till; 2-5 ft. of coarse sand above; slope fully vegetated above cut face	c-closely spaced slumped areas; some full face, but most involving only lower 2/3 of slope; significant subsequent flowage of slumped silts.	
2. TOE	a-sands of terrace	b-stiff red-brown clayey silt till, few stones.	c-primarily slumped and flowed silts; scattered till exposures.	
3. BEACH	a-30-50 ft. beach; largely sand but cobbles in shoreward portion.	b-30-50 ft. cobble beach	c-30-50 ft. m-c sand beach	d-0-15 ft. cobble beach
	e-0-20 ft. c. sand beach	f-0-15 ft. cobble beach in front of revetment	g-0-10 ft. cobble beach behind revetment	h-0-25 ft. sand and cobble beach

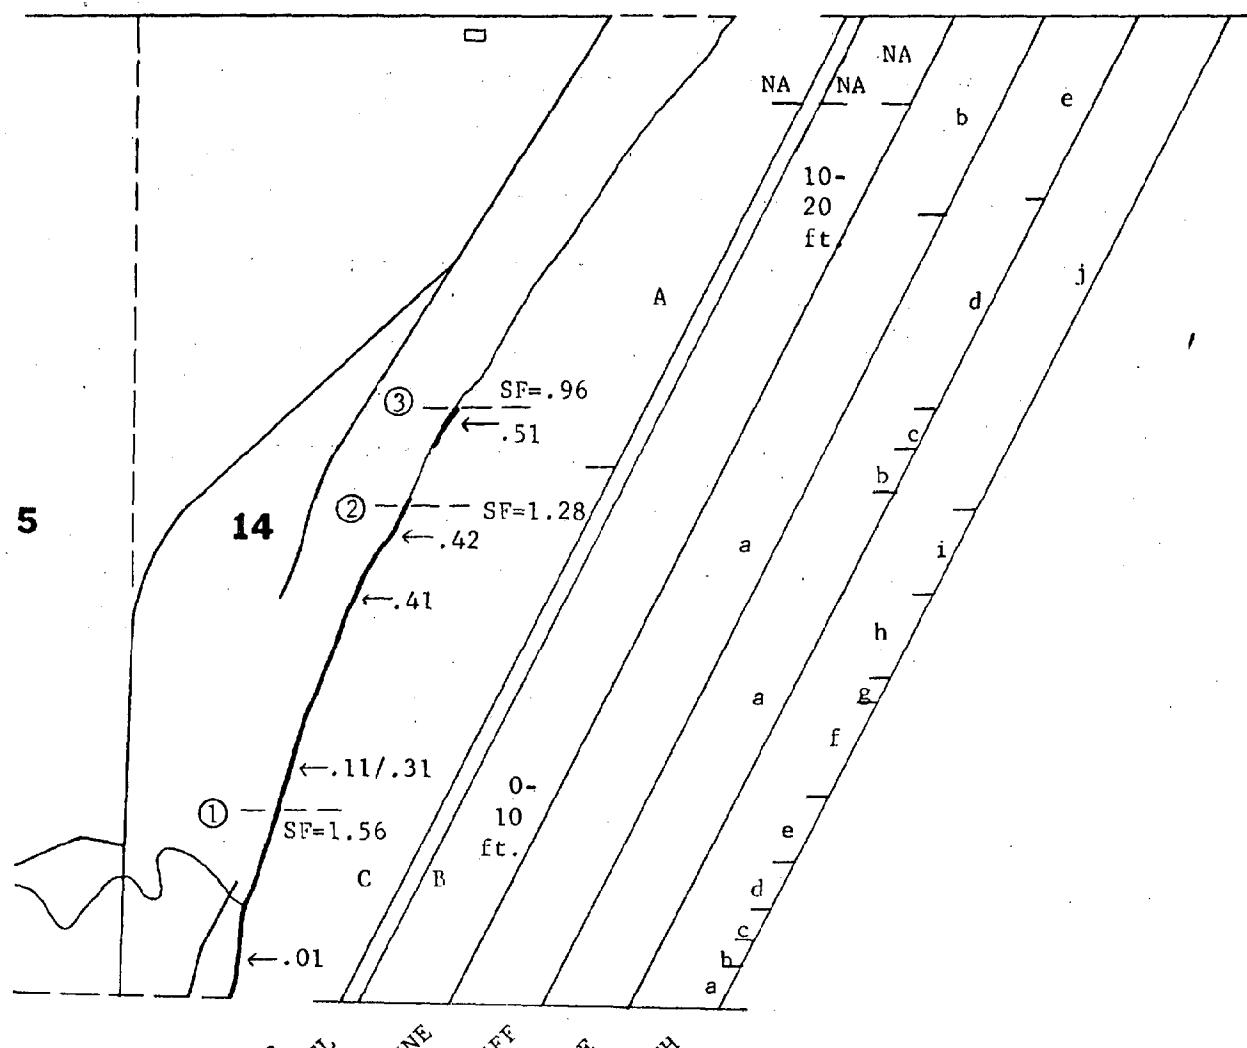
1. BLUFF	a-slumping and soil fall	b-vegetated and stable		
2. TOE	a-rip-rap	b-sand	c-rip-rap	d-slumped clay and silt, some sand
	e-sand			
3. BEACH	a-0-65 ft. sand	b-no beach	c-0-40 ft. sand	d-no beach
	e-0-40 ft. sand	f-no beach	g-0-25 ft. sand	h-no beach
	i-0-45 ft. sand	j-0-30 ft. sand

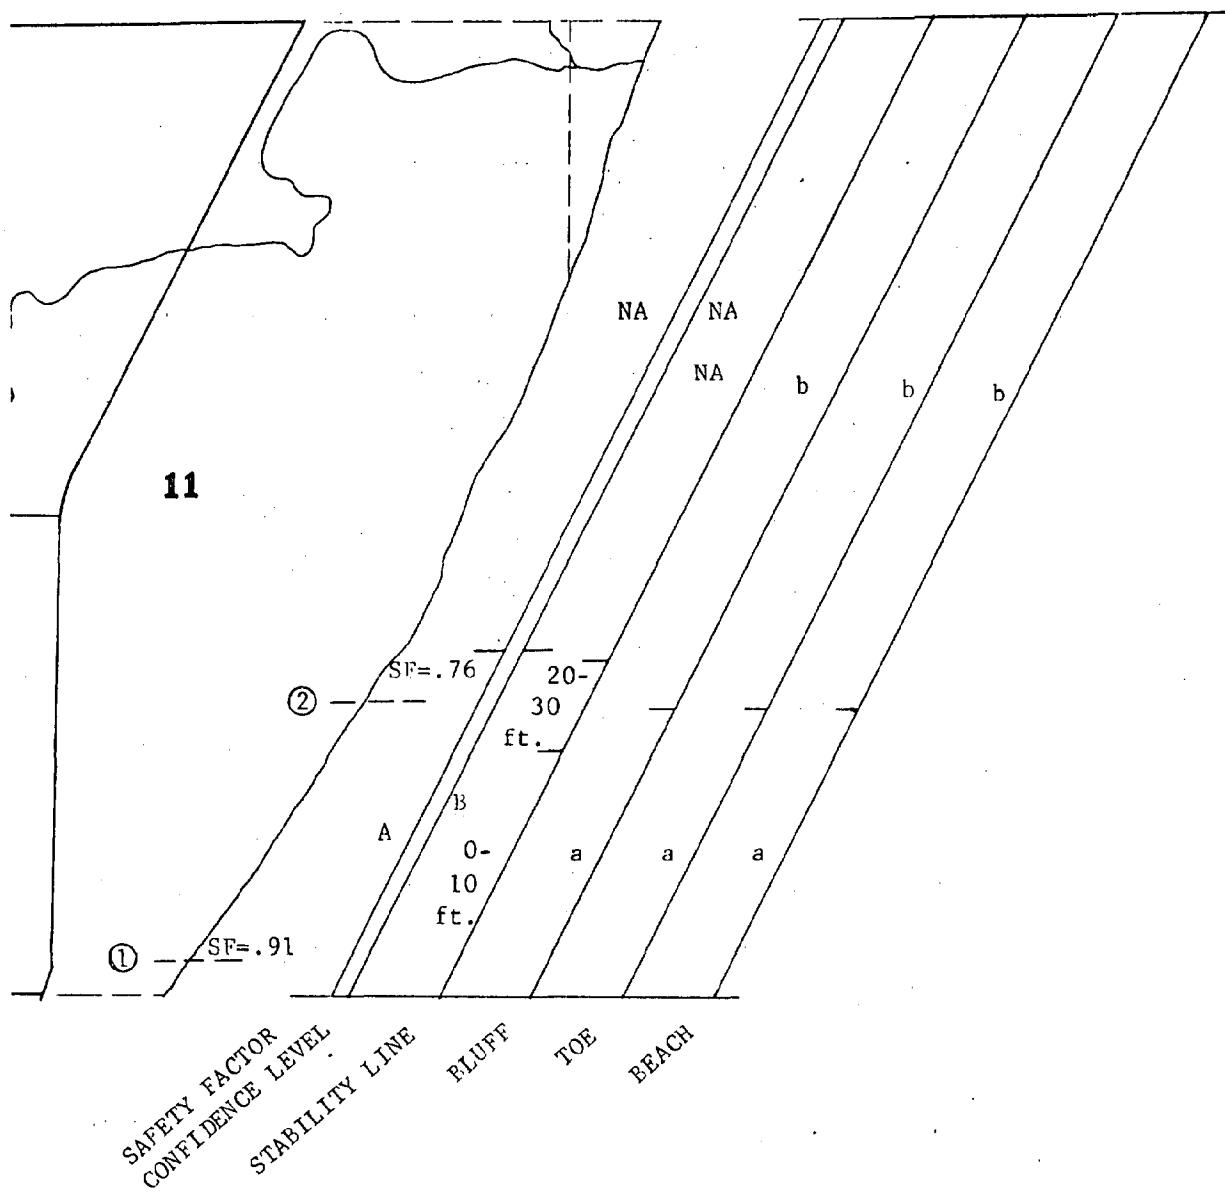
1. BLUFF	a-undercutting and soil fall	b-slumps and shallow slides in sand	
2. TOE	a- till 3A and slumped sand, silt and clay	b-slumped sand	
3. BEACH	a-sand and gravel, greater than 30 ft.	b-50-80 ft. sand

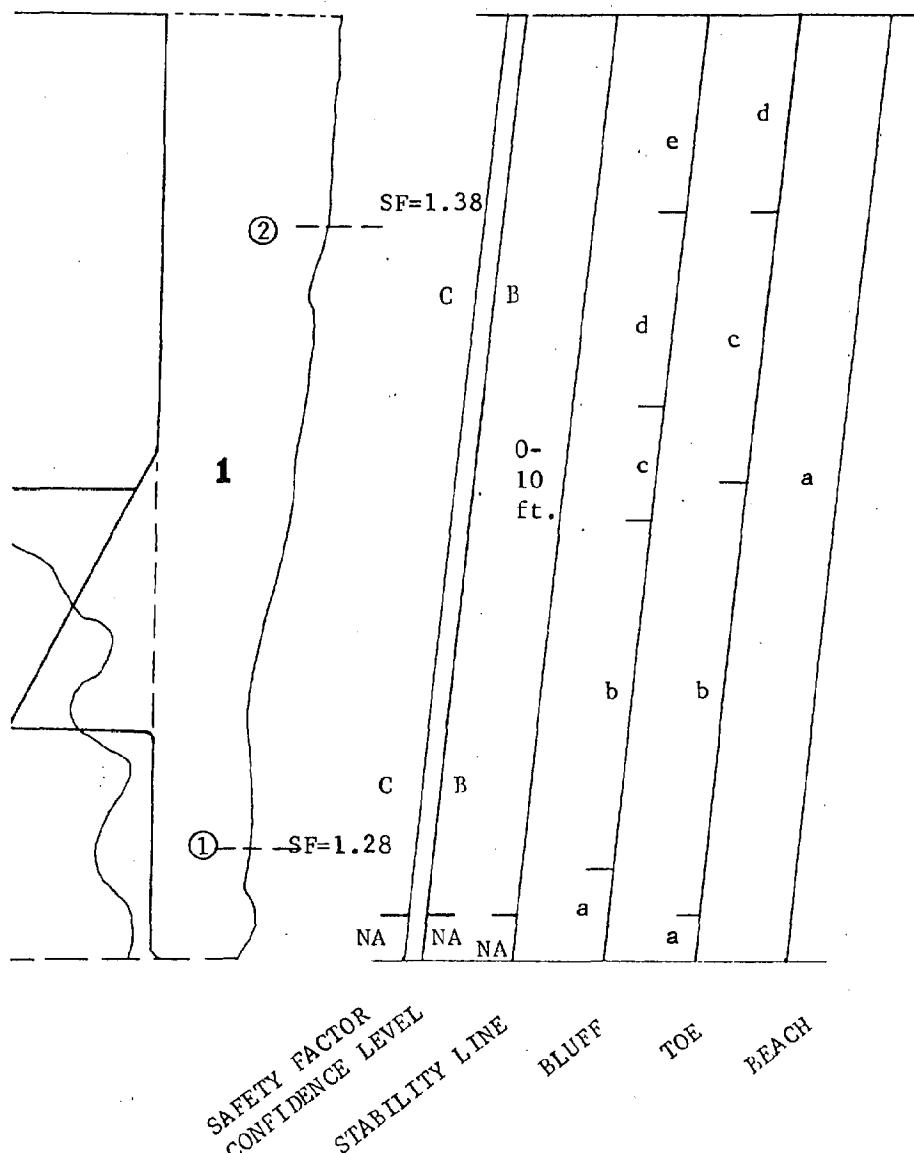
1. BLUFF	a-high angle slumping, upper $\frac{1}{2}$ of slope remains vegetated.	b-large scale slumping, full face involved.	c-undercutting and soil fall; full face involved.	d-undercutting and soil fall, usually involves only the lower 1/3 of bluff; upper slopes remain vegetated.
2. TOE	a-till '3A'	b-sand and slumped sand	c-till '3A' and slumped sand	d-slumped till, silts, and clays
3. BEACH	a-30-55 ft. of sand, some gravel near lake margin.

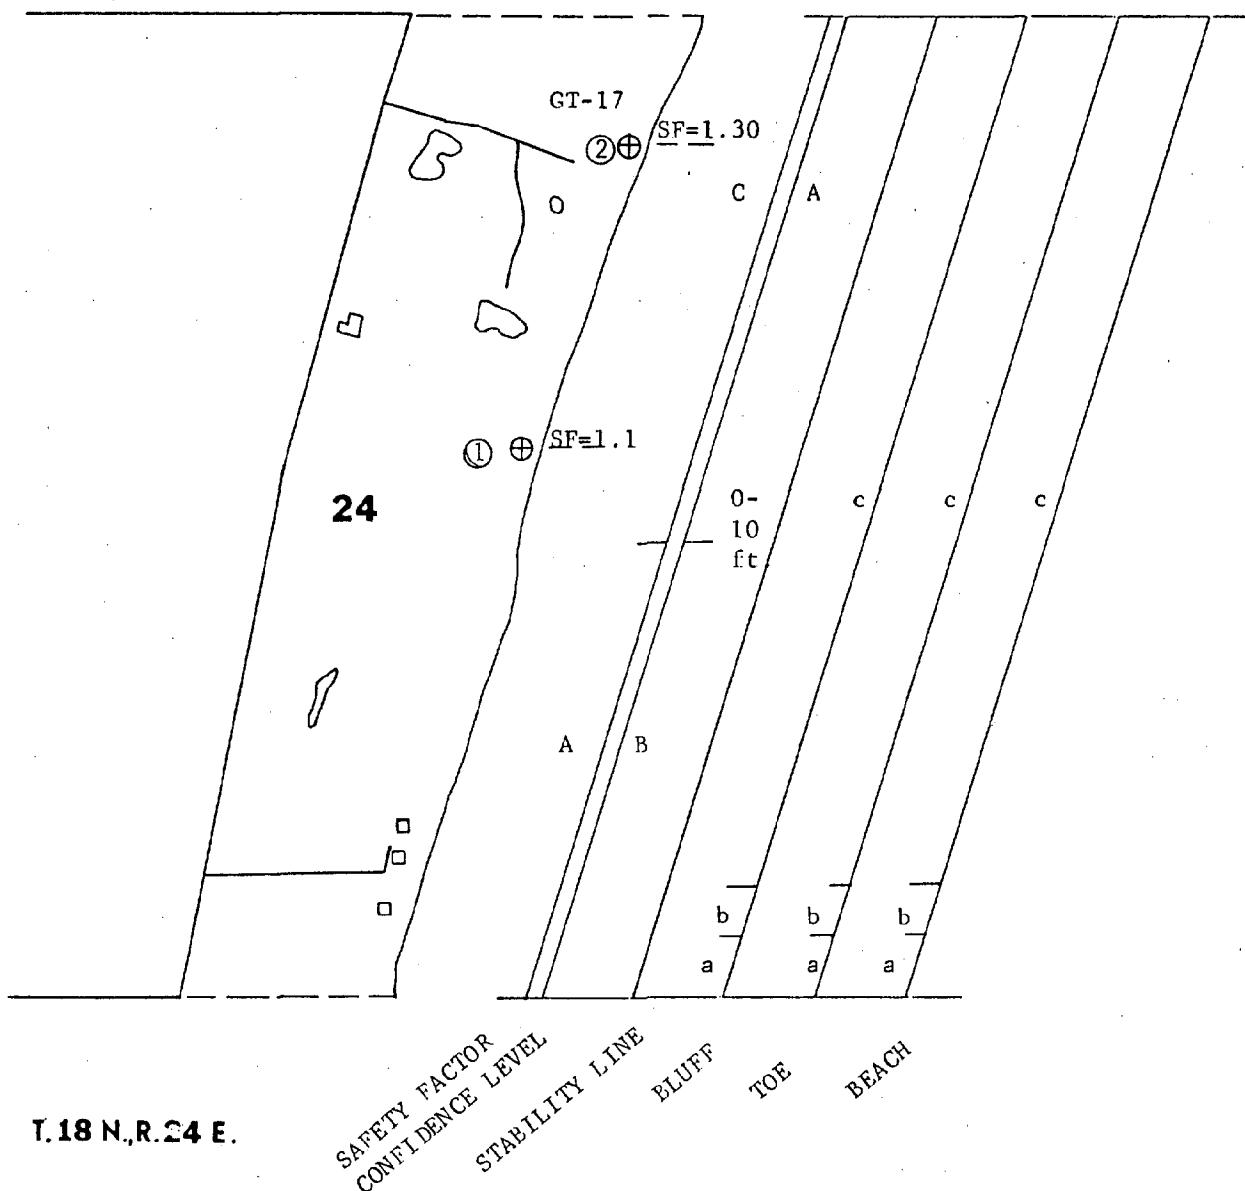
1. BLUFF	a-moderately steep bluffs with considerable slumping in the lower 1/3 of the slope; the upper 2/3 generally vegetated with grasses	b-large slumps of the total face; vegetation still in place on the slump blocks	c-rapid erosion resulting in high angle slumping and soil falls; at some locations only the lower slopes are involved	
2. TOE	a-till '3A' together with slumped till and sand and gravel	b-slumped sand and gravel	c-till '3A' and slumped till and sand and gravel	
3. BEACH	a-20-30 ft. of cobbles	b-no beach	c-0-30 ft. of cobbles

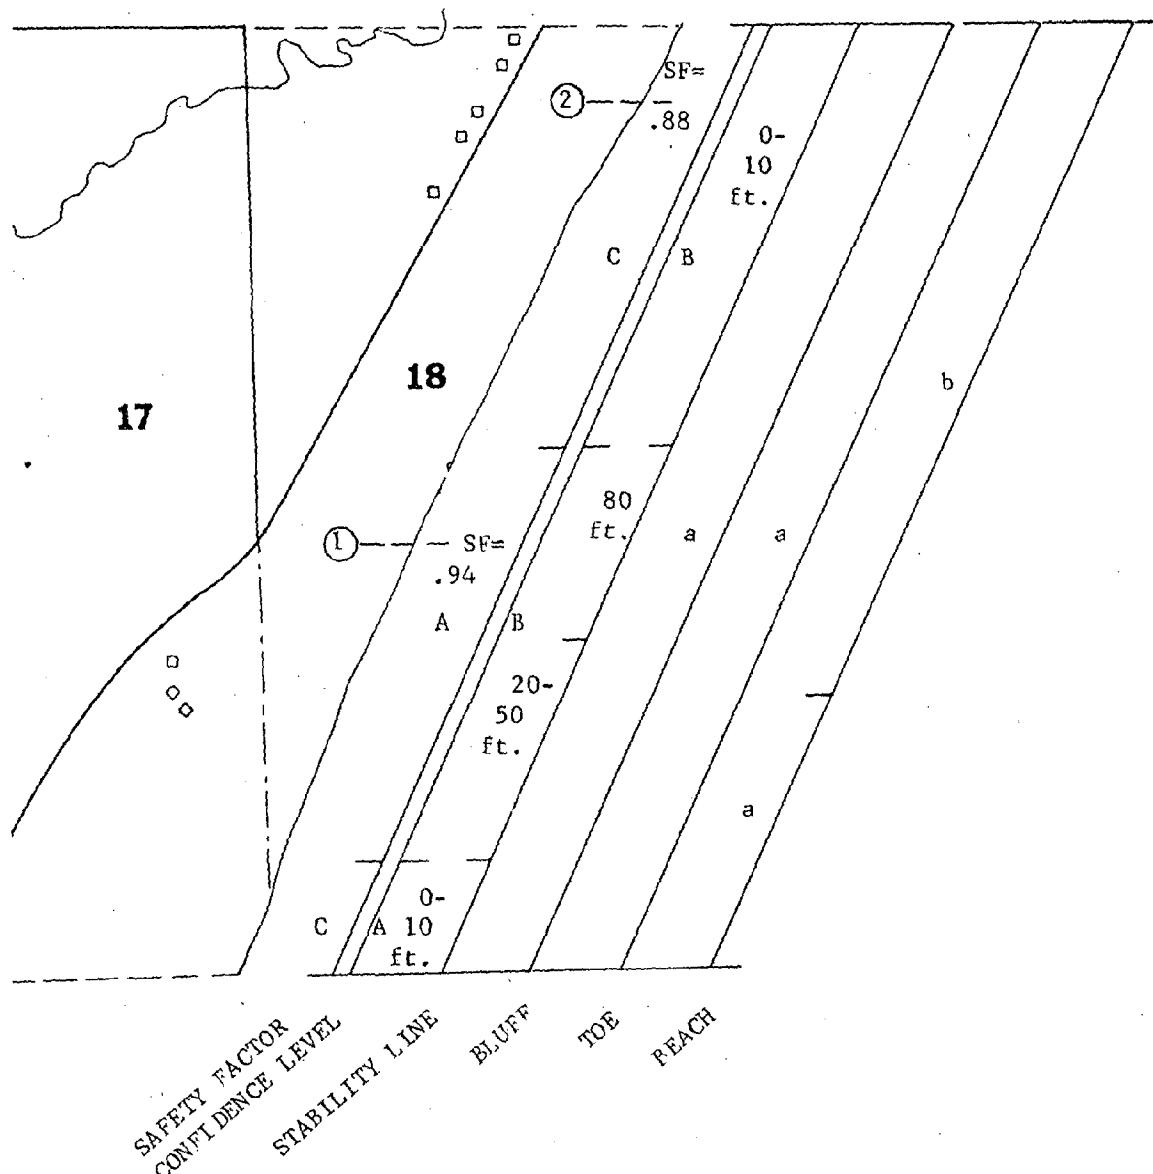
1. BLUFF	a-primarily soil falls, high angle slumping secondary		
2. TOE	a-slumped till '3A', some slumped sand		
3. BEACH	a-20-30 ft. gravel and cobbles	b-5-50 ft. gravel and cobbles

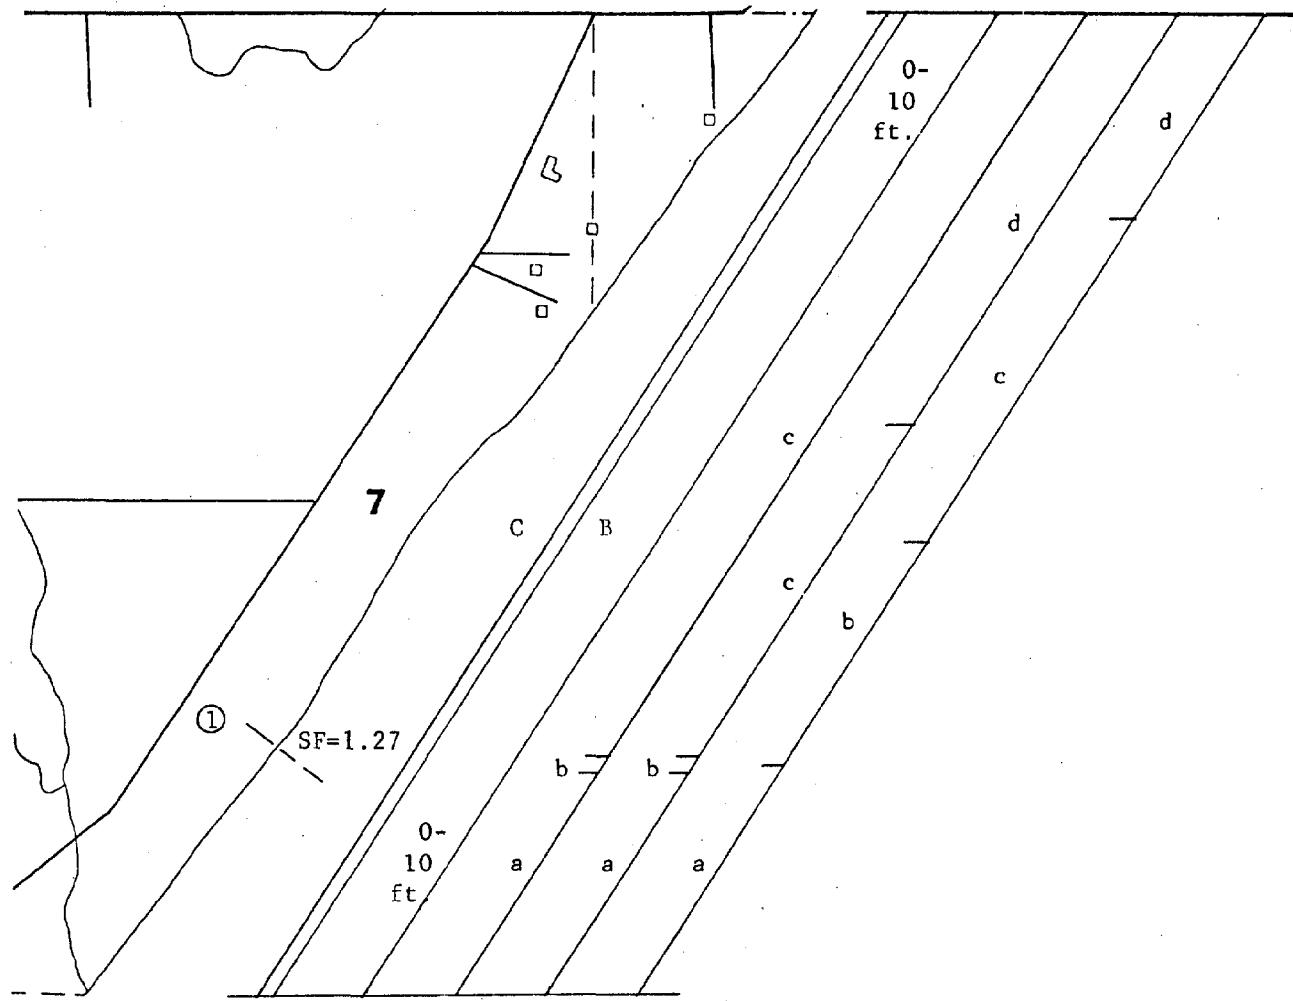
1. BLUFF	a-steep rapidly eroding bluffs; high angle slumps and soil falls; lower slopes covered by slumped material.	b-full face slumping; slump block heavily vegetated.	c-same as segment 'a'	
2. TOE	a-primarily slumped till '3A'	b-slumped till '3A' and over-lying lacustrine sediments	c-mainly slumped till '3A'	d-slumped till '3C' and sand and gravel
3. BEACH	a-20-30 ft. cobbles	b-20-30 ft. cobbles and boulders	c-20-50 ft. sand and cobbles	d-20-30 ft. cobbles

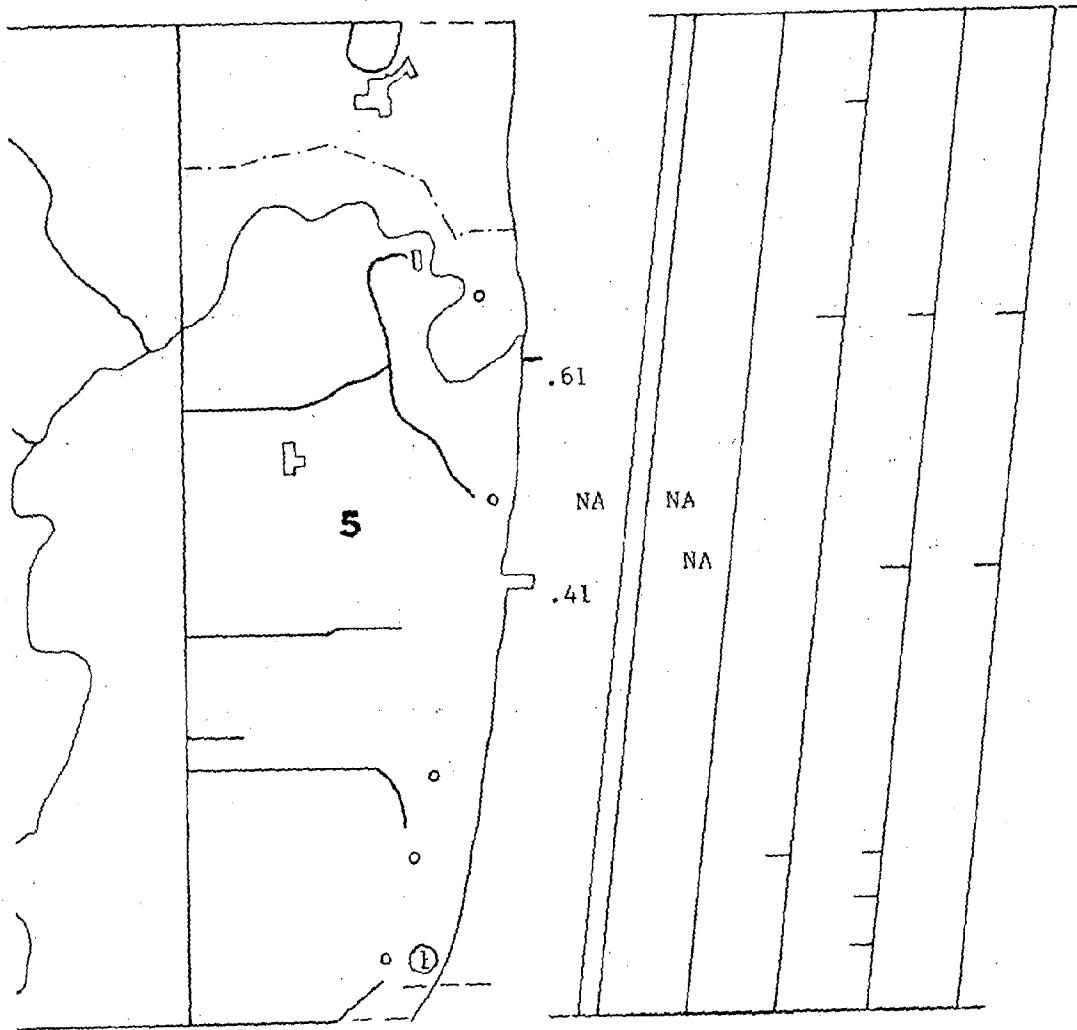
1. BLUFF	a-rapidly eroding high bluff; slumping and sliding, largely based in sand and gravel in lower half of the slope	b-large scale slumping; slump blocks vegetated	c-no bluff	d-grass covered stable slopes
2. TOE	a-slumped sand and gravel	b-slumped till '3C'	c-slumped till '3C' and sand	d-slumped till '3C'
	e-slumped till '3C' and sand	f-sand		
3. BEACH	a-20-40 ft. sand and cobbles	b-0-20 ft. sand	c-greater than 50 ft. of sand

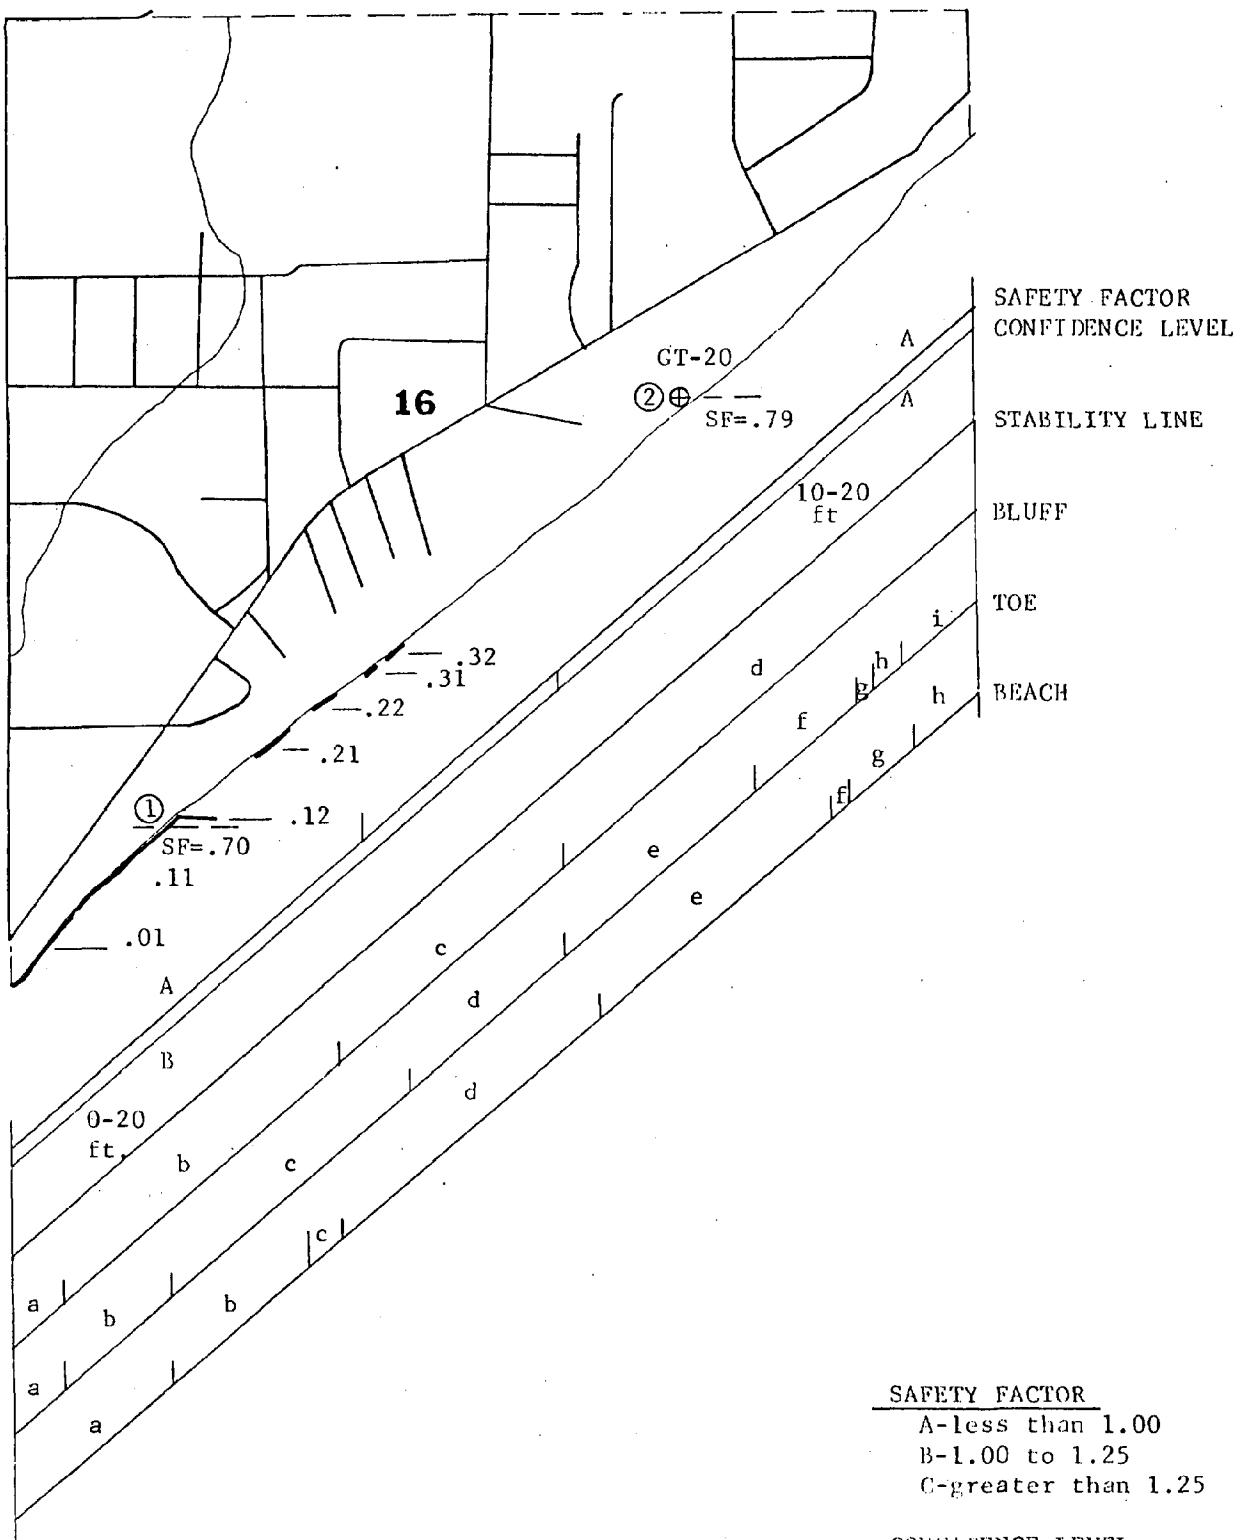
1. BLUFF	a-no bluff	b-low bluff; slumps and flows	c-no bluff	d-steep medium to low bluff, sapping and soil fall
2. TOE	a-revetment	b-slumped silt and clay behind revetment	c-cobbles and fill	d-silt
	e-slumped silt and clay	f-sand and silt	g-till '3B'	h-silt
	i-till '3C'			
3. BEACH	a-0-20 ft. sand	b-30-50 ft. sand	c-no beach	d-30-50 ft. sand
	e-0-20 ft. cobbles	f-no beach	g-200 ft. cobbles	h-30 ft. sand and cobbles
