# SHORE EROSION STUDY Technical Report

SHORELINE EROSION AND BLUFF STABILITY ALONG LAKE MICHIGAN  
AND LAKE SUPERIOR SHORELINES OF WISCONSIN

DOUGLAS AND WESTERN BAYFIELD COUNTIES  
WISCONSIN POINT TO BARK BAY

July 1980

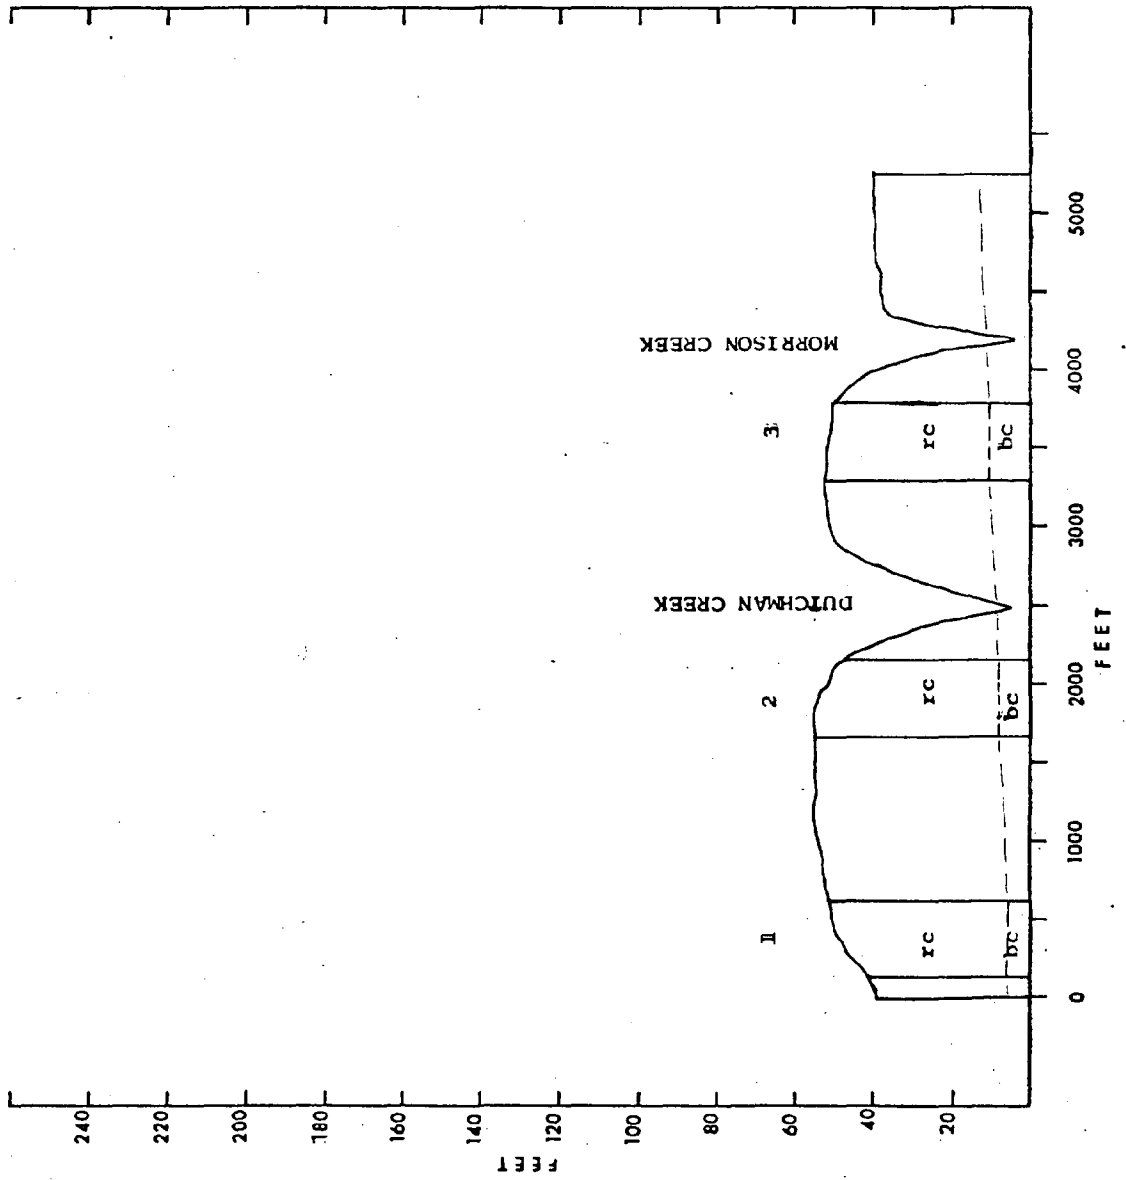
T.49N., R. 13W., Sec. 36

- a) red clay; slumped; protected by beach
- b) clay, slumped, protected, vegetated with alder and grass or scarped at large slump blocks
- c) clays, slumped, partially protected, failing for 10 ft vertically by shallow sliding with 2-3 ft scarps at base unvegetated
- d) clays, slumped, unprotected from waves, failing by shallow sliding and mudflows with 8-12 ft scarps at base, unvegetated
- e) clays, slumped, partially protected, failing for 10 ft vertically by shallow sliding with 2-3 ft scarps at base unvegetated

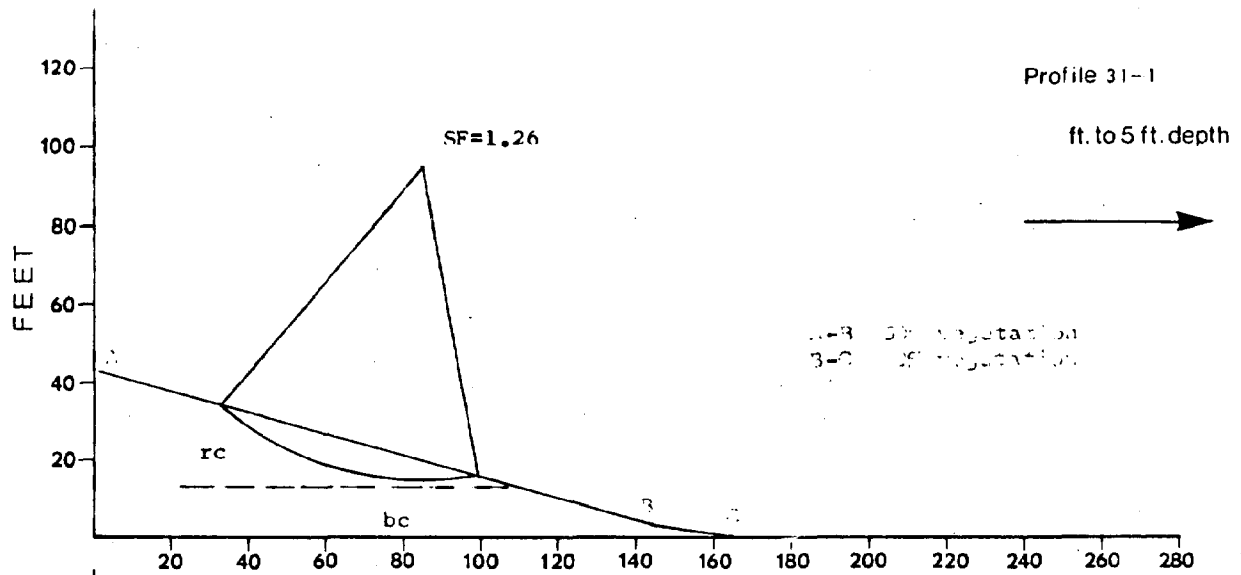
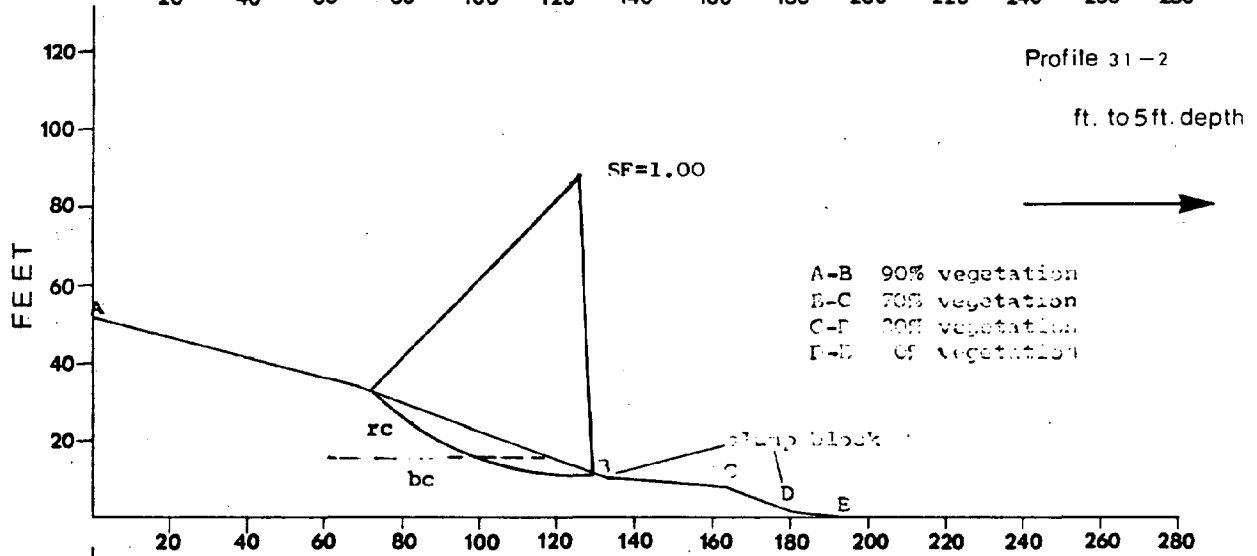
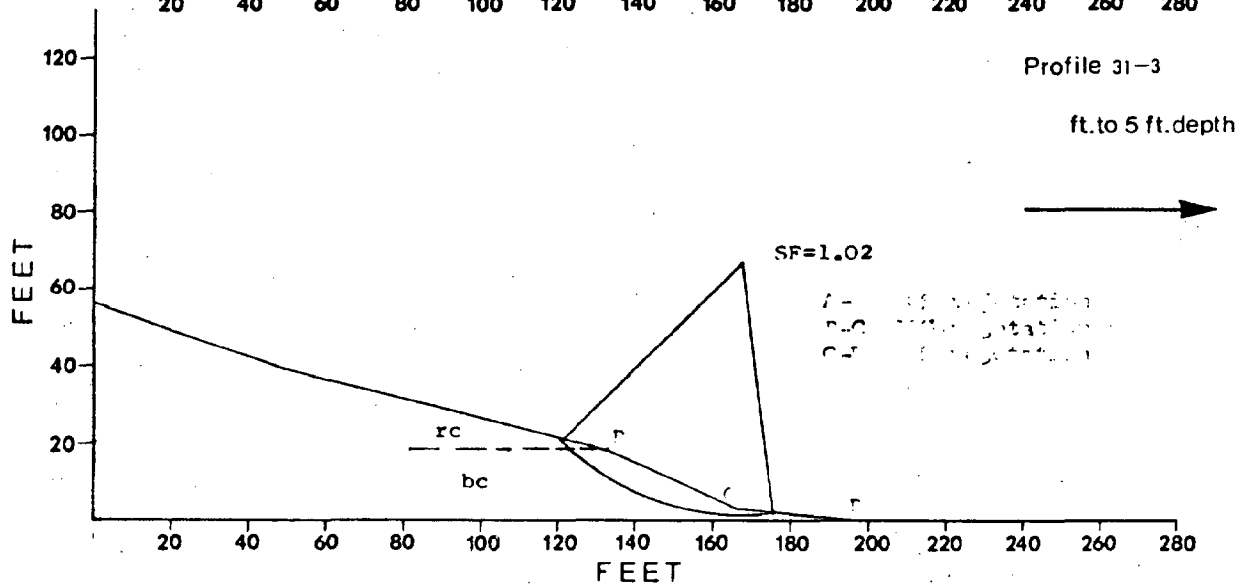
- a, c, and e) 50-90% vegetated with birch, alder, occasional fir, with horsetails in wet or locally failed places; predominantly red clay slumped; medium scale rotational slumps and shallow slides; bluff crest rises from 40 ft to 50 ft eastward; rounded but commonly showing a scarp and cut by 1-5 ft ravines.
- b, d, and f) 10-40% vegetated with alder; birch with grass in clumps moving downslope, horsetails in wet areas; red clay, slumped; bluff surface straight and failing; bluff height 40' rising to 55' to the east

- a, c, e, g, and i) Medium sand, with pebble concentration 3' from shore with occasional boulders; 15-20' wide; driftwood accumulation at back of beach
- b, d, f, and h) Covered, beach absent

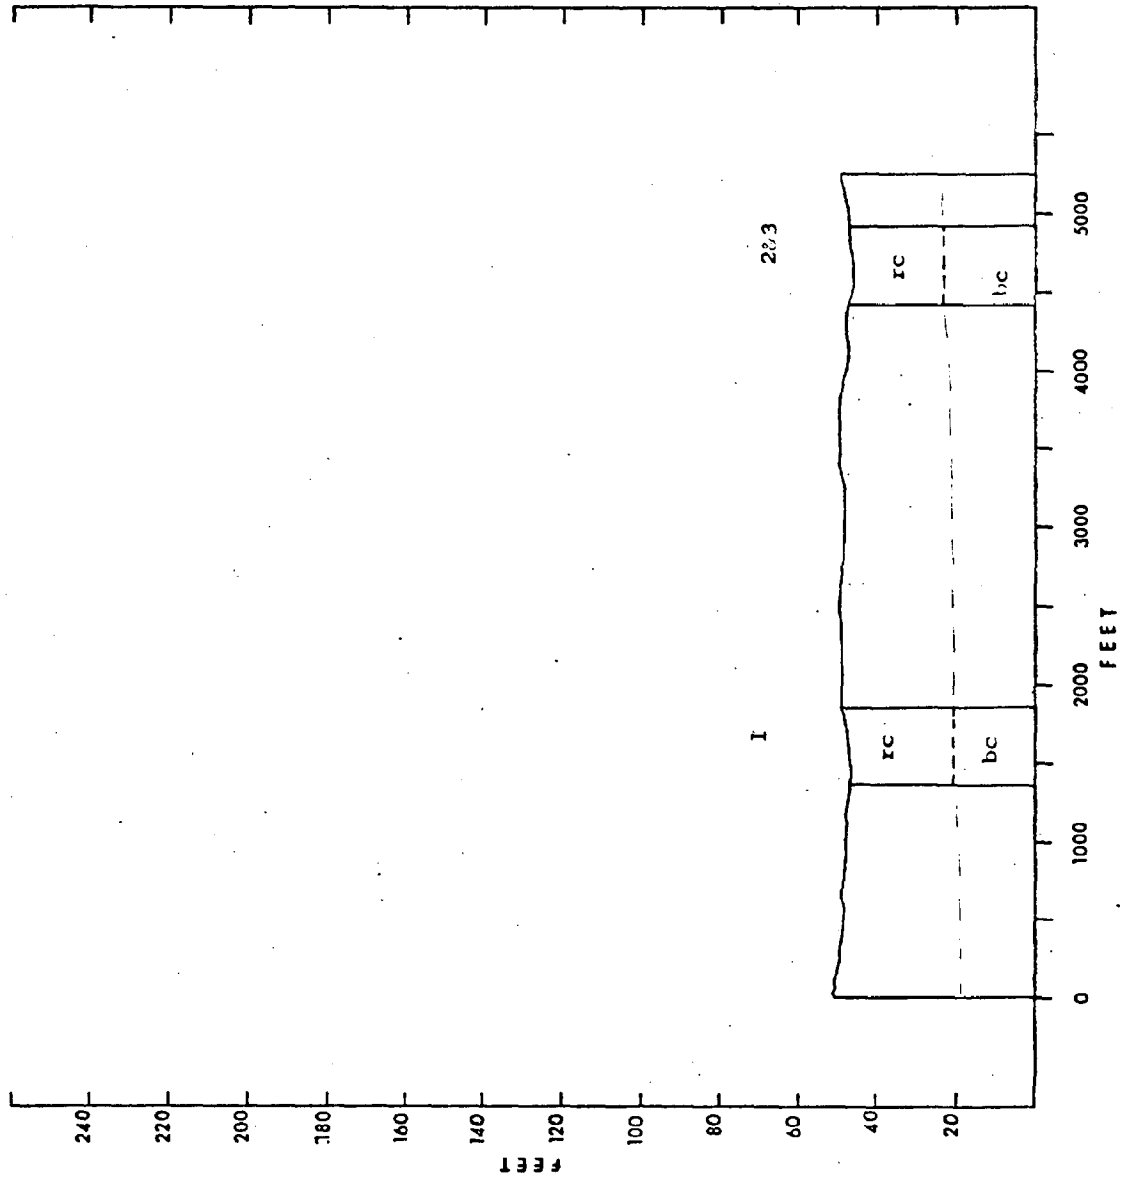
T. 49 N., R. 12 W., Sec. 32

- a) 45-50 ft high; crest scalloped; shallow slides; vegetation (50-60%) restricted to clump on actively moving slump blocks; clay
- b) 45-50 ft high; crest subdued; well-vegetated (80-90%) with alder, birch, some conifer, grass, moss, and horsetails toward the toe; fairly stable of late but fresher a-mid-slope scarp was often noted, clay
- c) 45-50 ft high, crest newly scalloped; vegetation being destroyed (0-10%); shallow slides, clay

- a) mixed-colored clay (red-brown-gray); slumped; generally protected from wave action
- b) red and brown clay; slumped; under wave attack; failing for 12 ft vertically by shallow slides and mudflows

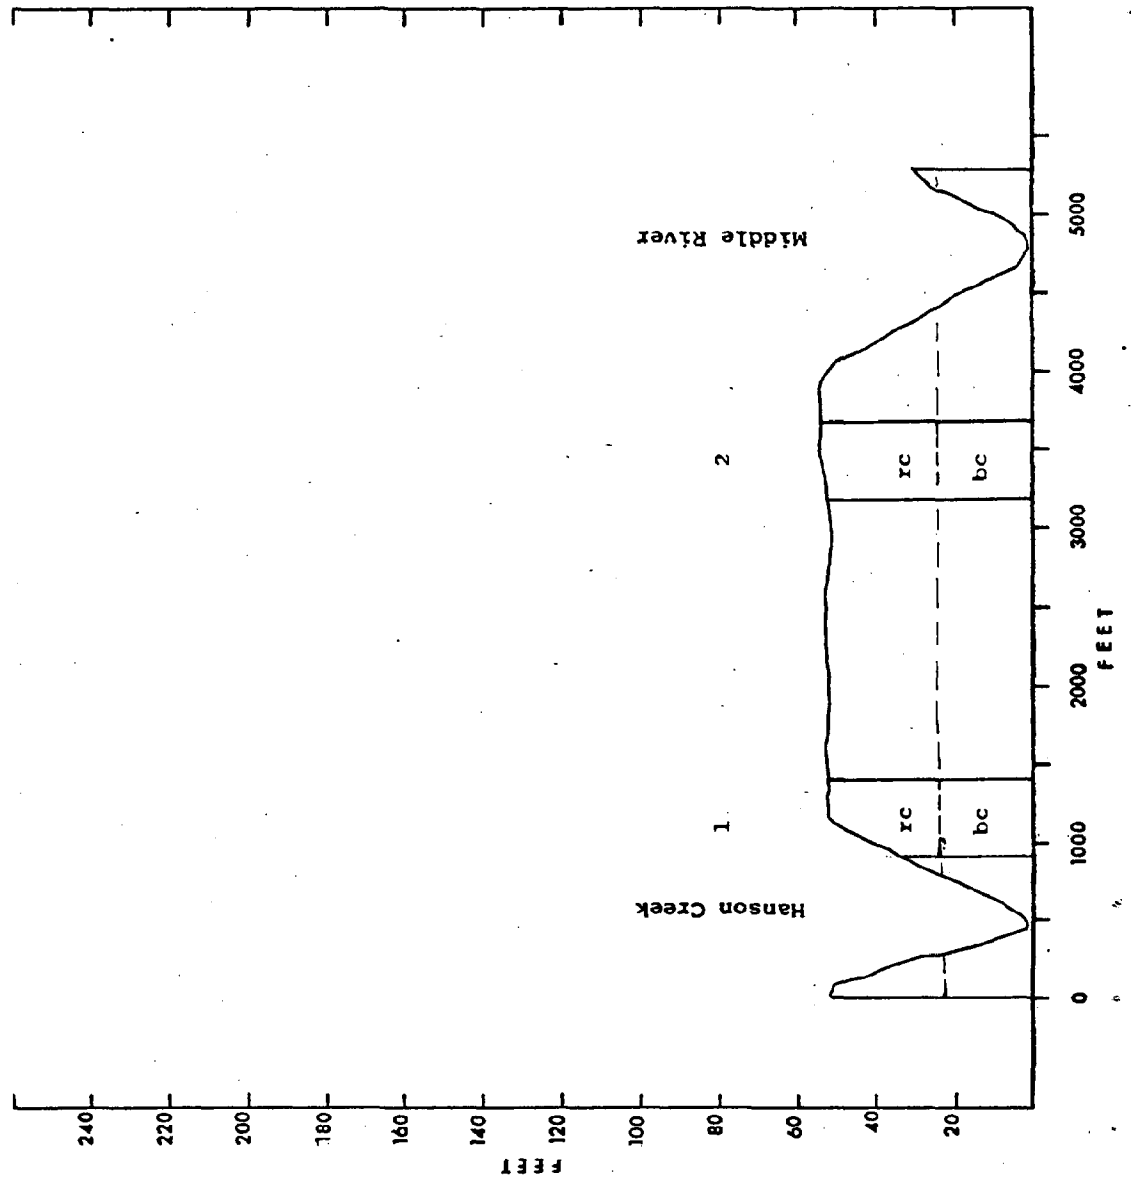
T.49 N., R.12 W., Sec.35

- a) 50 ft dropping to 0 ft; shallow slide and block fall; 0% vegetation, red and brown clay
- b) absent
- c) rising to 50 ft; eastward shallow slides; flows from top 0-5 to 40-50% alder and grass; two clay units
- d) 30 ft falling to 0 ft; no failure seen; vegetation 95-100%, birch, alder, grass, horsetails
- e) 50-55 ft; shallow sliding and flows from top; vegetation usually 0-20% alder grass slumped clay
- f) 30 ft falling to 0 ft; no failure seen; vegetation 95-100%, birch, alder, grass, horsetails
- g) absent gentle graded slope - well vegetated
- h) 0 ft rising to 30 ft; shallow slides and some block fall; 10-20% tree-clumps and horsetails, slumped clay

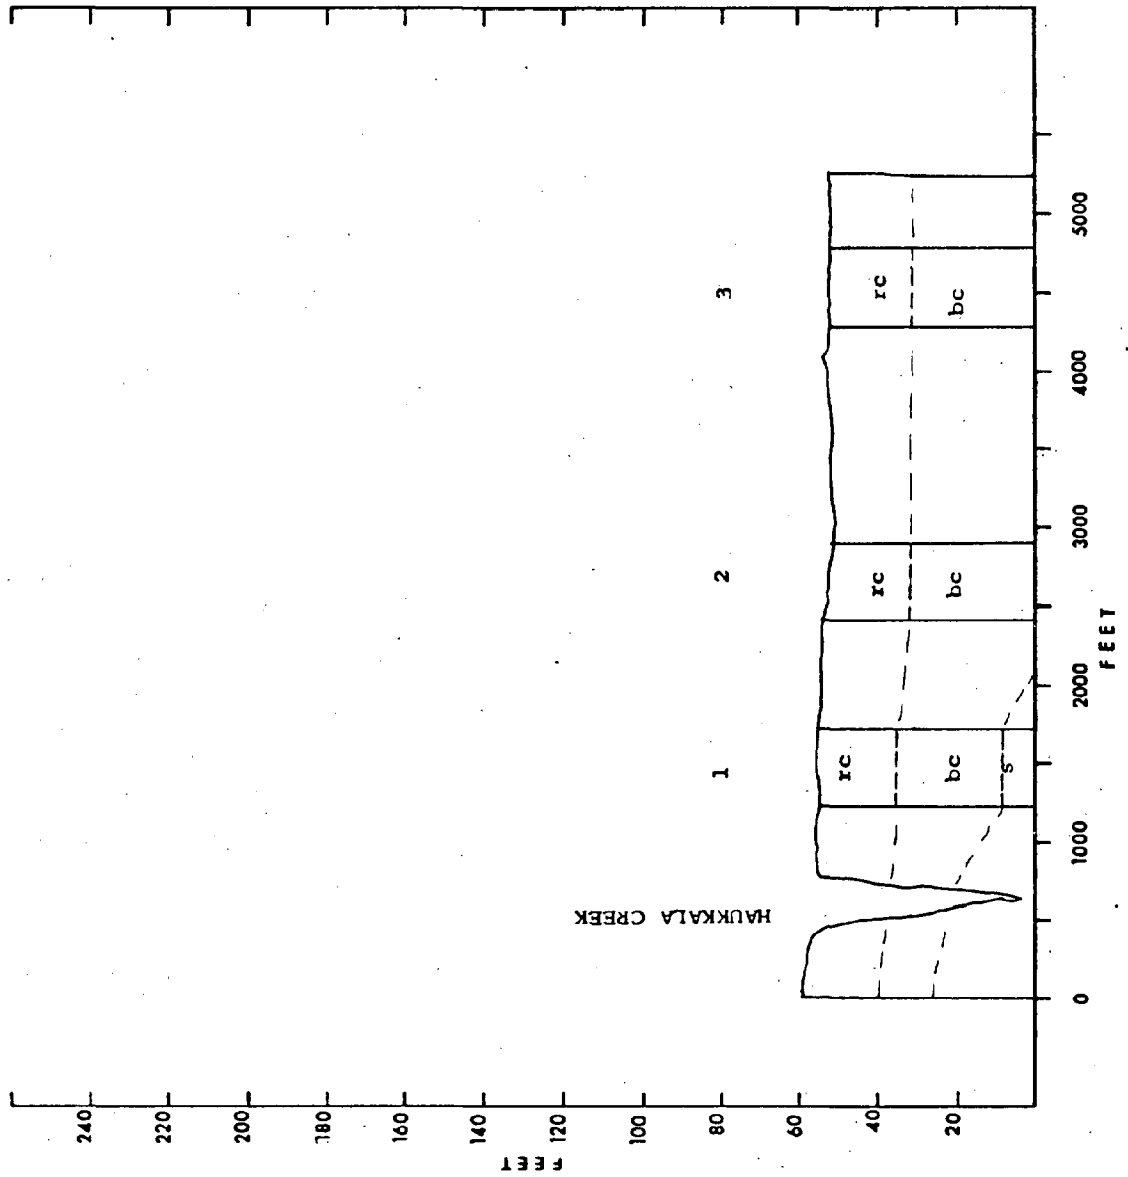
T.49 N., R. 11W, Sec. 23/14

- a) 10-20% vegetation with occasional alder or birch clump; red to brown clay over sand with till; shallow slides and mudflows; 55-60 ft high; crest fairly even; sand with till forms bench.
- b) 10% vegetation; with grass tufts and birch clump; steep failing slope; red to brown clay over sand with till; 60-65' high
- c) 80-90% vegetation; horsetails and alder; hummocky rounded bluff face; clay over sand with till (?); even crest 55-60'
- d) 50% vegetation with grass birch and alder, red over brown clay: shallow slides with scarps common: 50-55' with even crest

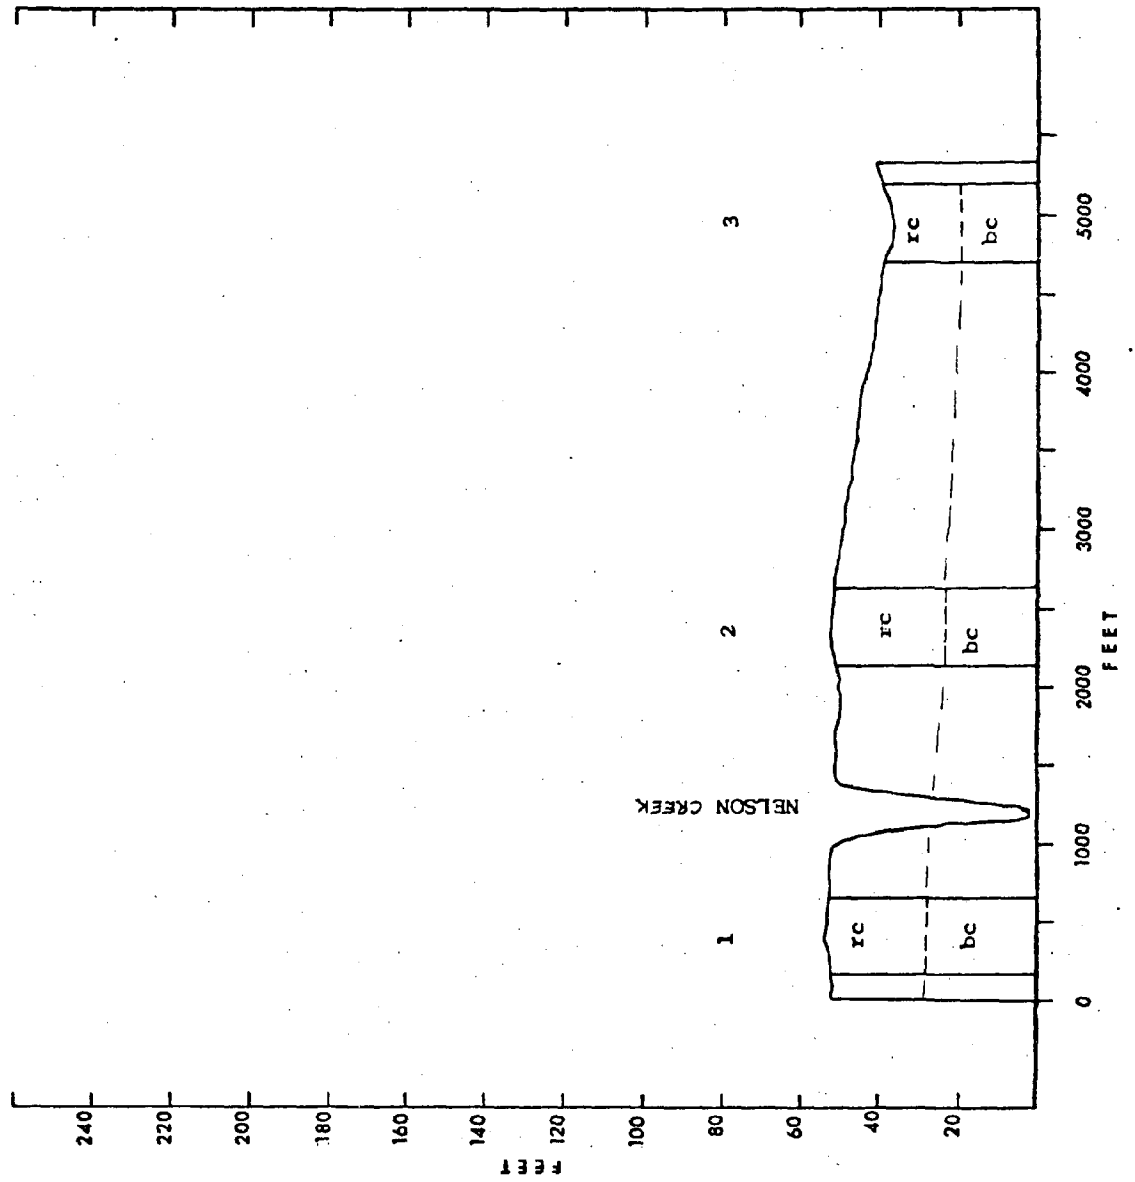
T.49 N., R. 11 W., Sec. 13

- a) 50-55 ft; crest scalloped and scarped; shallow sliding slumps; 70-90% alder and grass silty clay over clay
- b) absent-estuary
- c) 50-55 ft; single block slide with shallow failure above and below; 60% alder and grass; slumped silty clay over clay
- d) 40-50 ft. declining to east; crest scarped and scalloped; poorly expressed single block failure; numerous shallow failures - hummocky; vegetated 40-80% birch, alder and grass, horsetails; silty clay over clay
- e) 35-40 ft; broadly scalloped; single-block moderately-deep slide, shallow sliding on main and toe scarps; vegetated 70-90% alder and grass

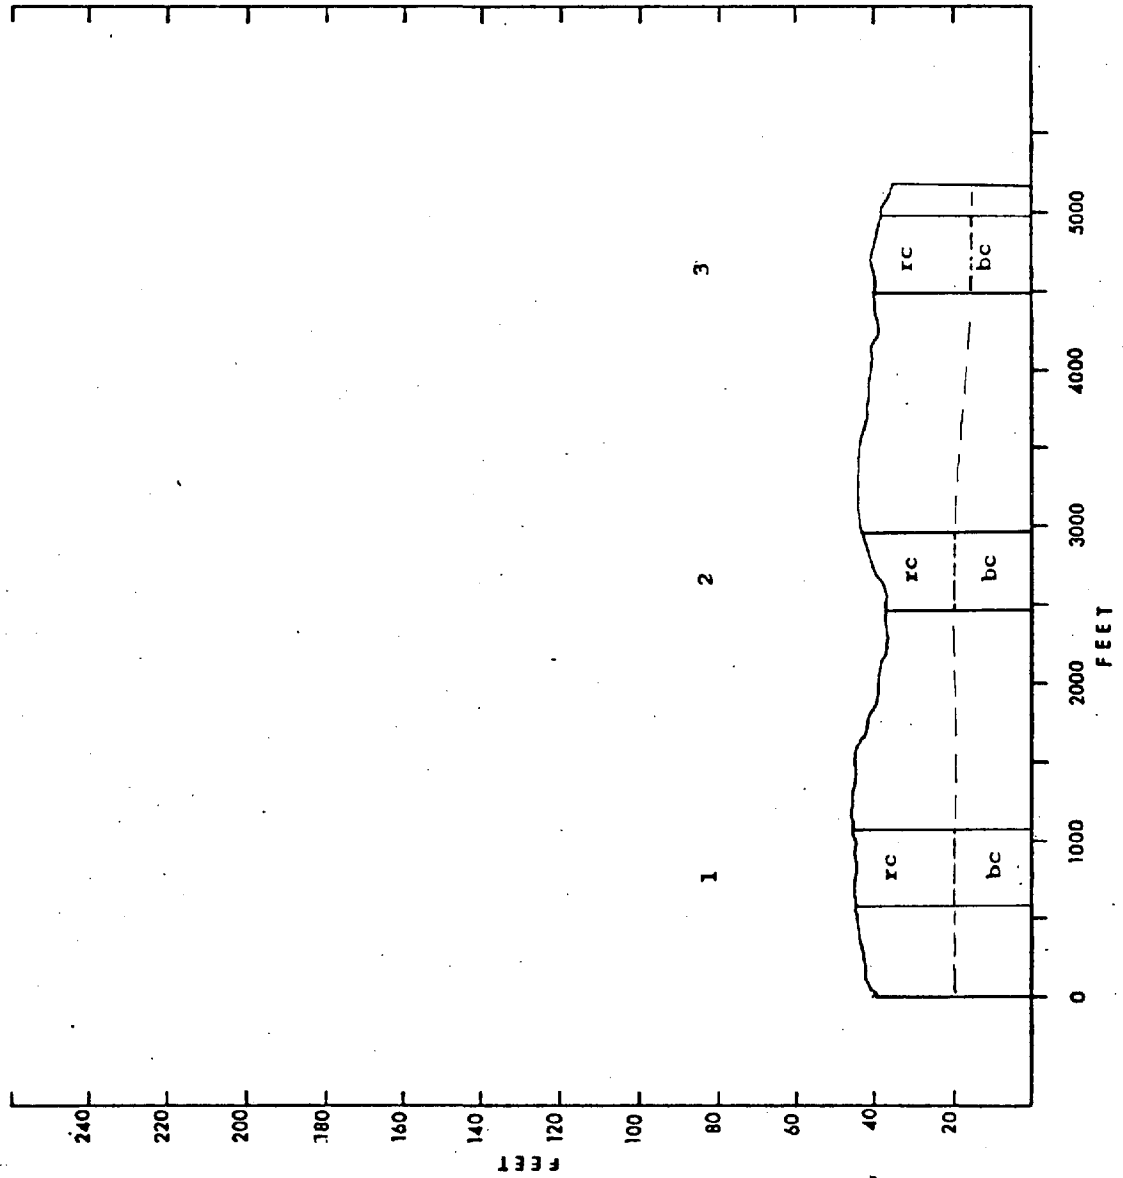
T. 49 N., R. 10 W., Sec. 18

- a) 50 ft at west, dropping to 35 in middle and rising back to 40 ft at east; crest broadly scalloped, both scarped and rounded; failure is by many processes and is quite varied spatially: large rotational slumps, slides and flows on slump scarp; brown silty clay; birch, alder, grass, moss and horsetails.

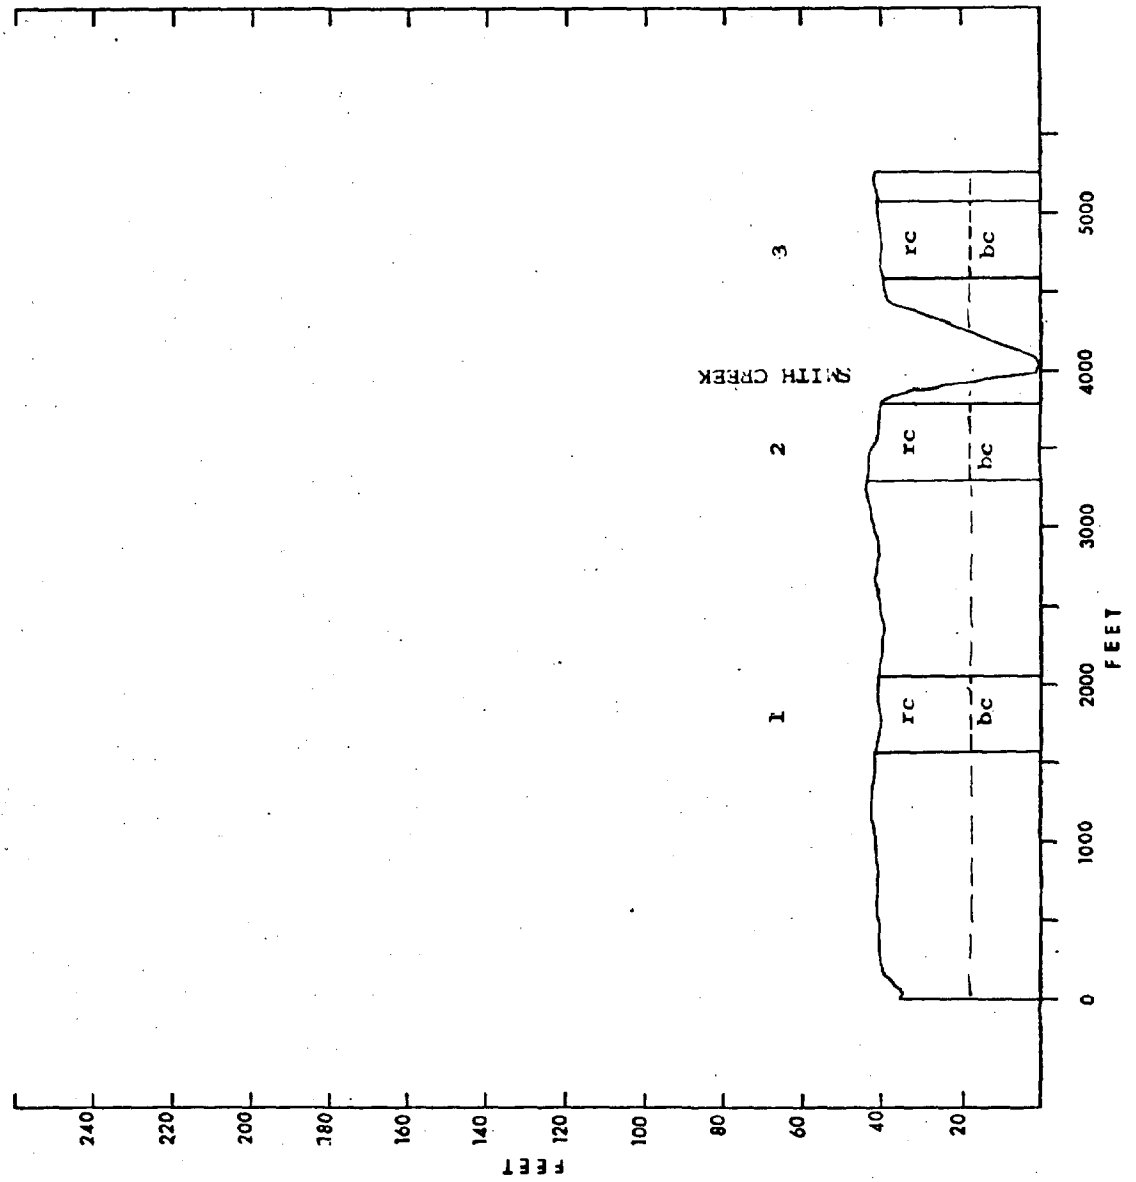
T. 49 N., R. 10 W., Sec. 17/8

- a) 35-40 ft; crest broadly scalloped, scarped or rounded; single moderately deep slide, shallow sliding and flowing on main scarp and toe; vegetation 70-90%, birch, alder, grass, horsetails; red-brown silty clay, mostly slumped
- b) 35-40 ft. crest scalloped and scarped; shallow sliding and flowing, lacks large single block failure; vegetation 40-60%, alder and grass moving down slope; silty clay
- c) absent - Smith Creek; boulders offshore
- d) 40 ft; crest scalloped, rounded; failing by single block, shallow slide, with sliding and flowing above; vegetation 80-90%, birch, alder, grass, silty clay
