# MELVILLE CONDITION SURVEY

Rhode Island Port Authority and  
Economic Development Corporation

July 1, 1982

RE: Melville Condition Survey  
CEM No. 4001

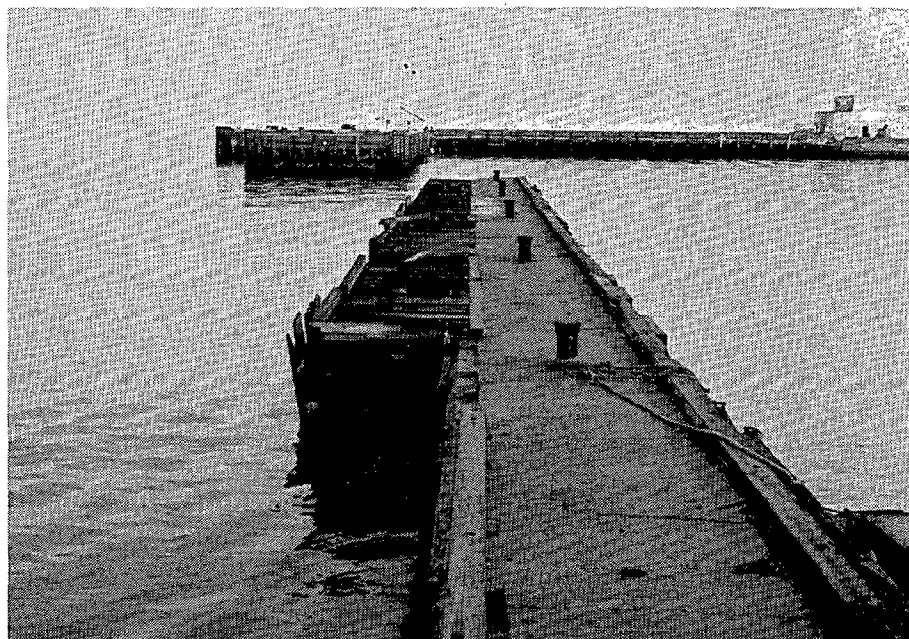
Granite and Timber Pier: The granite block/timber pier located at the end of the South Fueling Pier requires moderate rehabilitation. (See photo 3) Figure No. 4 indicates the typical construction of the Pier. The concrete cap which provides a portion of the deck area is cracked and shows signs of movement. The timber pile supported, timber deck portion of the pier is severely deteriorated and requires

PHOTO 3 - GRANITE PIER LOCATED AT THE NORTH END  
OF THE SOUTH FUELING PIER. NOTE THE DETERIORATED  
TIMBER SECTION AND THE STEEL PIPE BOLLARDS

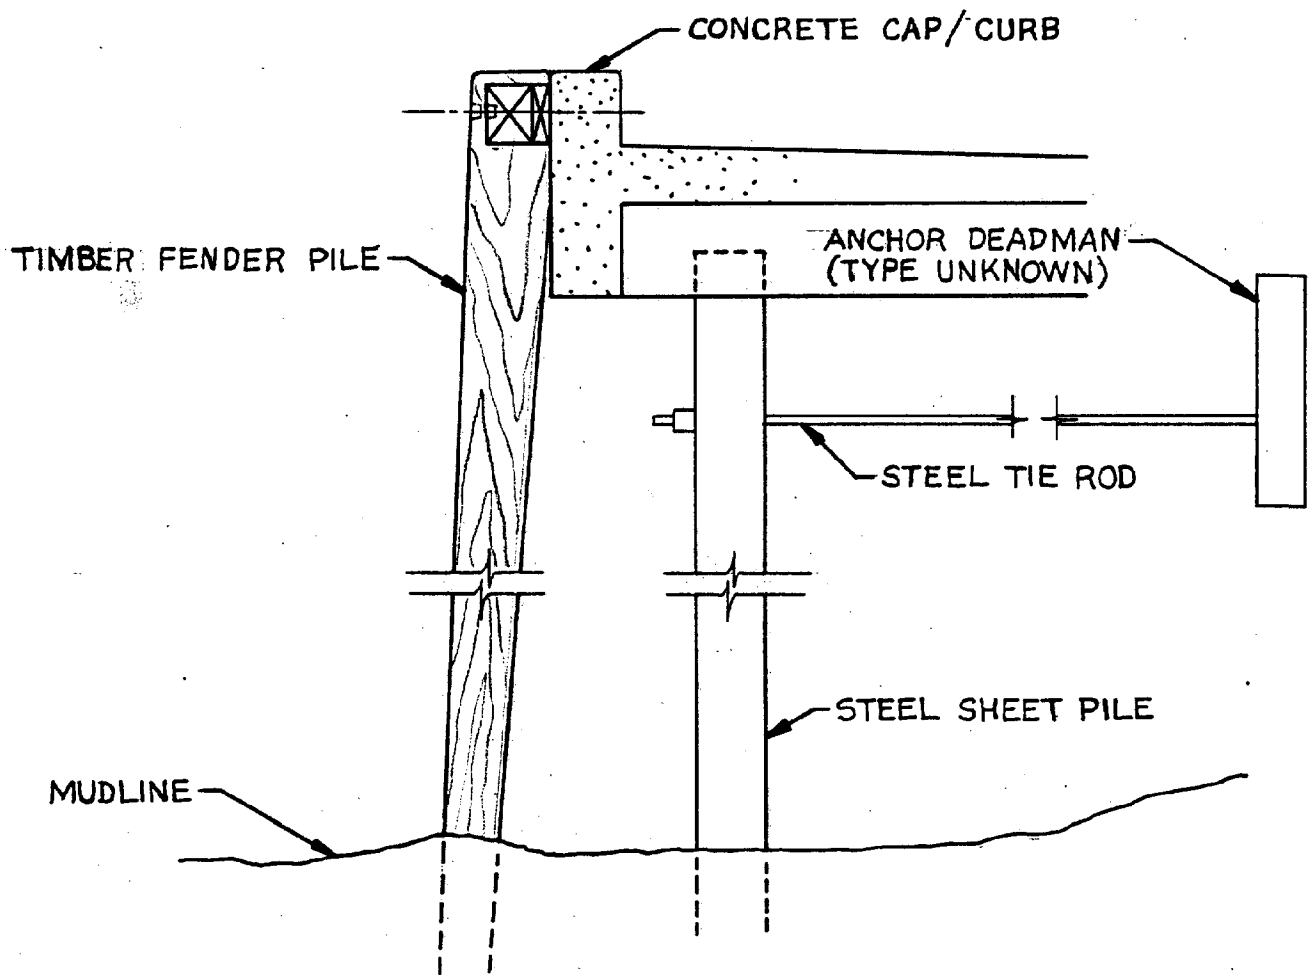
FIGURE NO. **5**

directions at various locations to provide strength both laterally and longitudinally. All bollards and cleats were found to be in excellent condition. Figure No. 5 indicates the typical construction of the FBM pier. Approximately six structural piles were found to have sustained significant damage apparently from external impact. (See Photo 5) In these cases, the piles are broken at their connection to the pile cap, the concrete cover gone and the reinforcing exposed and corroded. On approximately eight other piles, cracking or spalling was noted and the reinforcing was exposed and corroded. With the exception of these piles, the remainder of the pier looked in excellent condition.

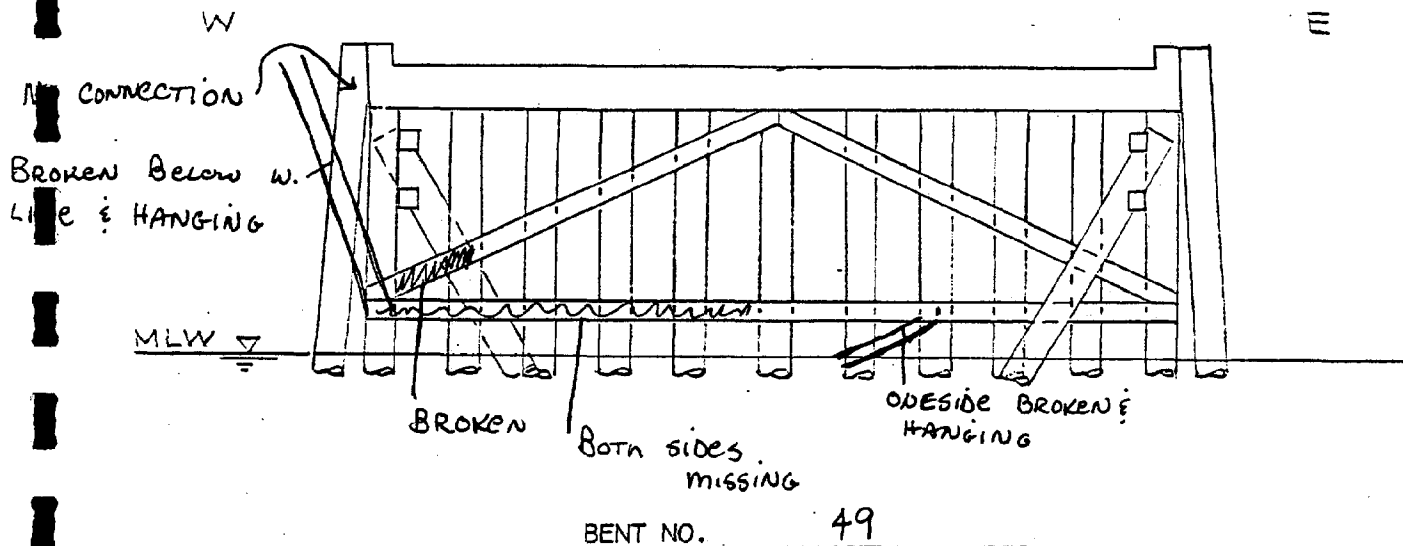
CABLE HANGING UNDER PIER

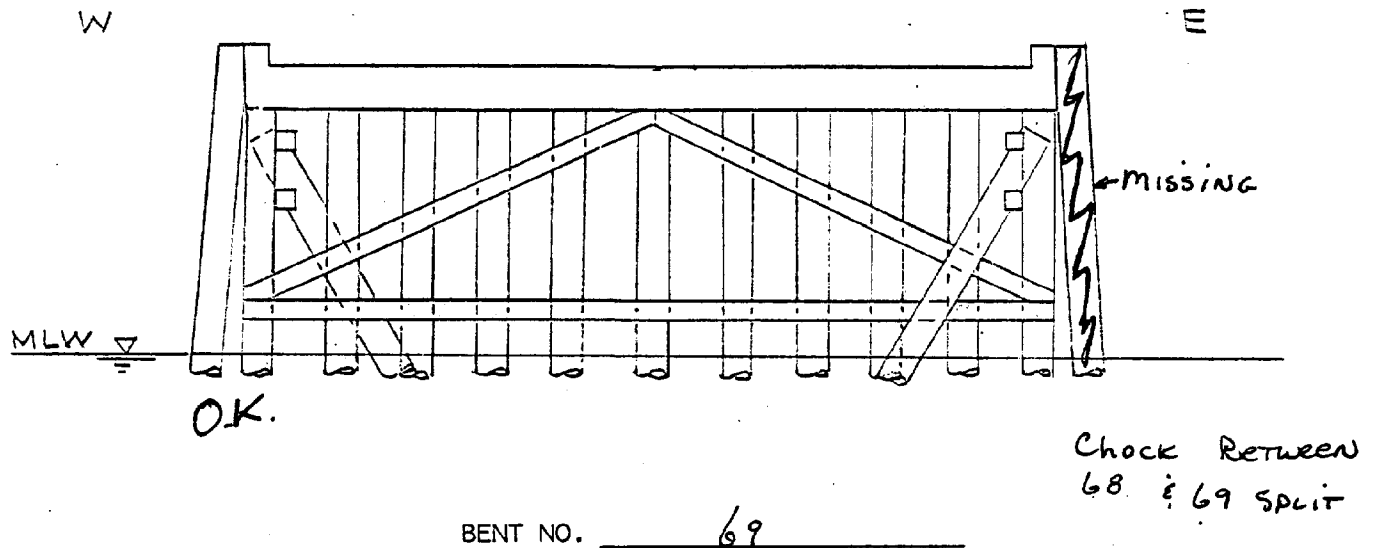
2 PLATES - 2 BOLTS EAST side UNDER CONCRETE

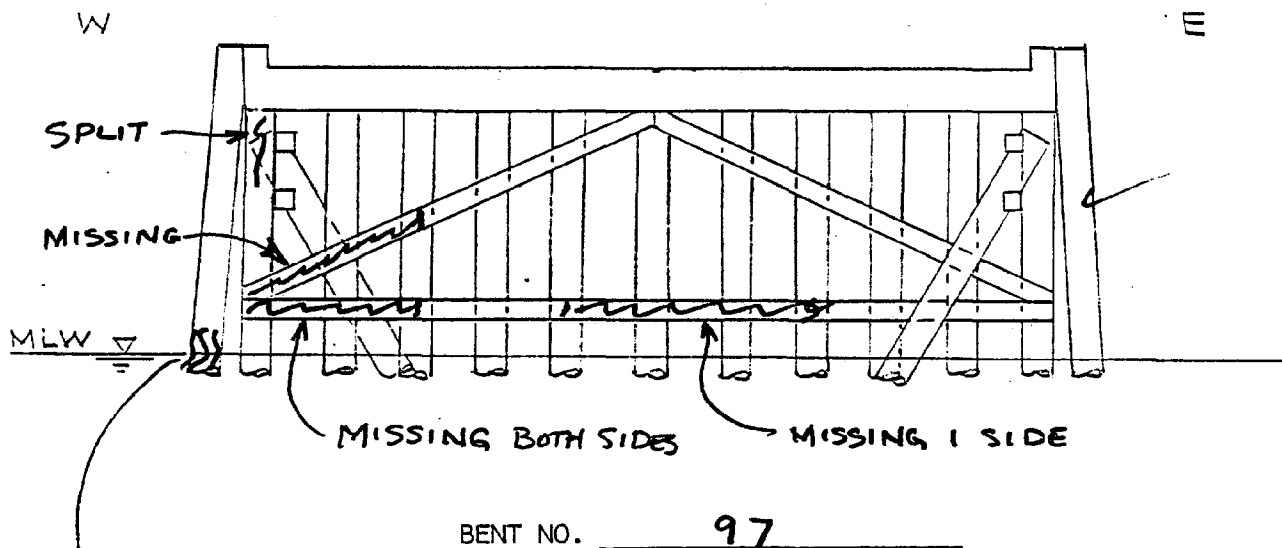
WOEMY @ LOW WATER LINE - FENDER PILE UNTREATED

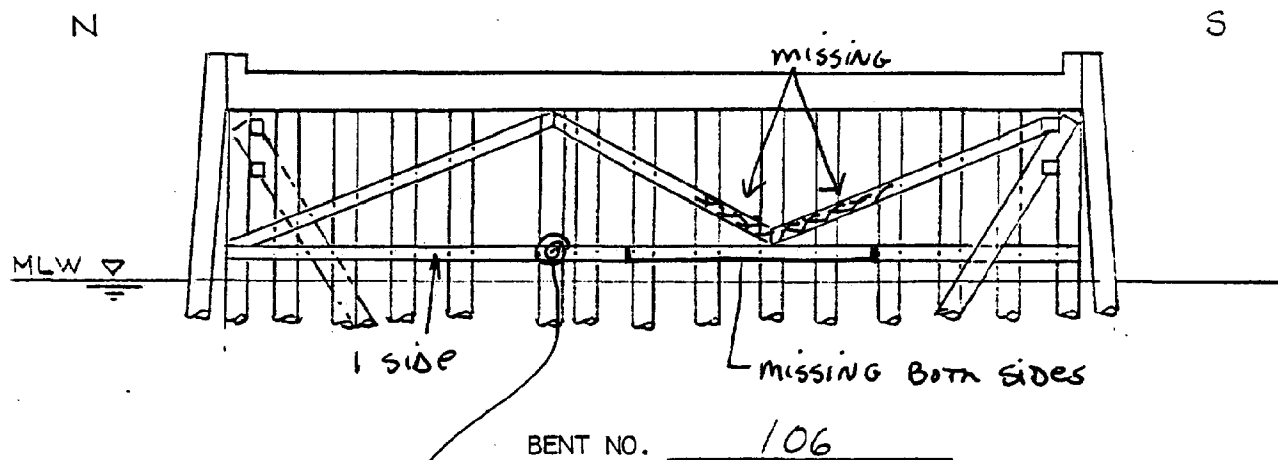
BIG HOLE IN PILE LOOKS LIKE ROT AROUND BOLT  
LOWER BRACE LOOKS BAD

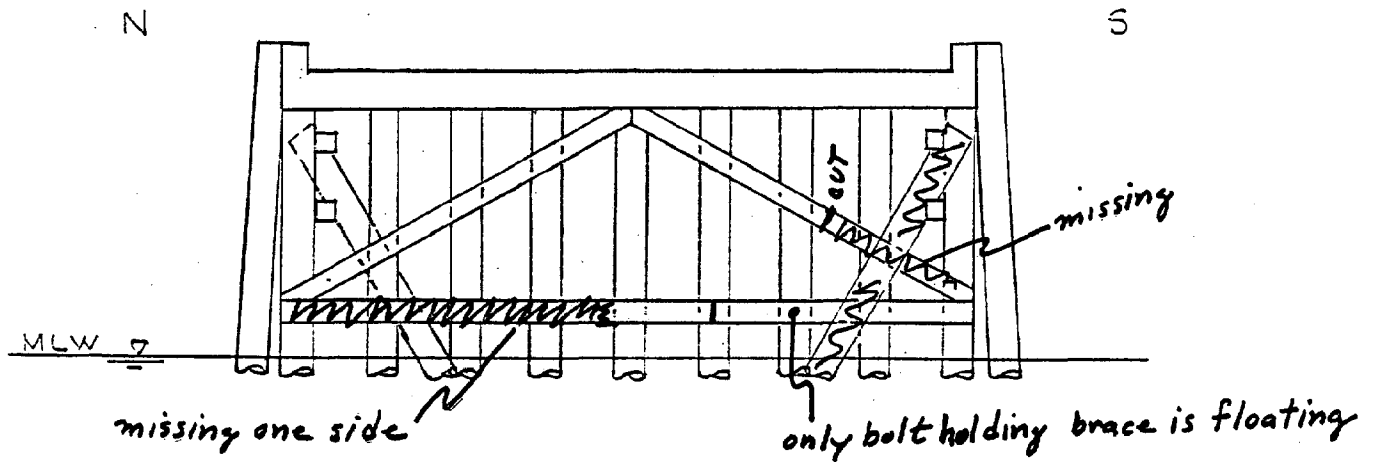
BENT NO. 23  
STA 1+50NOTES:

Two large bolts & plates hanging below deck
