Torpedo Plant Dock and Piers:

Technical Analysis and Design Recommendations

City of Alexandria, Virginia

July, 1979

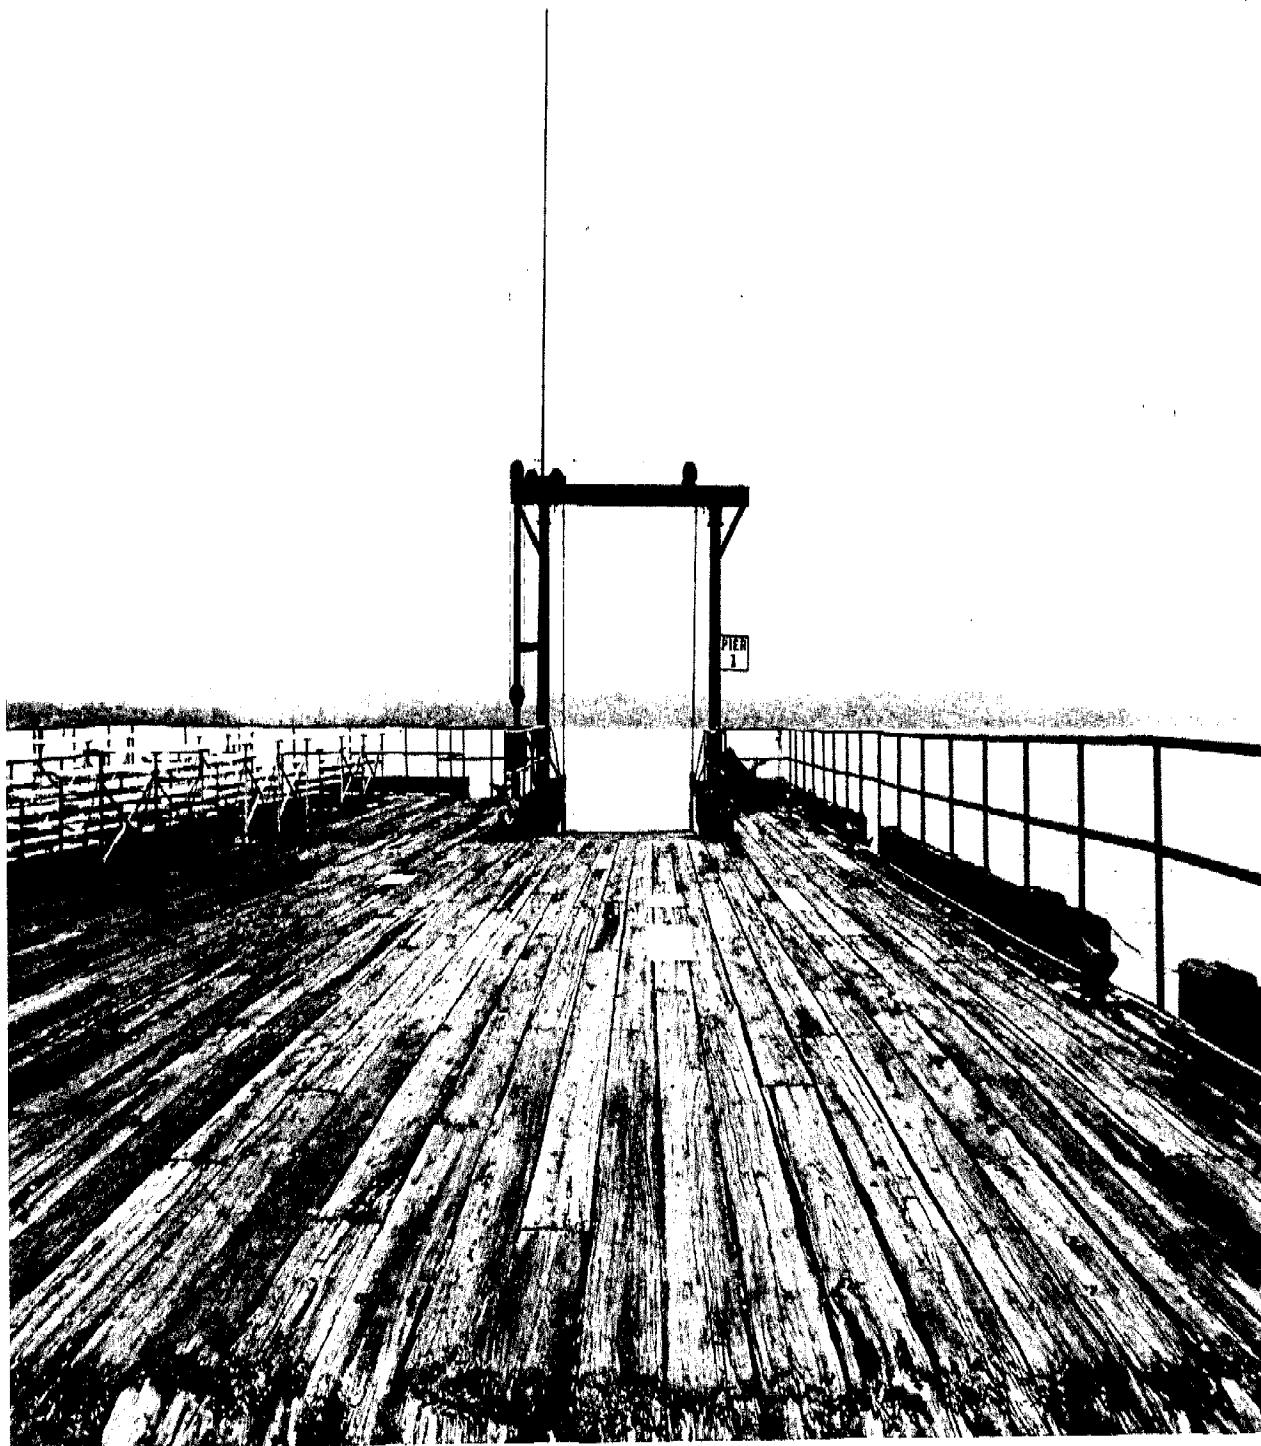
Figure 12 North Pier

- **The North Pier is in generally good condition.**
 - The concrete portion which extends to the bulkhead line is in good condition.
 - The timber piles which support the wood pier between the bulkhead line and the pierhead line are good—31 percent showed decay of outer fibers only.
 - The internal bracing of the timber structure is in good condition.
 - 80 percent of the fender piles are deteriorated and need to be replaced.

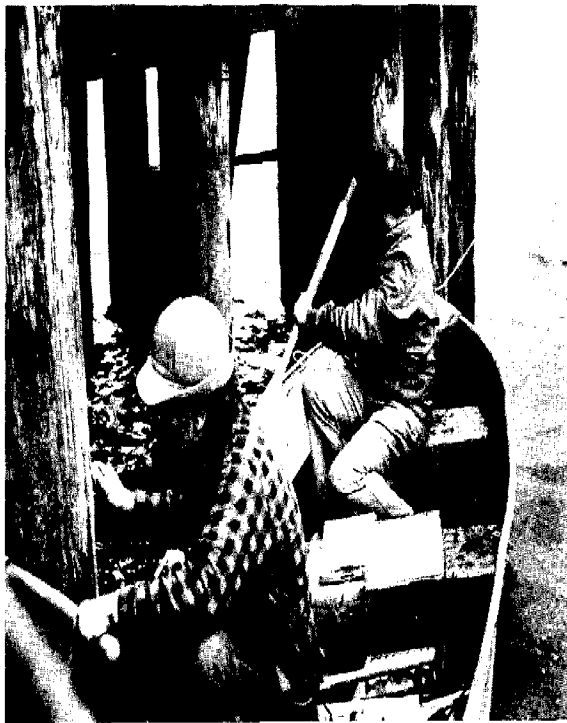
Figure 13 Consultants taking wood borings of the piles to determine the structural condition of the North Pier

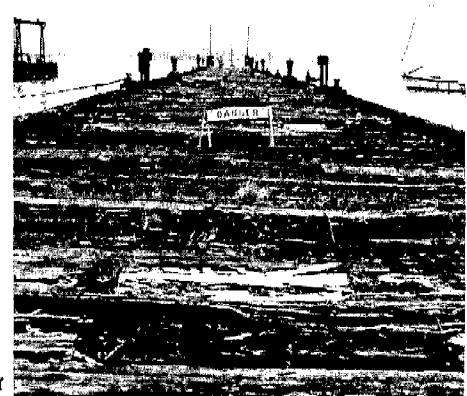
- **The South Pier will require a new superstructure but the foundation piles appear sound and in good condition.**
 - The deck, stringers, headers and cross-bracing are badly deteriorated.
 - The foundation piles are sound with some surface deterioration.

Figure 15 Deteriorated timber deck on South Pier

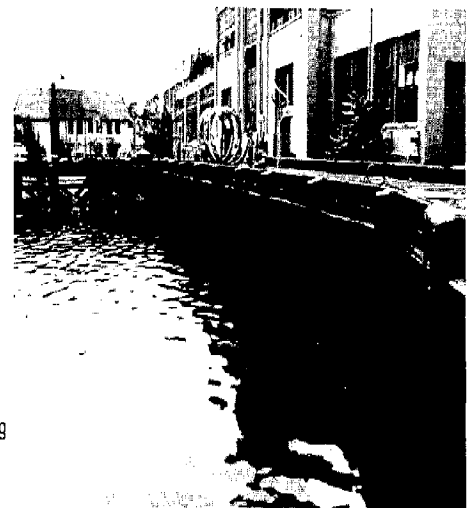
- **The dock is in good condition but some headers, stringers and the fender piles need to be replaced.**
 - Access to the pilings is limited but the conditions are considered the same as for the North Pier.
 - Some foundation piles, headers and stringers are deteriorated and need to be replaced.
 - Decking is usable but deteriorating.
 - Fender piles are deteriorated and mechanically damaged.

Figure 16 The Existing Dock is considered structurally sound

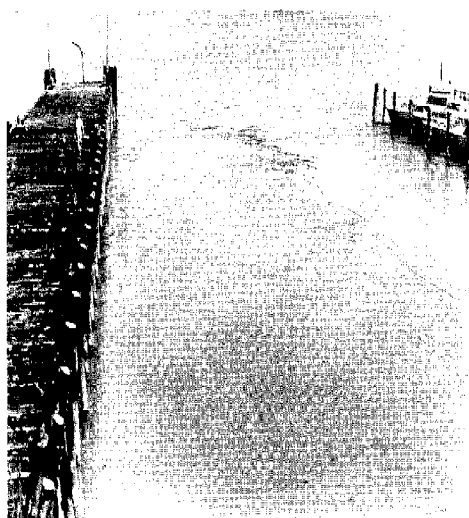
Figure 18 Water depth at low tide

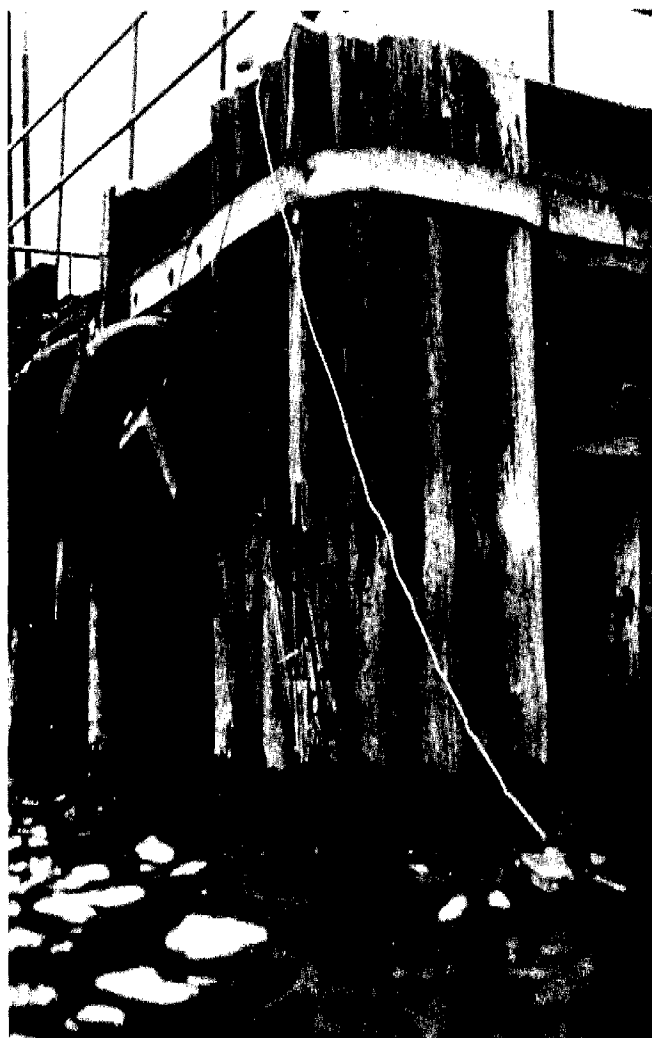
Figure 39 North Pier

The timber foundation piles supporting the timber section of the pier are in generally good condition. Of the interior piles inspected, approximately 31 percent exhibited evidence of decay in the outer fibers, but beyond that depth, the piles appear to be sound.

The fender piles around the perimeter of the North Pier have suffered the greatest deterioration and damage due to past usage and exposure, particularly in the tidal zone. It is estimated that approximately 80 percent of these piles, including the clusters at the northeast and southeast corners and along the south side of both the timber and the concrete sections of the pier will require replacement.

On that basis and considering the current condition of the concrete and timber sections of the North Pier, rehabilitation appears to be feasible. The requirements for the concrete section are basically cosmetic, except for the replacement of the timber fender piles.

For the timber section of the pier, rehabilitation can be accomplished by replacement of the pile bracing members, repair of the deteriorated or unsound decking, and replacement of the timber fender piles and pile clusters. The decay noted in the bearing piles can be arrested with the use of an internal fumigant. This action will prolong the expected life by approximately ten years.

Consideration should be given to replacement of the guard timbers around the perimeter of the deck where required, installation of mooring hardware compatible with anticipated usage and the installation of perimeter railings for the protection of pedestrians using the facility.

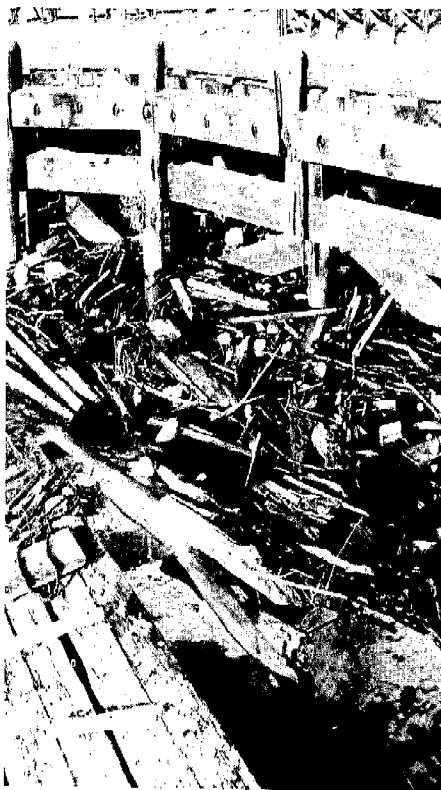
Figure 43 Debris collects at base of dock

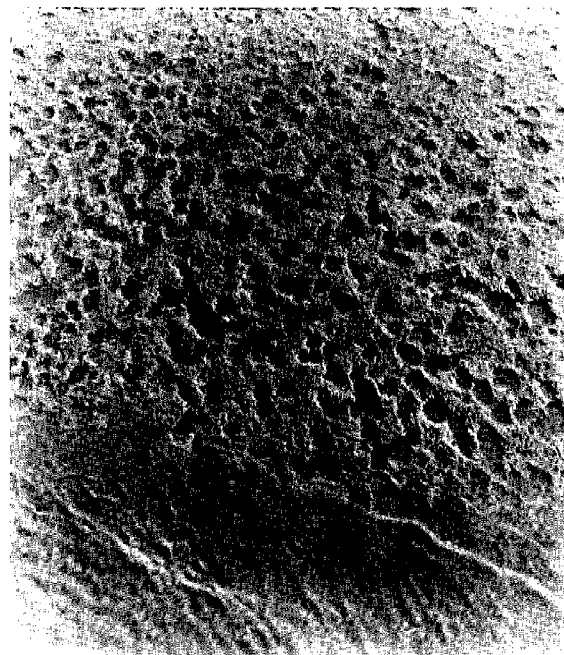
Figure 45 Riverbottom at Torpedo Plant Basin during low tide

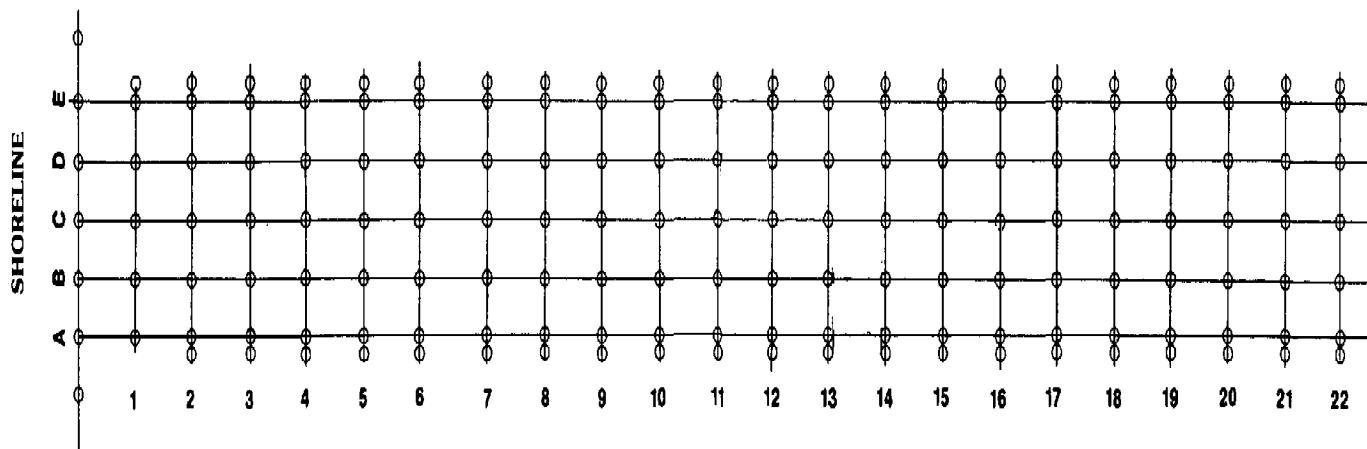
Figure 48 Piling Plan
of South Pier

Location No. 6 Column A,C-appear sound Column B,D,E-decayed x-Brace-all decayed	Location No. 10 Column B,E-decayed Column C-poor treatment Column D-appears sound Plates-contain some decay	Location No. 14 Column A,B,D-appear sound Column C,E-decayed x-Brace-all decayed Plates-appear sound

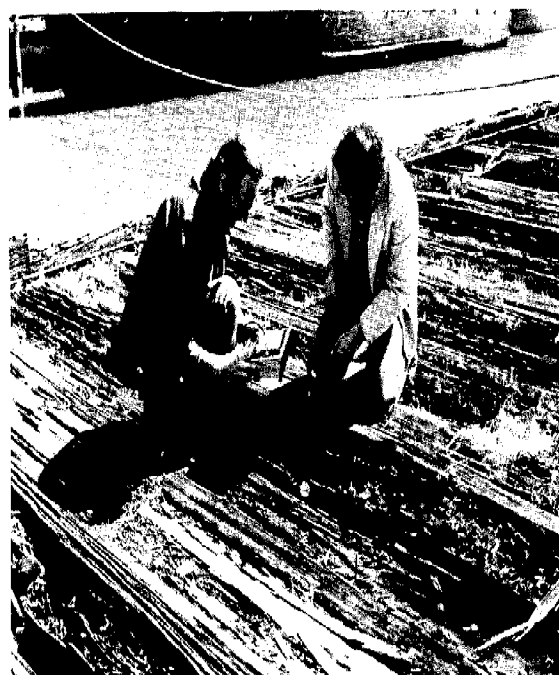
- b) The timber structure above the piles is not expected to be salvageable. The effective cross-section of the structural members has been considerably reduced due to internal decay at the holes for the steel connecting bolts.

Figure 51 VPI Consultants checking surface conditions of South Pier
