FIVE ISLANDS WHARF STUDY,

GEORGETOWN, MAINE

June 7, 1990

Subject: Five Islands Wharf Study 89-2783  
Final Report

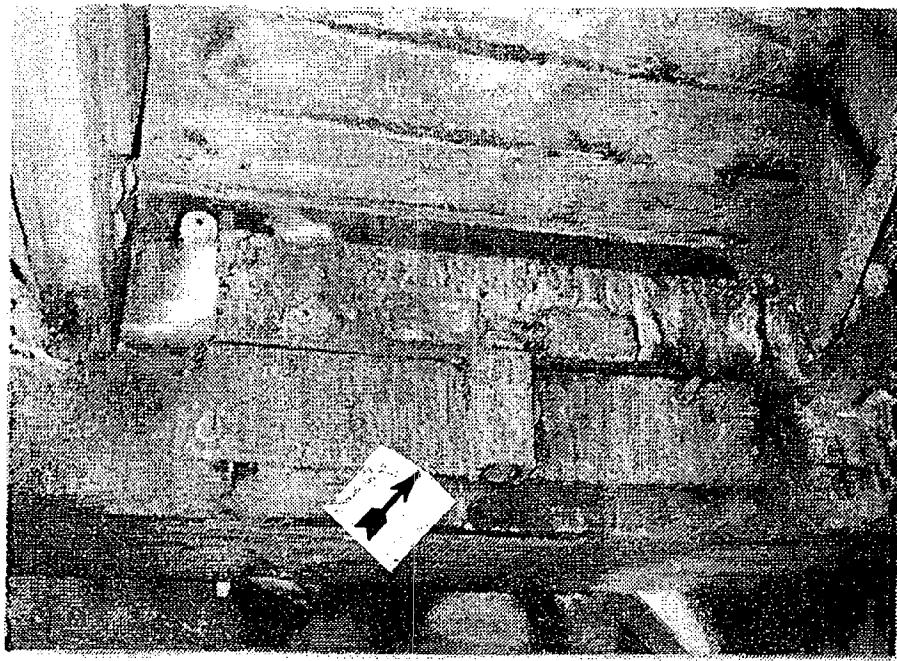
A

rusted hinge under float ramp badly in need of repair.

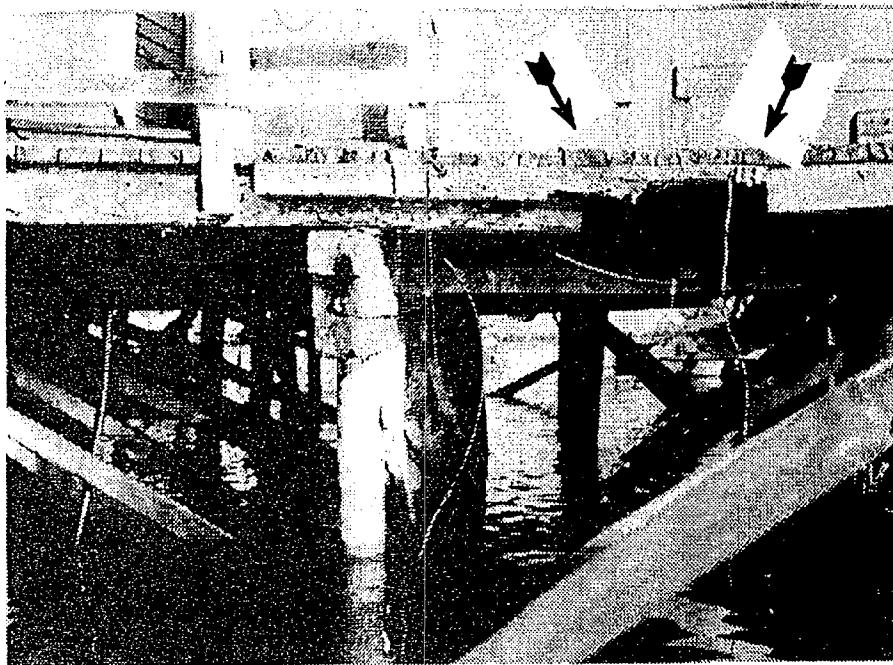
South end of dock showing rotting of decking and beams.

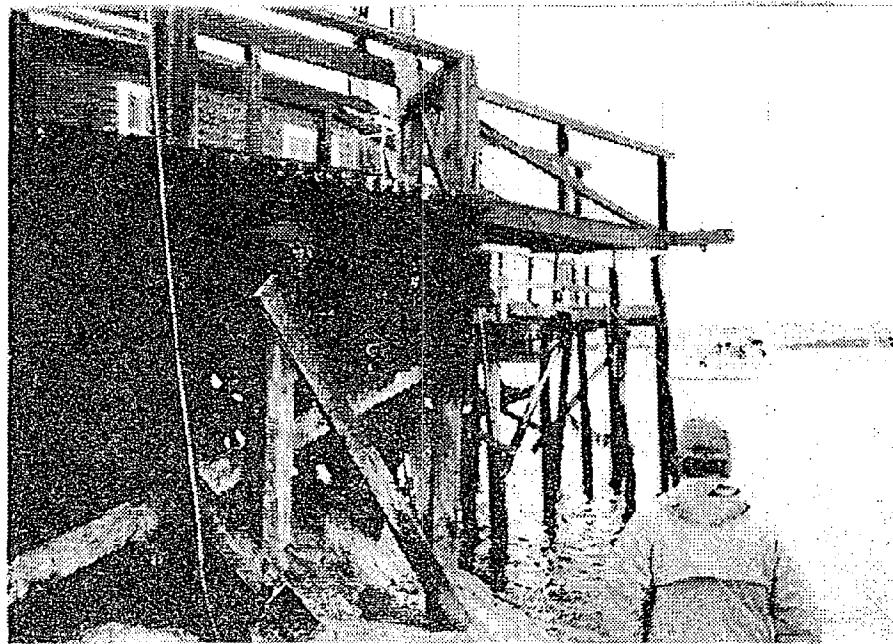
Overall view of south end of dock.

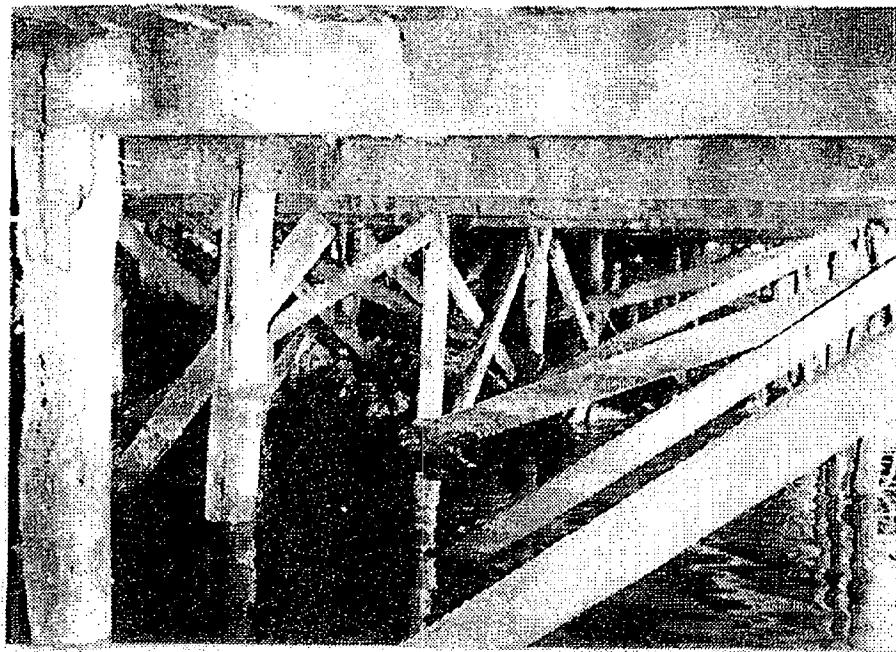
A

Typ. piles and cross members.

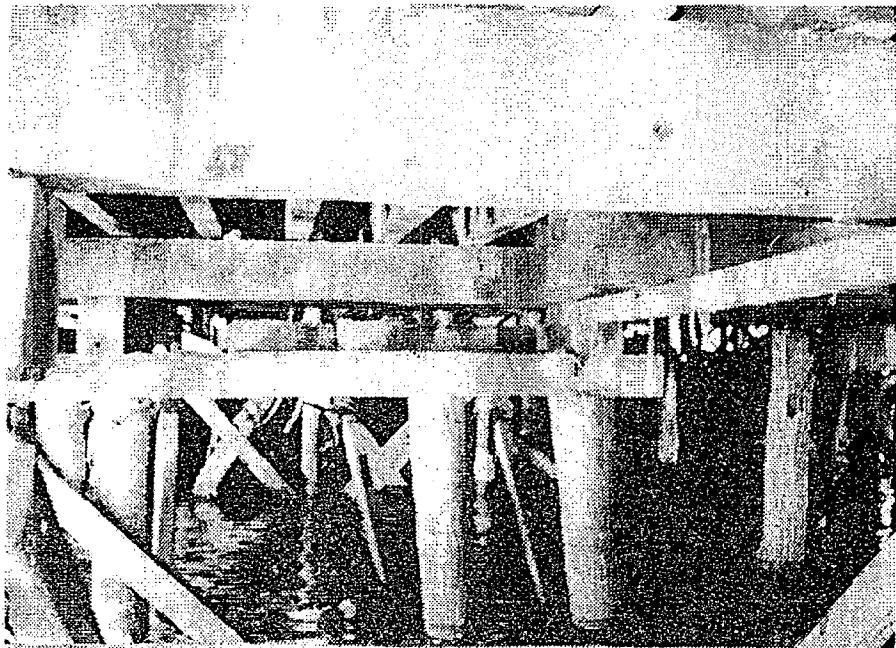
B

Typ. cross beam design, built to get desired elevation.

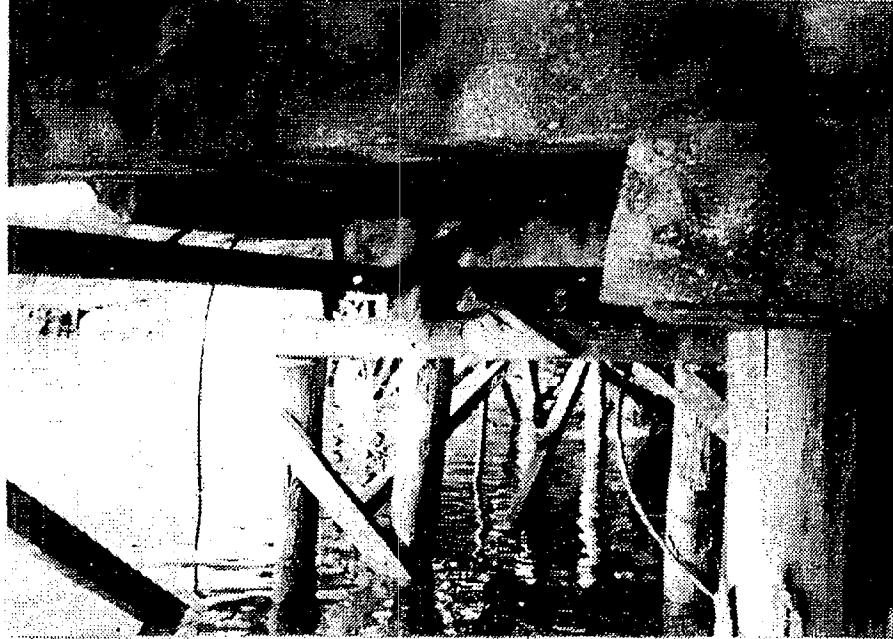
Typ. blocking used for elevation desired.

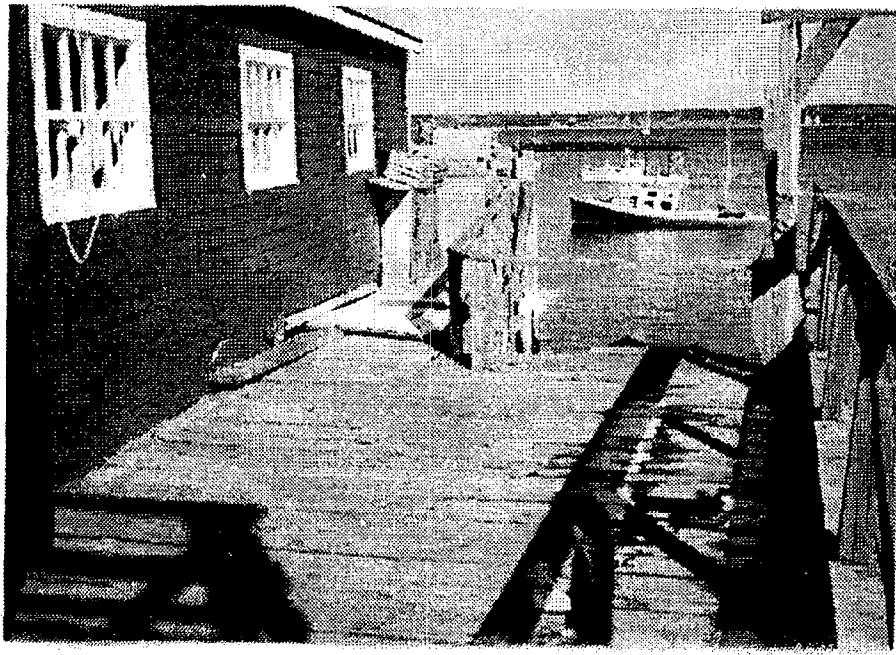
Deteriorated decking out by town float.

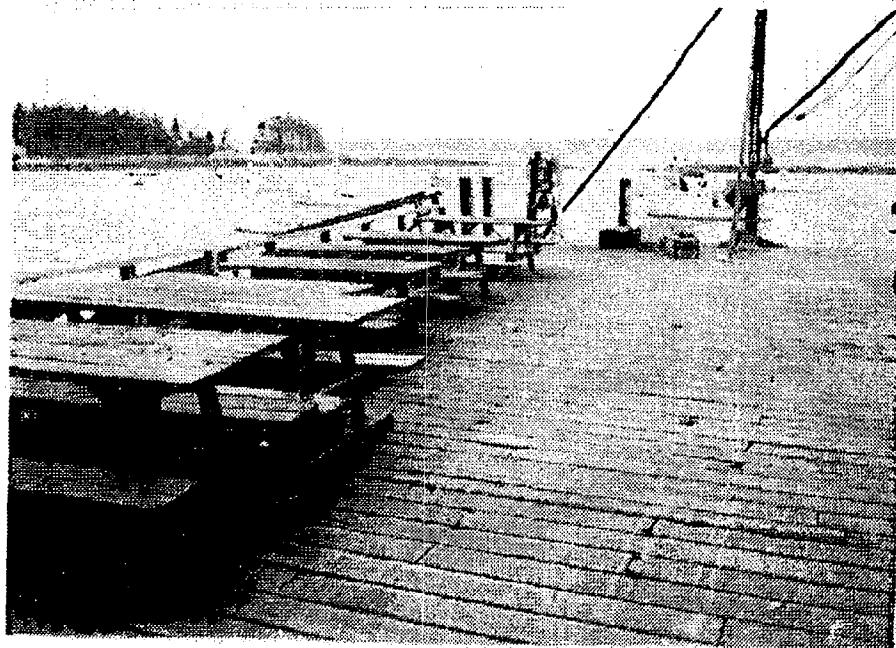
Photo showing decking towards front of dock.

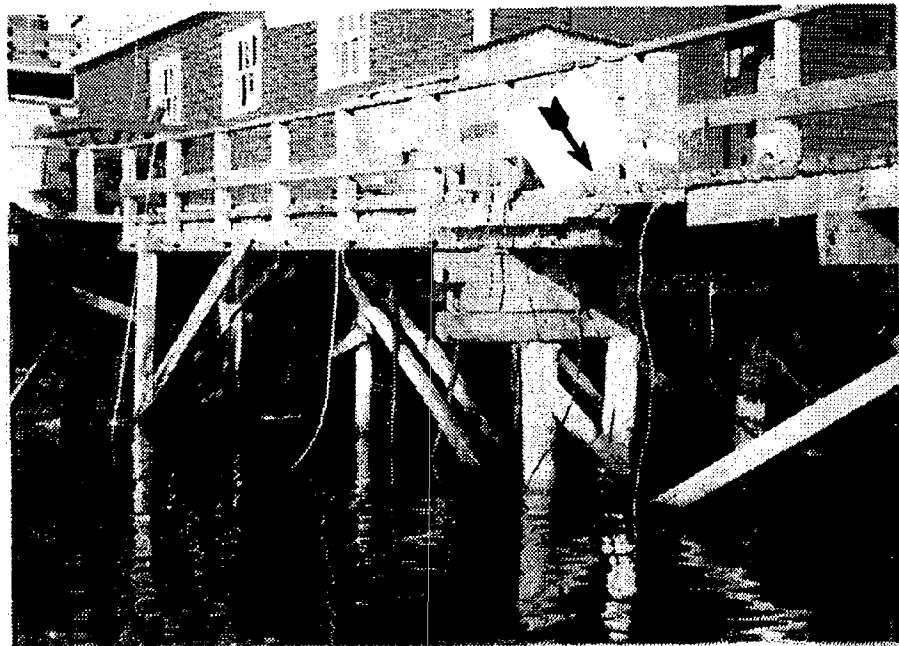
Severe rotting of beam at south end of dock.

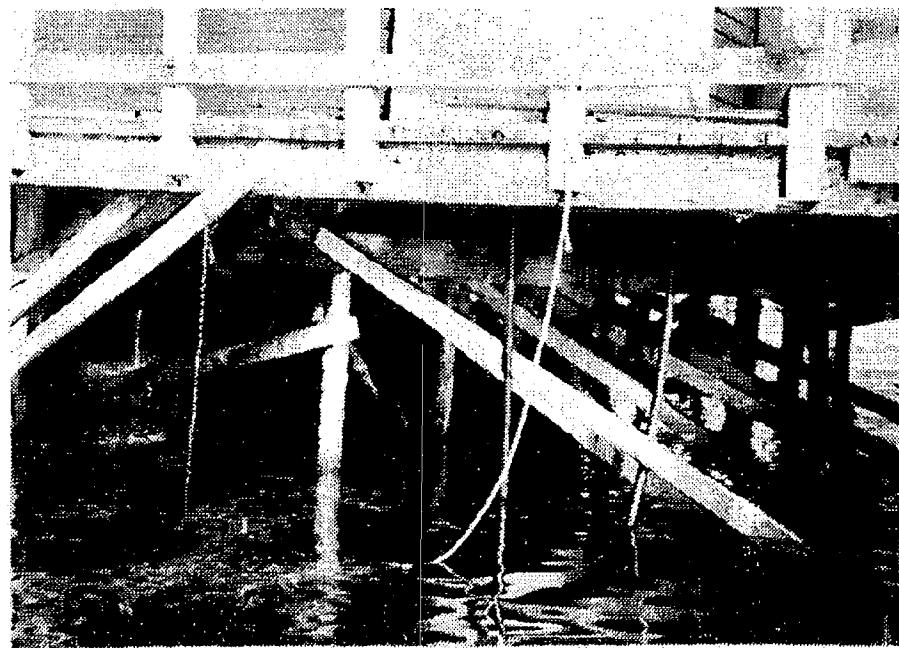
South end of dock showing pipes and wires not to standard codes.

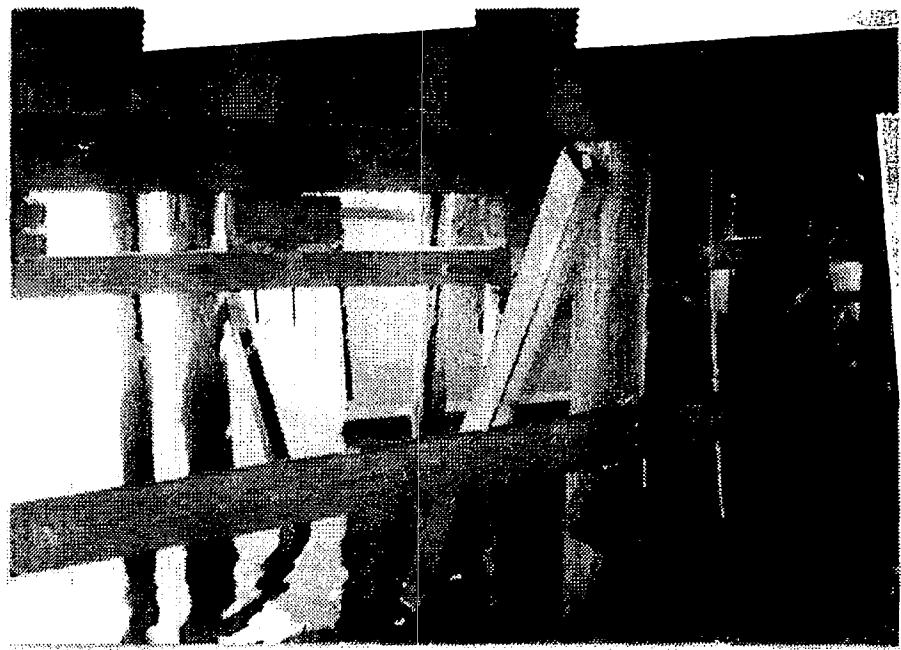
A

Typ. cross bracing towards front of dock.

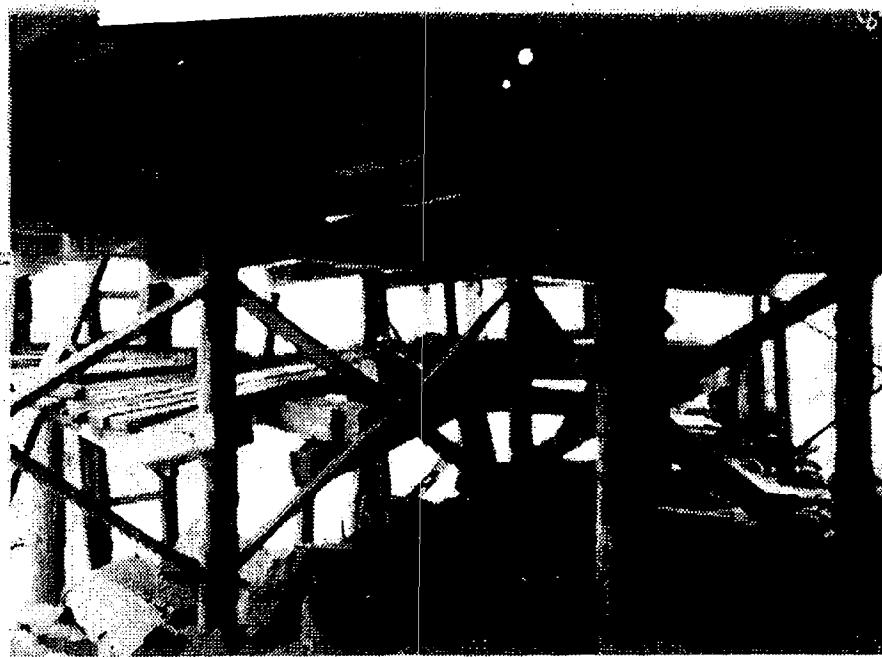
A

Piles and lower unused deck north of Cooker.

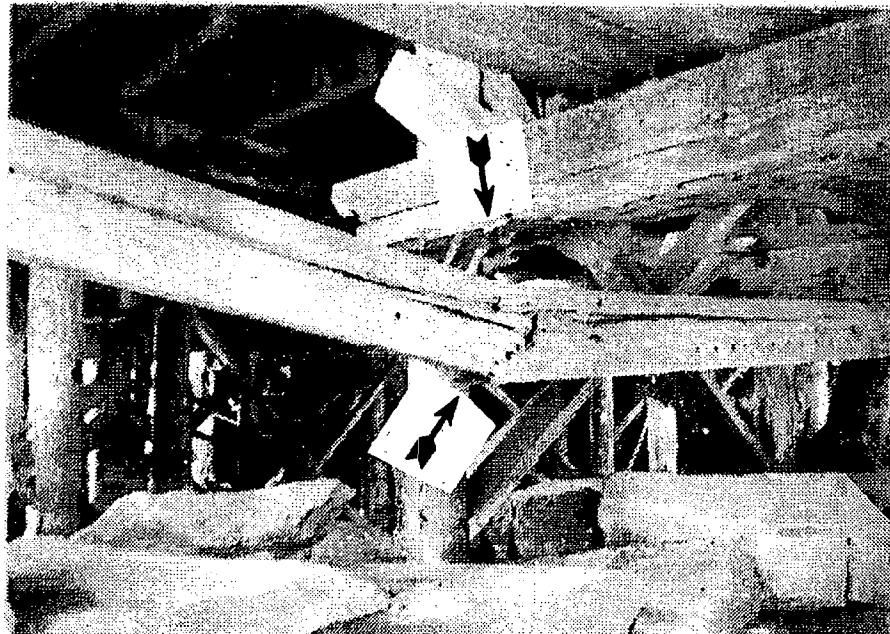
B

Typ. failed beams on lower deck from above, north of Cooker.

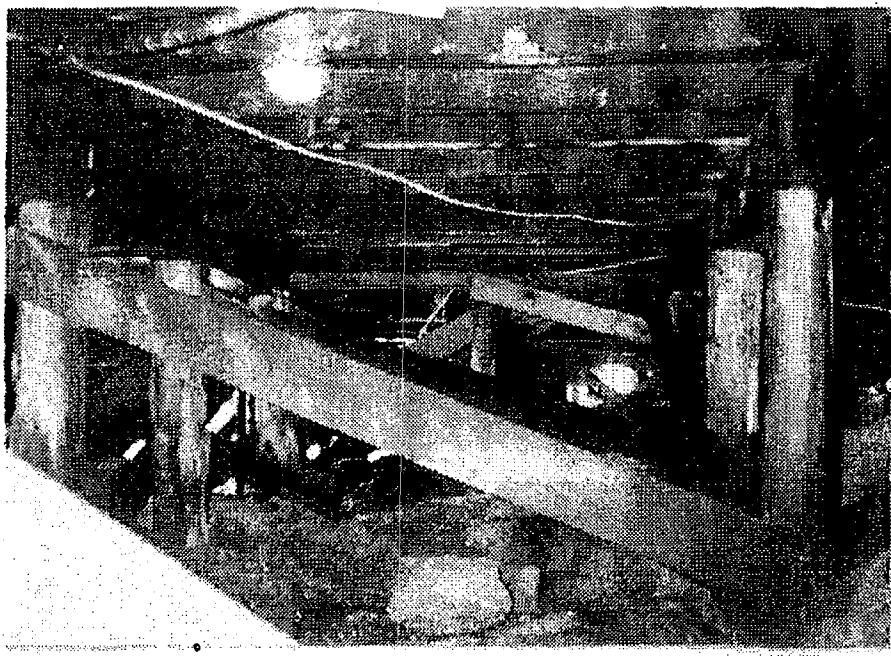
A

Typ. cross bracing, under Cook house.

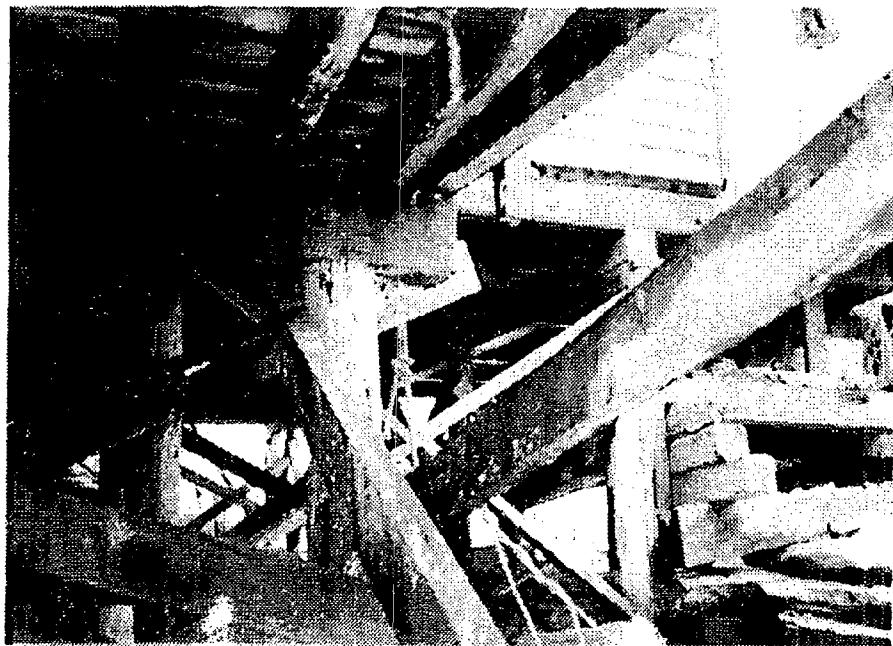
B

North end of dock looking towards Cook house.

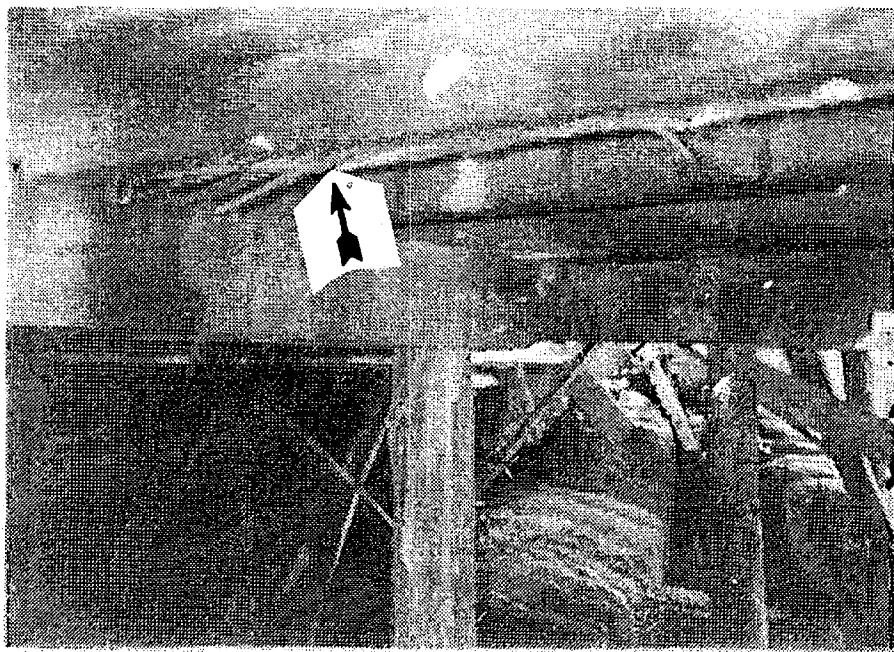
Typ. photo showing rotting rafters under Cook house.

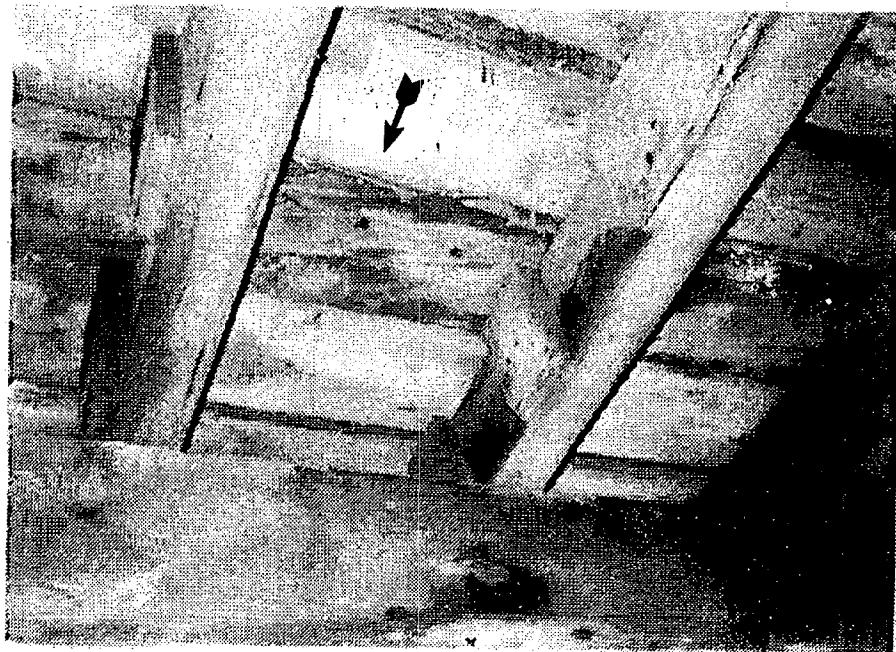
Typ. rotting decking and beams.

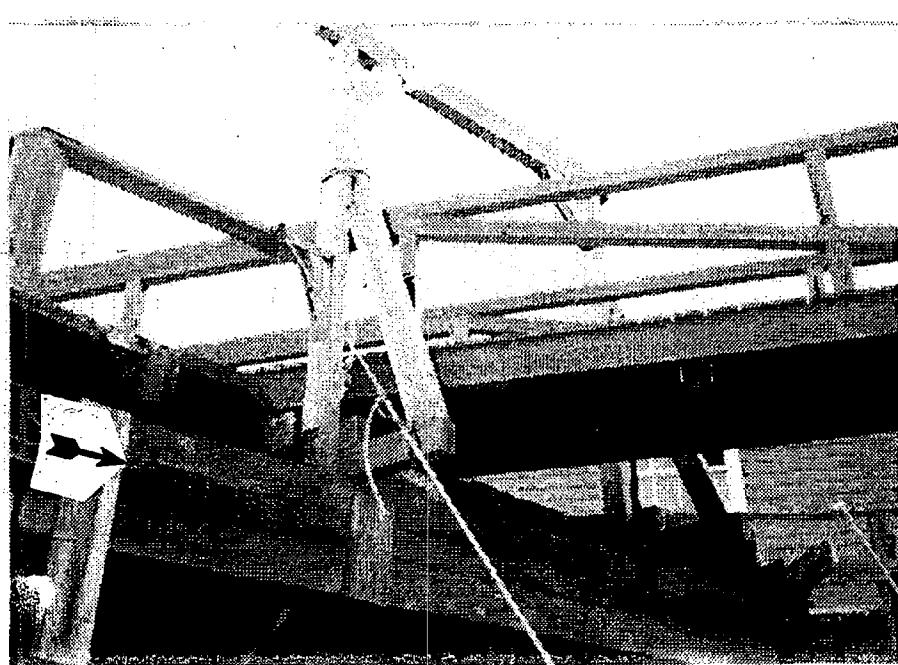
Town float, some beams showing signs of decay.

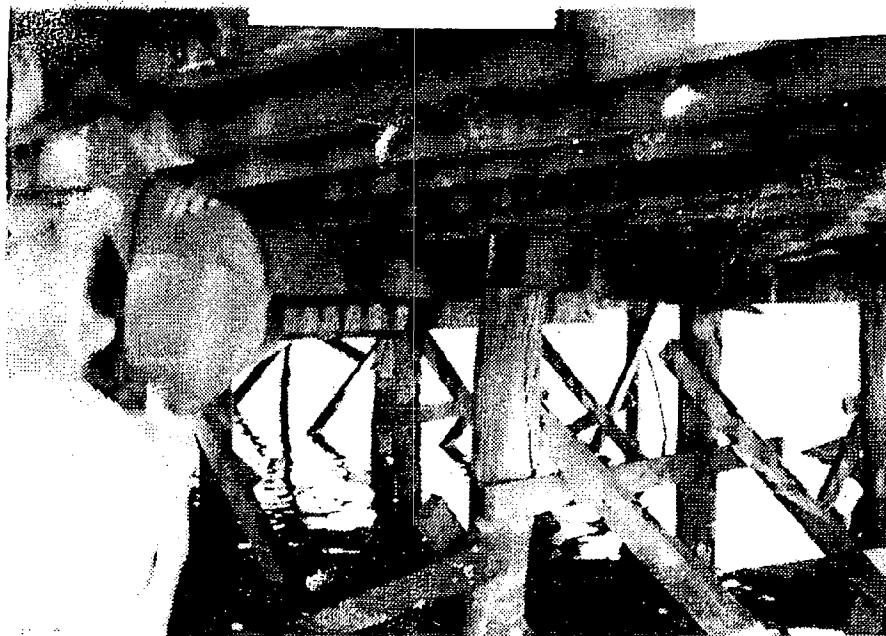
Checking for rot at rafter.
