The following policies and rules, which require modifications of aircraft for the purpose of remedying defects affecting airworthiness, are hereby adopted. They shall become effective upon publication in the **FEDERAL REGISTER** unless otherwise indicated, in order to promote safety of the flying public. Compliance with the notice, procedures, and effective date provisions of section 4 of the Administrative Procedure Act would be impracticable and contrary to the public interest and, therefore is not required.

1. Introduction to airworthiness directives (CAA policies)—(a) General. (1) The Civil Aeronautics Act of 1938, as amended, empowers the Administrator of Civil Aeronautics to issue type certificates for aircraft after he determines that the aircraft is of proper design, material, specification, construction, and performance for safe operation, and that it meets the minimum standards prescribed by the Board. If the Administrator finds that the aircraft conforms to the type certificate therefor, and, after inspection, that the aircraft is in a condition for safe operation, upon application by the registered owner, he will issue an airworthiness certificate.

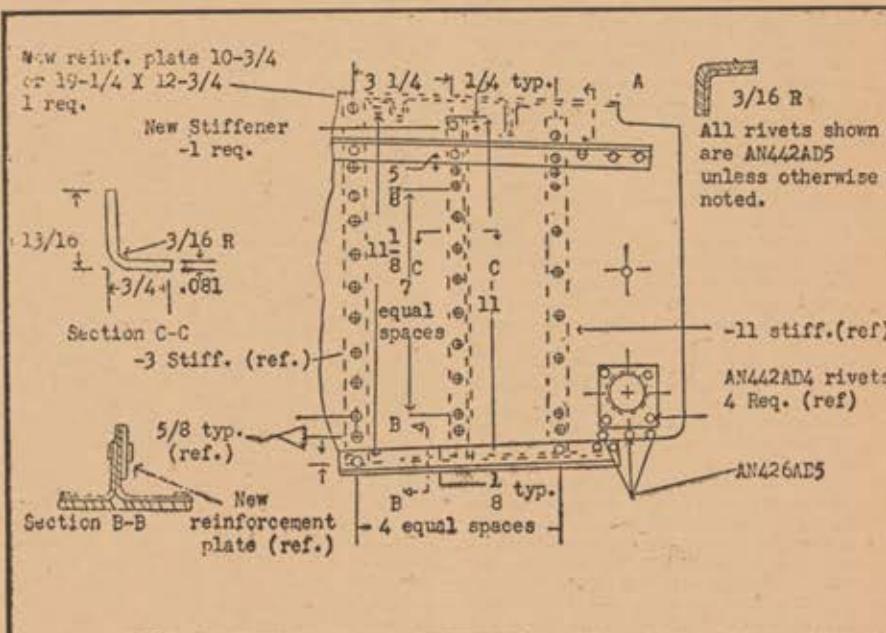
FIGURE 1.

a. The rear spar in the region of the aileron hinge brackets.

b. The upper and lower corners of the intermediate ribs, which support the aileron

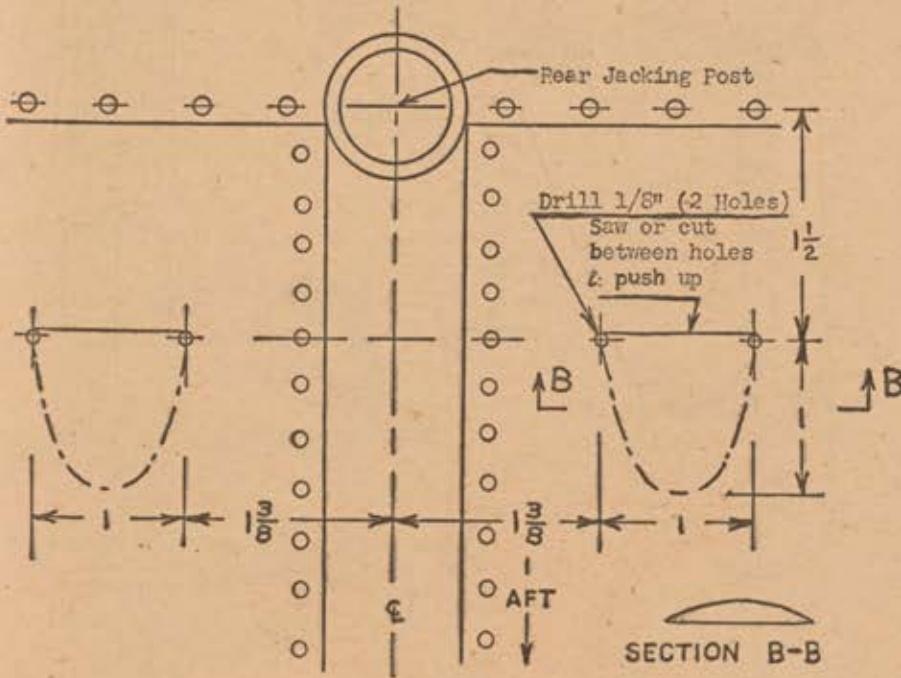
FIGURE 3.

47-34-2 BEECH (Was Mandatory Note 3 of AD-770-1 and Mandatory Note 4 of AD-765-1.) (Applies to airplanes which do not have drain provisions at bulkhead No. 15.)

Compliance required prior to December 1, 1947. To provide additional drainage, to prevent freezing of trapped moisture in the tail cone which could jam the elevator control system, a $\frac{1}{4}$ -inch diameter hole should be drilled near the front of the tail cone
