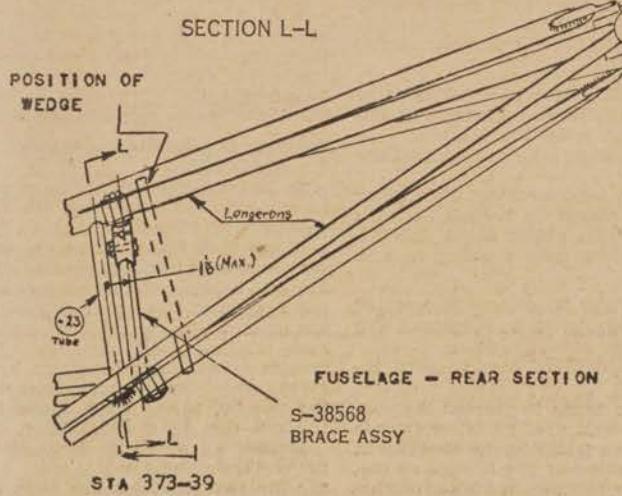
FIGURE 4.

h. If paint on longerons of tail fuselage has been damaged, touch up with paint.

DRILL "C" (.242) (2 HOLES), REAM (.250/.251)  
(2 HOLES) AN24-17 CLEVIS BOLT (2 REQ), AN320-4  
SHEAR NUT (2 REQ), AN960-416 WASHER (2 REQ),  
AN365-2-2 COTTER PIN (2 REQ)

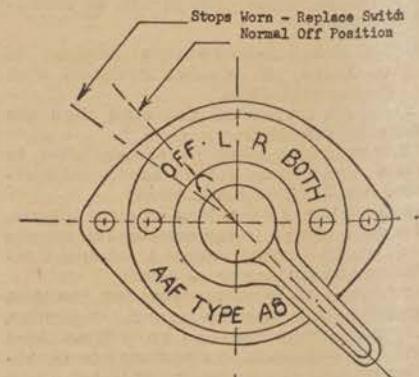
FIGURE 12.

position. The pointer projecting from the lever points to the middle "F" in the word "OFF." When the lever can be turned to a point beyond the centerline of the "O" in the word "OFF," the rotation stops have become worn and the switch should be replaced.

1. Inspection should consist of the following: Check switch lever for overtravel past the "off" position. The sketch below shows the location of the switch lever in the "off"

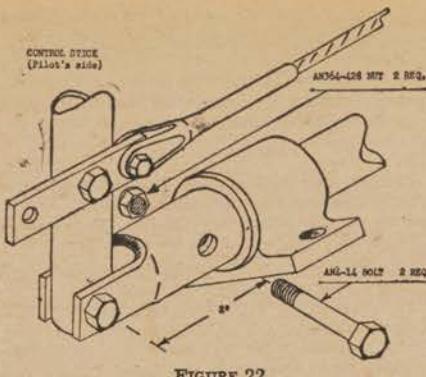
FIGURE 22.

As a result of a reported failure of the welded joint in the elevator control tube socket, the following, or equivalent, should be accomplished, to preclude the possibility of recurrence of this type failure:

(a) Install a  $\frac{1}{4}$ -inch AN steel bolt through the elevator control tube socket as shown below and secure with an elastic stop nut. Two installations will be necessary, one on the Pilot's side and one on the Passenger's.

(b) Due to the limited amount of clearance, it is recommended that the bolts be installed in the direction and location as shown. Ascertain that adequate clearance is provided when the control stick is operated throughout its full range.

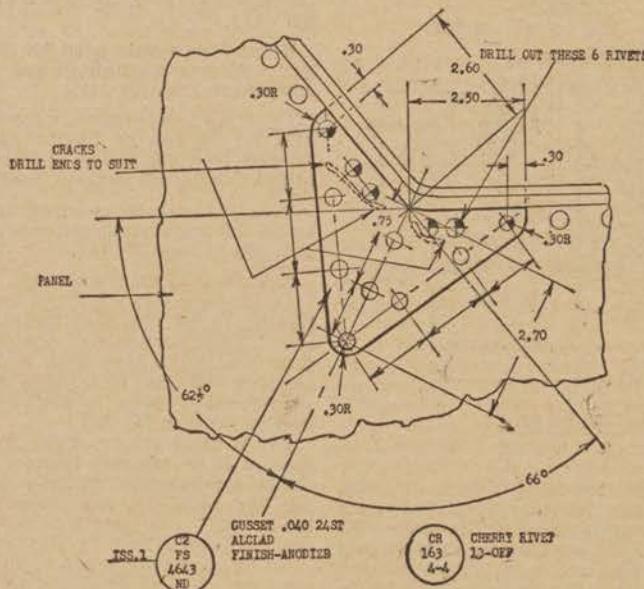
FIGURE 30.

VIEW ON FUSELAGE SIDE PANEL AT FRONT DOOR STEP SHOWING TYPICAL METHOD OF REPAIRING SKIN CRACKS.
