[Docket No. 94-NM-28-AD]

Airworthiness Directives; Boeing Model 767 Series Airplanes Equipped With General Electric CF6-80C2 Series Engines

ACTION: Notice of proposed rulemaking (NPRM).

SUMMARY: This document proposes the superseding of an existing airworthiness directive (AD), applicable to certain Boeing Model 767 series airplanes, that currently requires tests, inspections, and adjustments of the thrust reverser system. This action would add requirements for installation of a terminating modification on airplanes equipped with General Electric CF6-80C2 series engines, and repetitive operational checks of the electro-mechanical brake and the cone brake of the center drive unit following accomplishment of the modification. This action also would remove airplanes equipped with Rolls-Royce RB211-524 series engines from the applicability of the existing AD. This proposal is prompted by the identification of a modification that ensures that the level of safety inherent in the original type design of the thrust reverser system is further enhanced. The actions specified by the proposed AD are intended to prevent possible discrepancies that exist in the current thrust reverser control

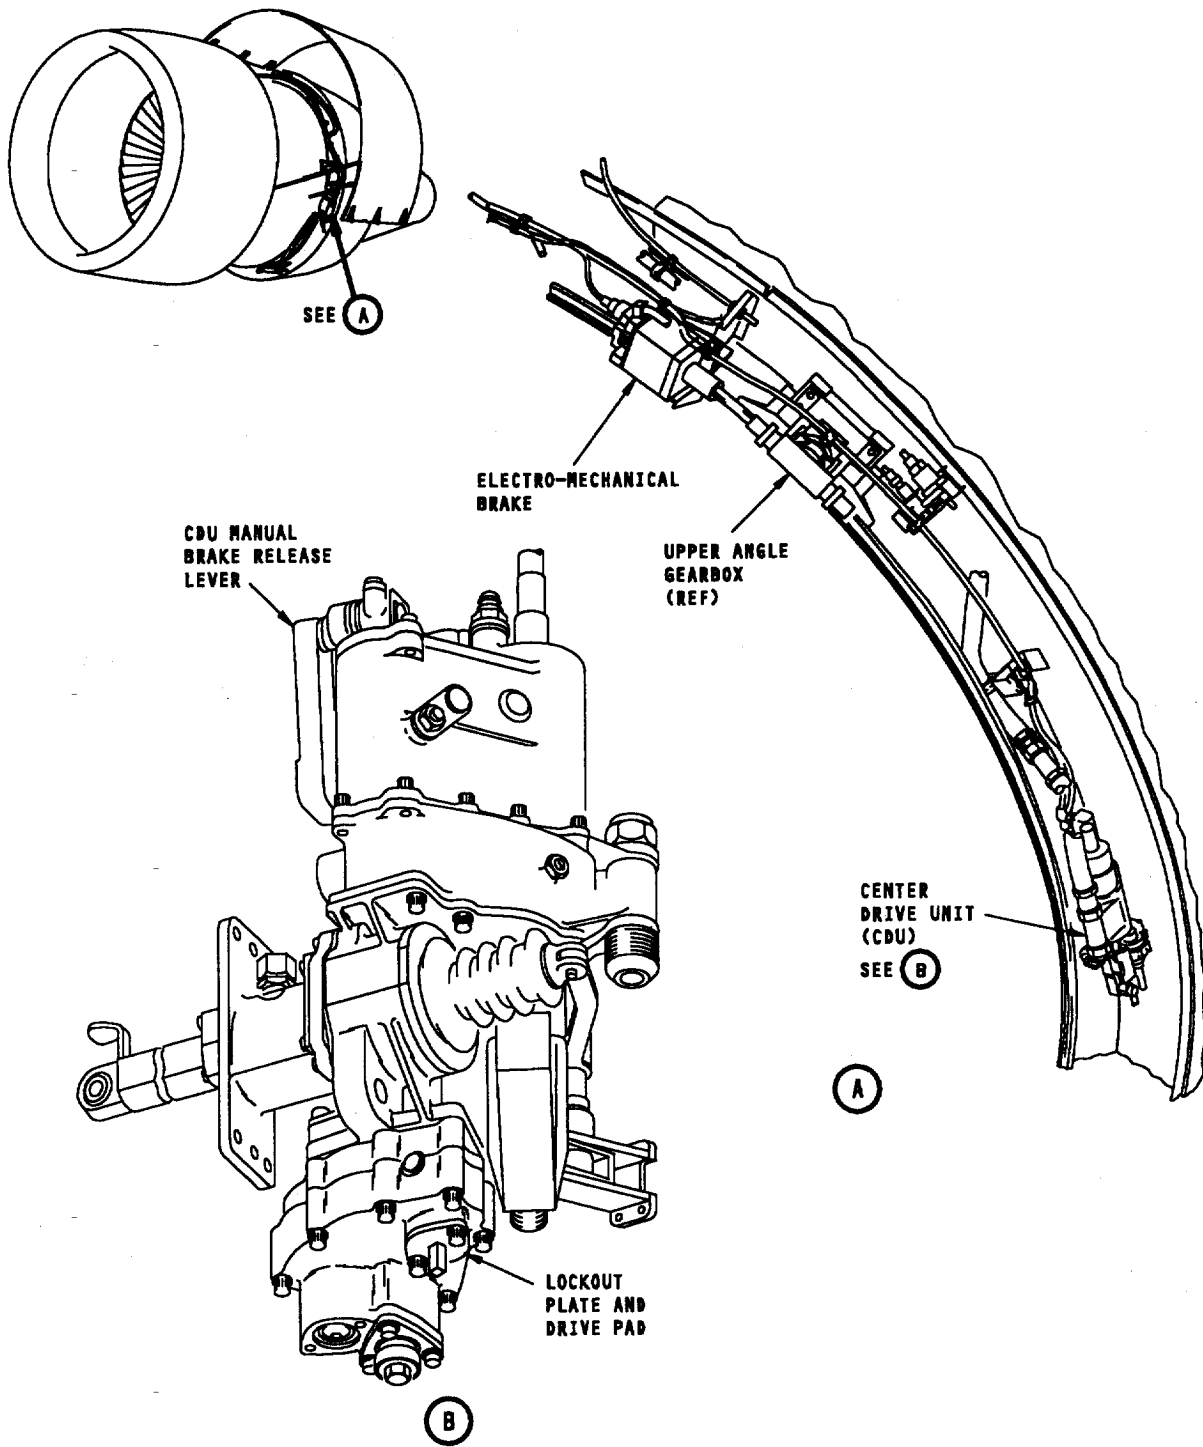
Electro-Mechanical Brake and CDU Cone Brake Torque Check
Figure 1

(1) The electro-mechanical brake system is working correctly if the torque is reached before you turn the wrench 450 degrees (1-1/4 turns).

(2) If the flexshaft turns more than 450 degrees before you reach the specified torque, you must replace the long flexshaft between the CDU and the upper angle gearbox.

- (3) If you do not get 90 pound-inches of torque, you must replace the electro-mechanical brake.
 - (f) Release the torque by turning the wrench in the opposite direction until you read zero pound-inches.
 - (1) If the wrench does not return to within 30 degrees of initial starting point, you must replace the long flexshaft between the CDU and upper angle gearbox.
 - (3) Fully retract the thrust reverser.
- C. Do a check of the torque of the CDU cone brake:
- (1) Pull up on the manual release handle to unlock the electro-mechanical brake.
 - (2) Pull the manual brake release lever on the CDU to release the cone brake.

- (a) If the torque is less than 15 pound-inches, you must replace the CDU.
