[Docket No. 94-NM-28-AD]

Airworthiness Directives; Boeing Model 767 Series Airplanes Equipped With General Electric CF6-80C2 Series Engines

ACTION: Notice of proposed rulemaking (NPRM).

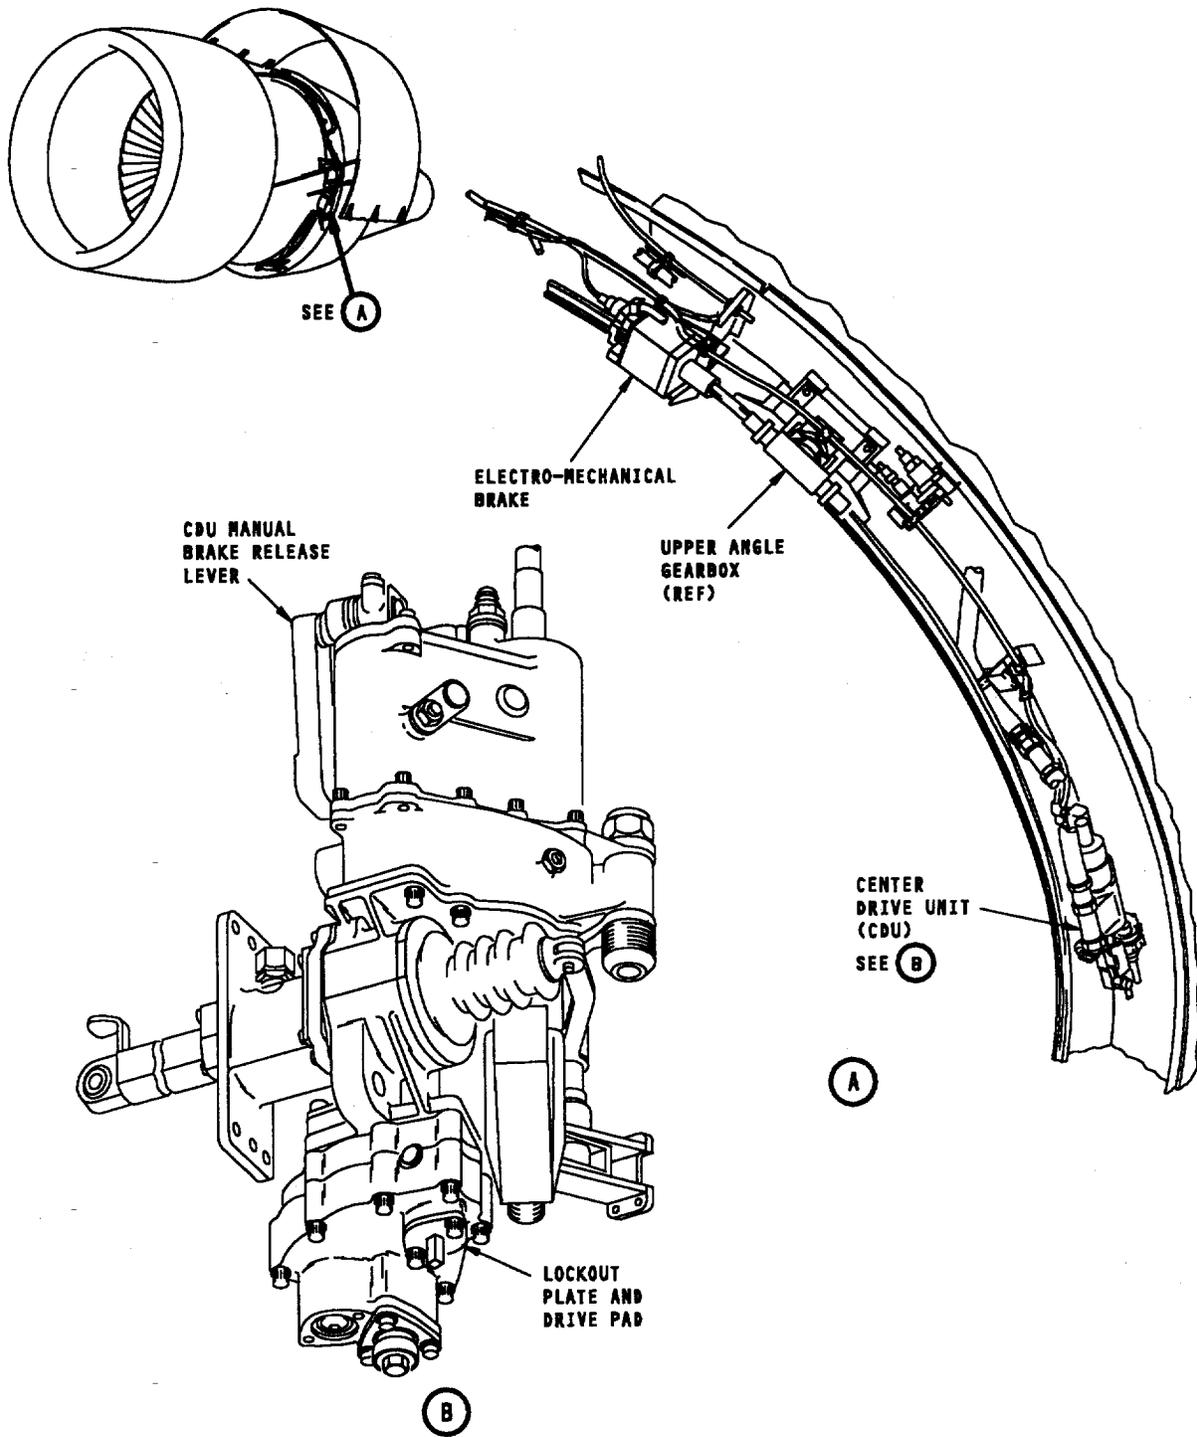
Electro-Mechanical Brake and CDU Cone Brake Torque Check
Figure 1

In addition, the FAA has determined that operational checks of the electro-mechanical brake and the cone brake of the center drive unit are necessary to provide an adequate level of safety and to ensure the effectiveness of the terminating modification following its installation in addressing the unsafe condition identified in this proposed AD. Procedures for accomplishment of the proposed operational checks are specified in Appendix 1 (including Figure 1) of this proposed AD.

2. Electro-Mechanical Brake and CDU Cone Brake Torque Check (Fig. 1)

(1) The electro-mechanical brake system is working correctly if the torque is reached before you turn the wrench 450 degrees (1-1/4 turns).

(2) If the flexshaft turns more than 450 degrees before you reach the specified torque, you must replace the long flexshaft between the CDU and the upper angle gearbox.

- (3) If you do not get 90 pound-inches of torque, you must replace the electro-mechanical brake.
 - (f) Release the torque by turning the wrench in the opposite direction until you read zero pound-inches.
 - (1) If the wrench does not return to within 30 degrees of initial starting point, you must replace the long flexshaft between the CDU and upper angle gearbox.
 - (3) Fully retract the thrust reverser.
- C. Do a check of the torque of the CDU cone brake:
- (1) Pull up on the manual release handle to unlock the electro-mechanical brake.
 - (2) Pull the manual brake release lever on the CDU to release the cone brake.

- (a) If the torque is less than 15 pound-inches, you must replace the CDU.
