[Docket No. 92-CE-63-AD]

Airworthiness Directives; Piper Aircraft Corporation PA-25 Series Airplanes

Piper Aircraft Corporation: Docket No. 92-CE-63-AD. Supersedes AD 93-21-12, Amendment 39-8763.

Appendix—Procedures and Requirements for Wing Forward Spar Attachment Assembly Inspection of Piper PA-25 Series Airplanes

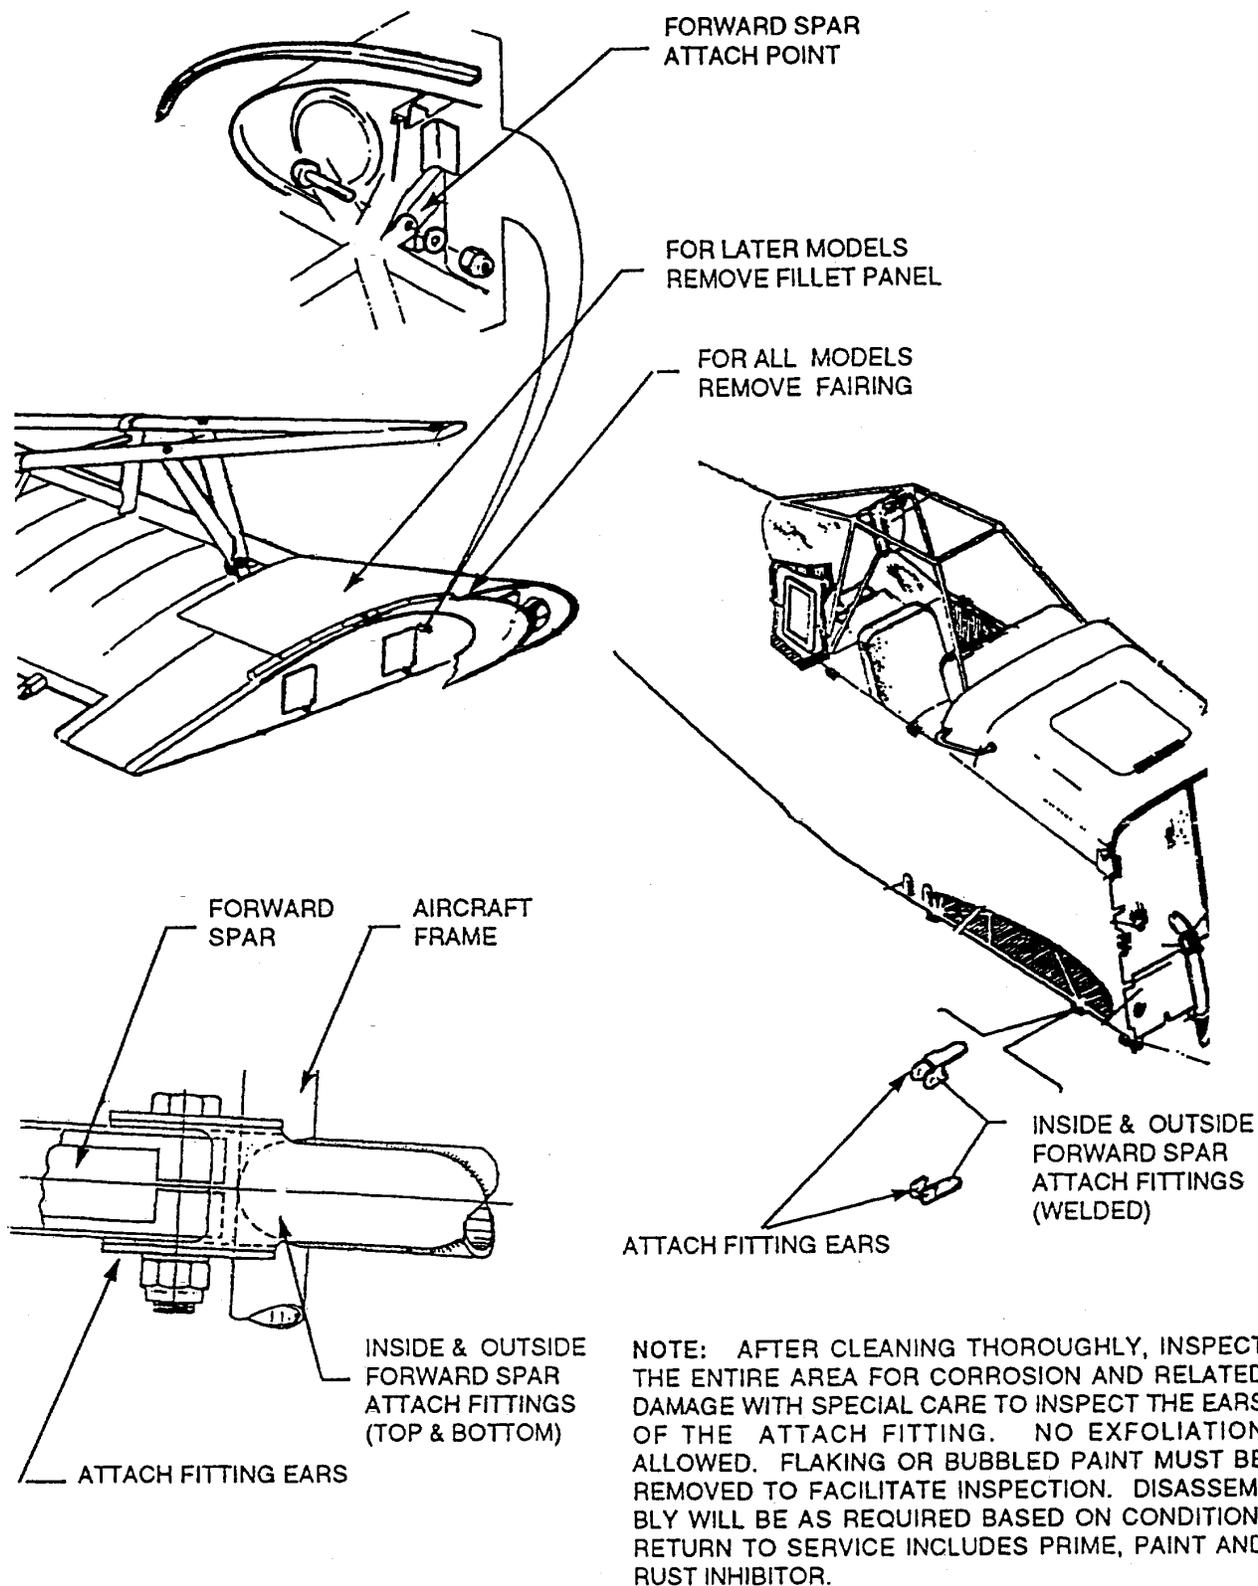
FIGURE 1

PA-25
Side View of the Front Wing Fitting
and Landing Gear Fittings

(a) Gain access to the left and right wing forward spar fuselage attach fittings by removing the screws retaining the wing fairing. Dismantle the wing fillet by removing the screws on the aft edge top and bottom and removing the wing fairing (see Figure 1 of the Appendix to this AD).

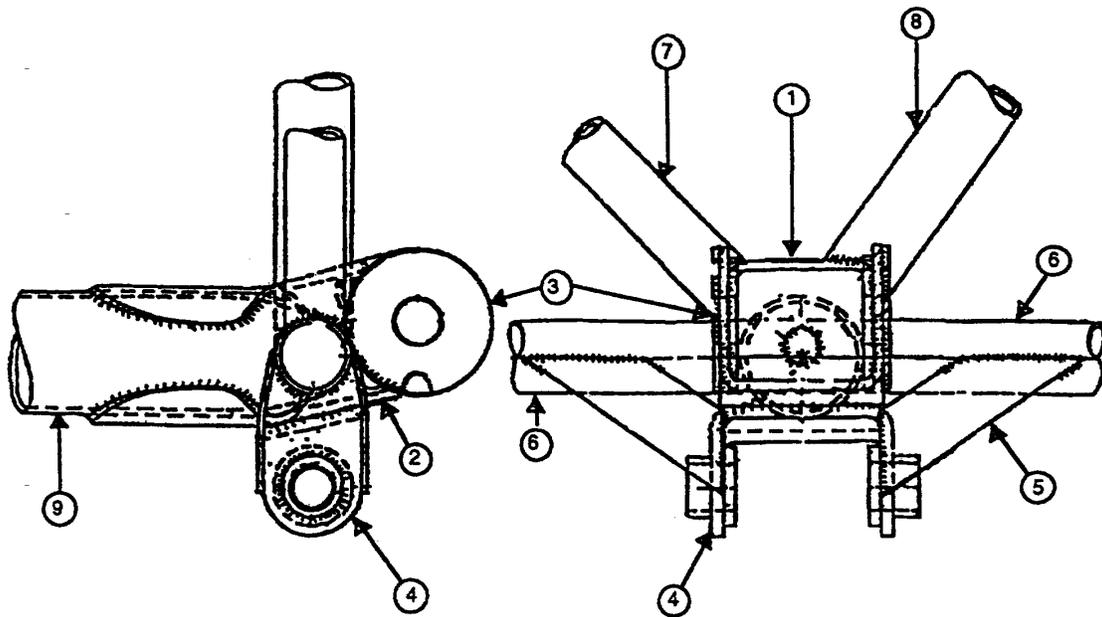
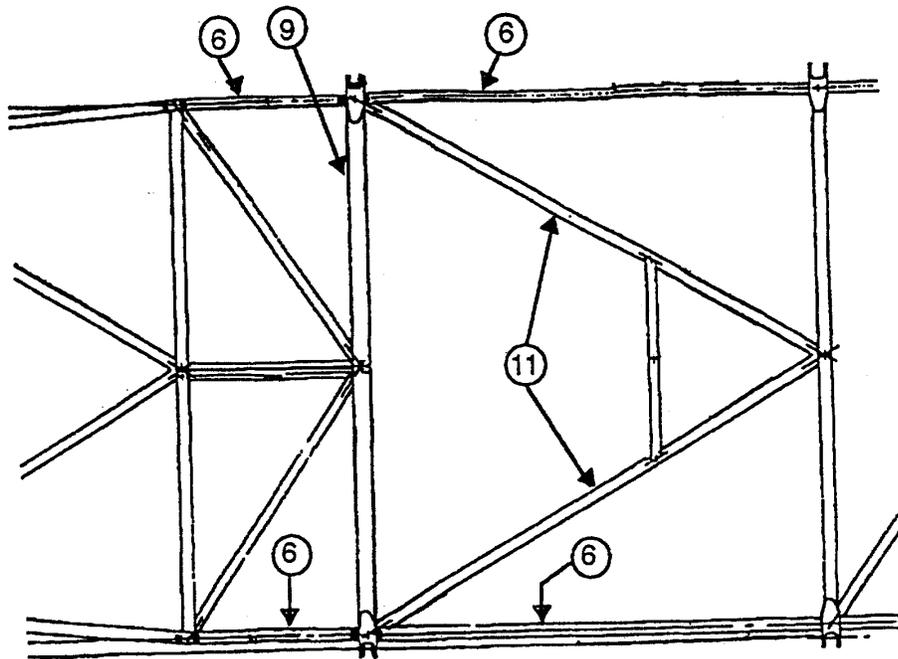
Figure 3a

PA-25-150
S/N - ALL
Front Wing Spar Attachment-Fittings and Tubes

1. Add couplant to the outside inspection surface (Refer to Figures 3a,

2. Add couplant to the inside inspection surface (Refer to Figures 3a, 4a and 5a, as applicable). Add the appropriate gain to obtain the backwall echo from the inspection surface. To assure proper coupling to the test sample, twist the probe (clockwise and counter-clockwise with a 45-degree twist). During the articulation of the probe, observe the A-trace on the screen and stop the probe twist at the point of adequate back surface signal amplitude to trigger the thickness gate on the first half-cycle. Measure and record the thickness. Repeat the above process at eight equally-spaced locations around the surface.

b. Cut the tubular members as referenced and specified in Figure 2 and either Figures 3a and 3b; Figures 4a and 4b; or Figures 5a and 5b, as applicable.

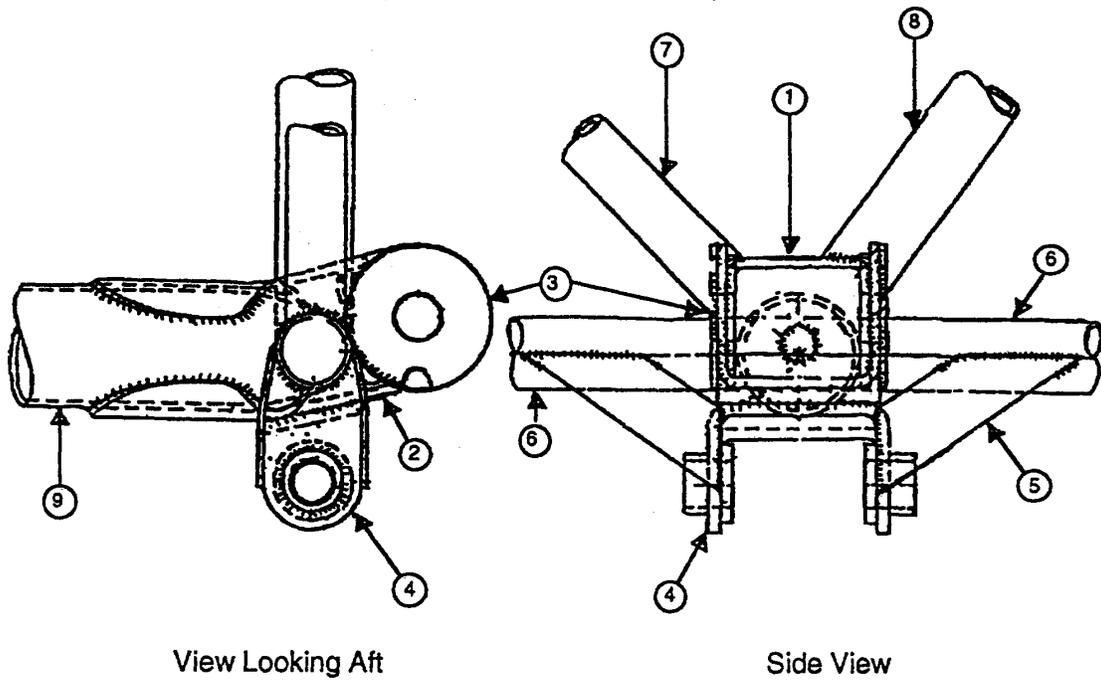
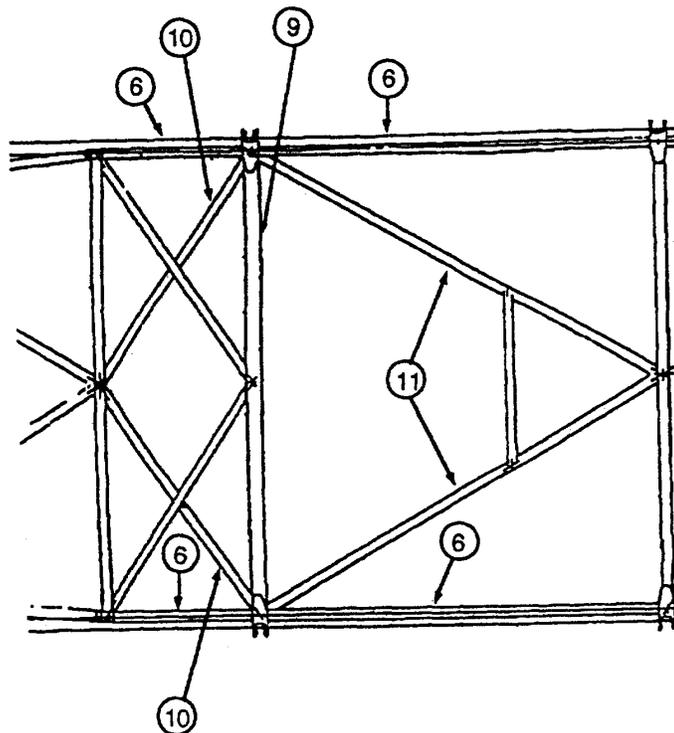
Figure 4a

PA-25-235
S/N - 25-2000 to 25-2985
Front Wing Spar Attachment-Fittings and Tubes

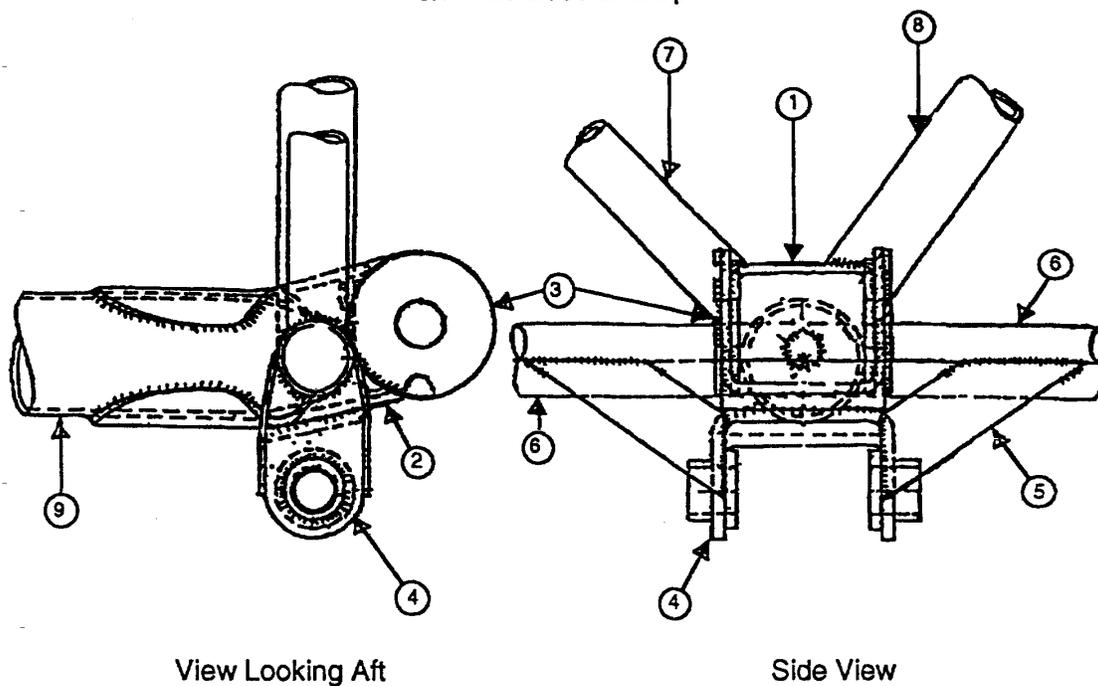
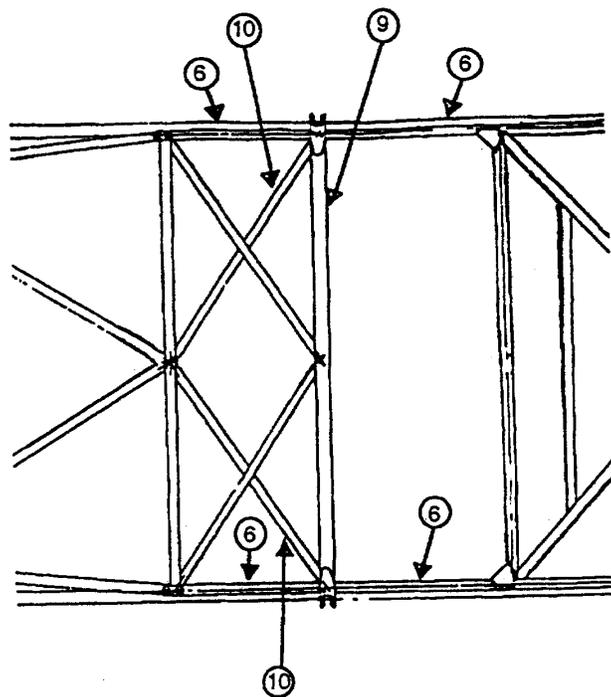
Figure 5a

PA-25-235,-260
S/N - 25-2986 and Up
Front Wing Spar Attachment-Fittings and Tubes
