[Docket No. 94-CE-28-AD]

Airworthiness Directives; Piper Aircraft Corporation PA-28 and PA-32 Series Airplanes

ACTION: Notice of proposed rulemaking (NPRM).

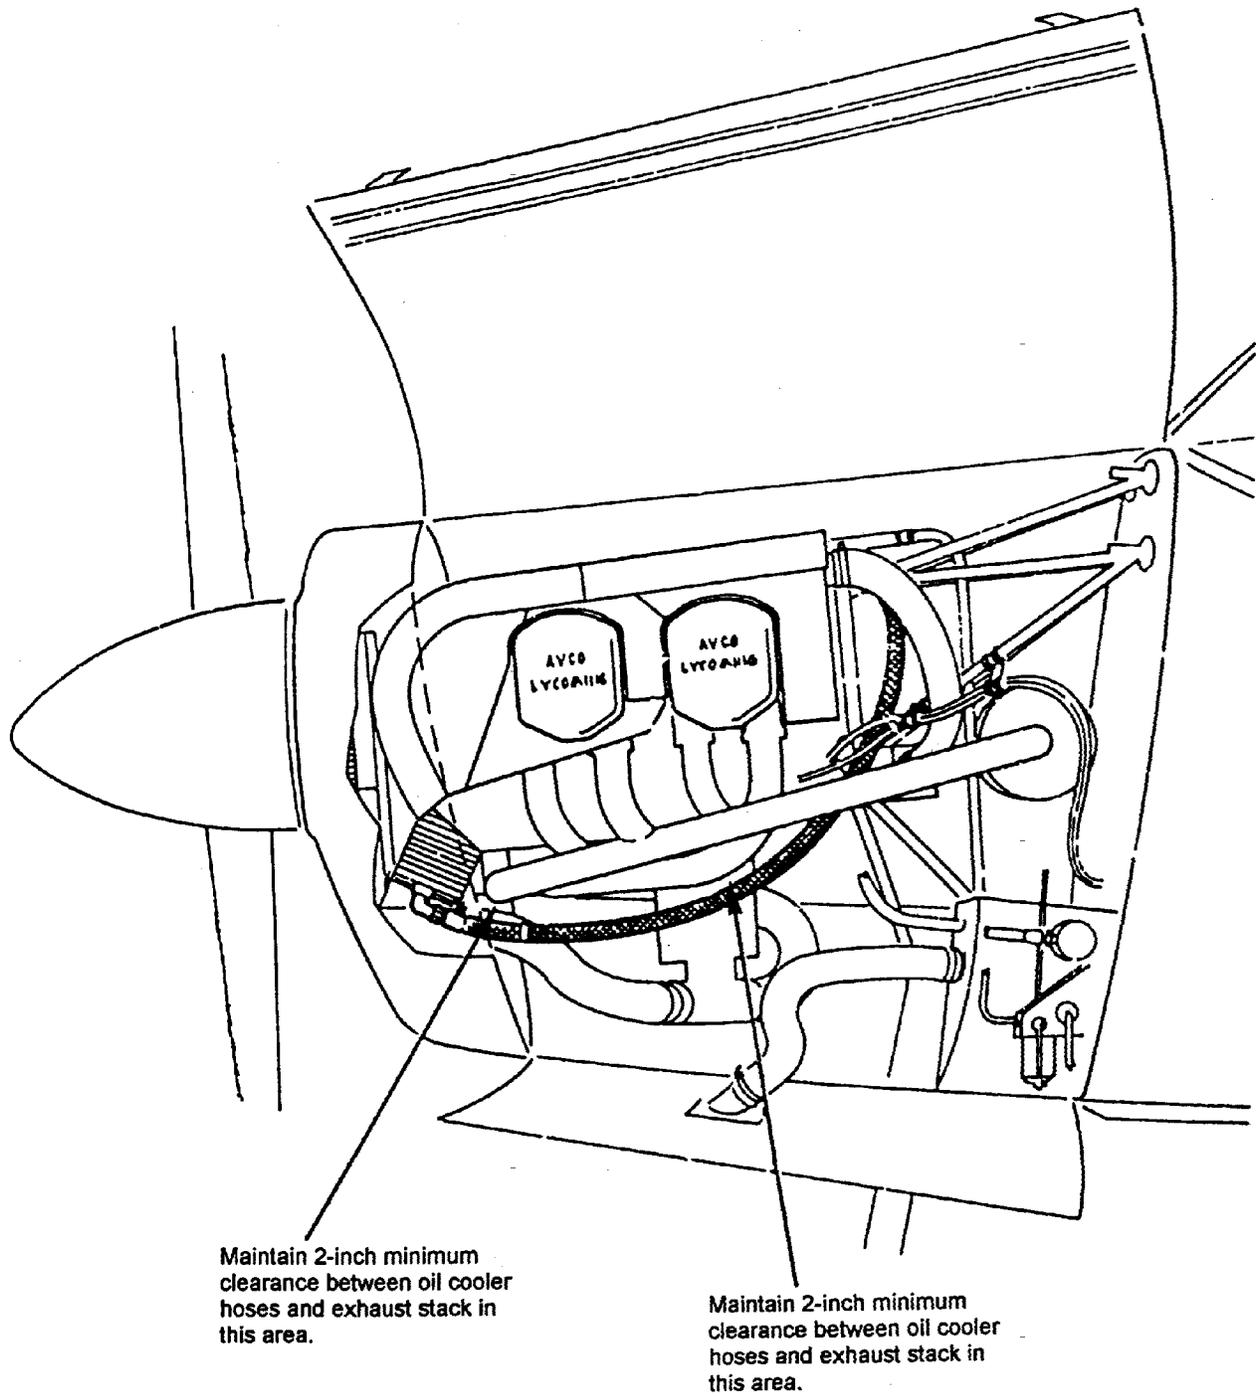
(i) The hose passes underneath and behind the electrical ground cable and in front of the lower of the two engine mount struts when the hose is routed to the rear of the engine; and

(ii) The hose is tied to the engine mount strut and a clearance of at least 2 inches exists between the oil hose and exhaust stack.

Note 2: Figure 1 of this AD relates to the conditions specified in paragraphs (a)(2)(i) and (a)(2)(ii) of this AD.

(2) On airplanes that have any oil cooler mounted in the front of the airplane, ensure that the following exists, and, prior to further flight, adjust accordingly:
