95-12-01 Piper Aircraft Corporation:

Amendment 39-9251; Docket No. 92-CE-63-AD. Supersedes AD 93-21-12, Amendment 39-8763.

Applicability: Models PA-25, PA-25-235, and PA-25-260 airplanes (all serial numbers), certificated in any category.

Appendix to AD 95-12-01—Procedures and Requirements for Wing Forward Spar Attachment Assembly; Inspection of Piper PA-25 Series Airplanes

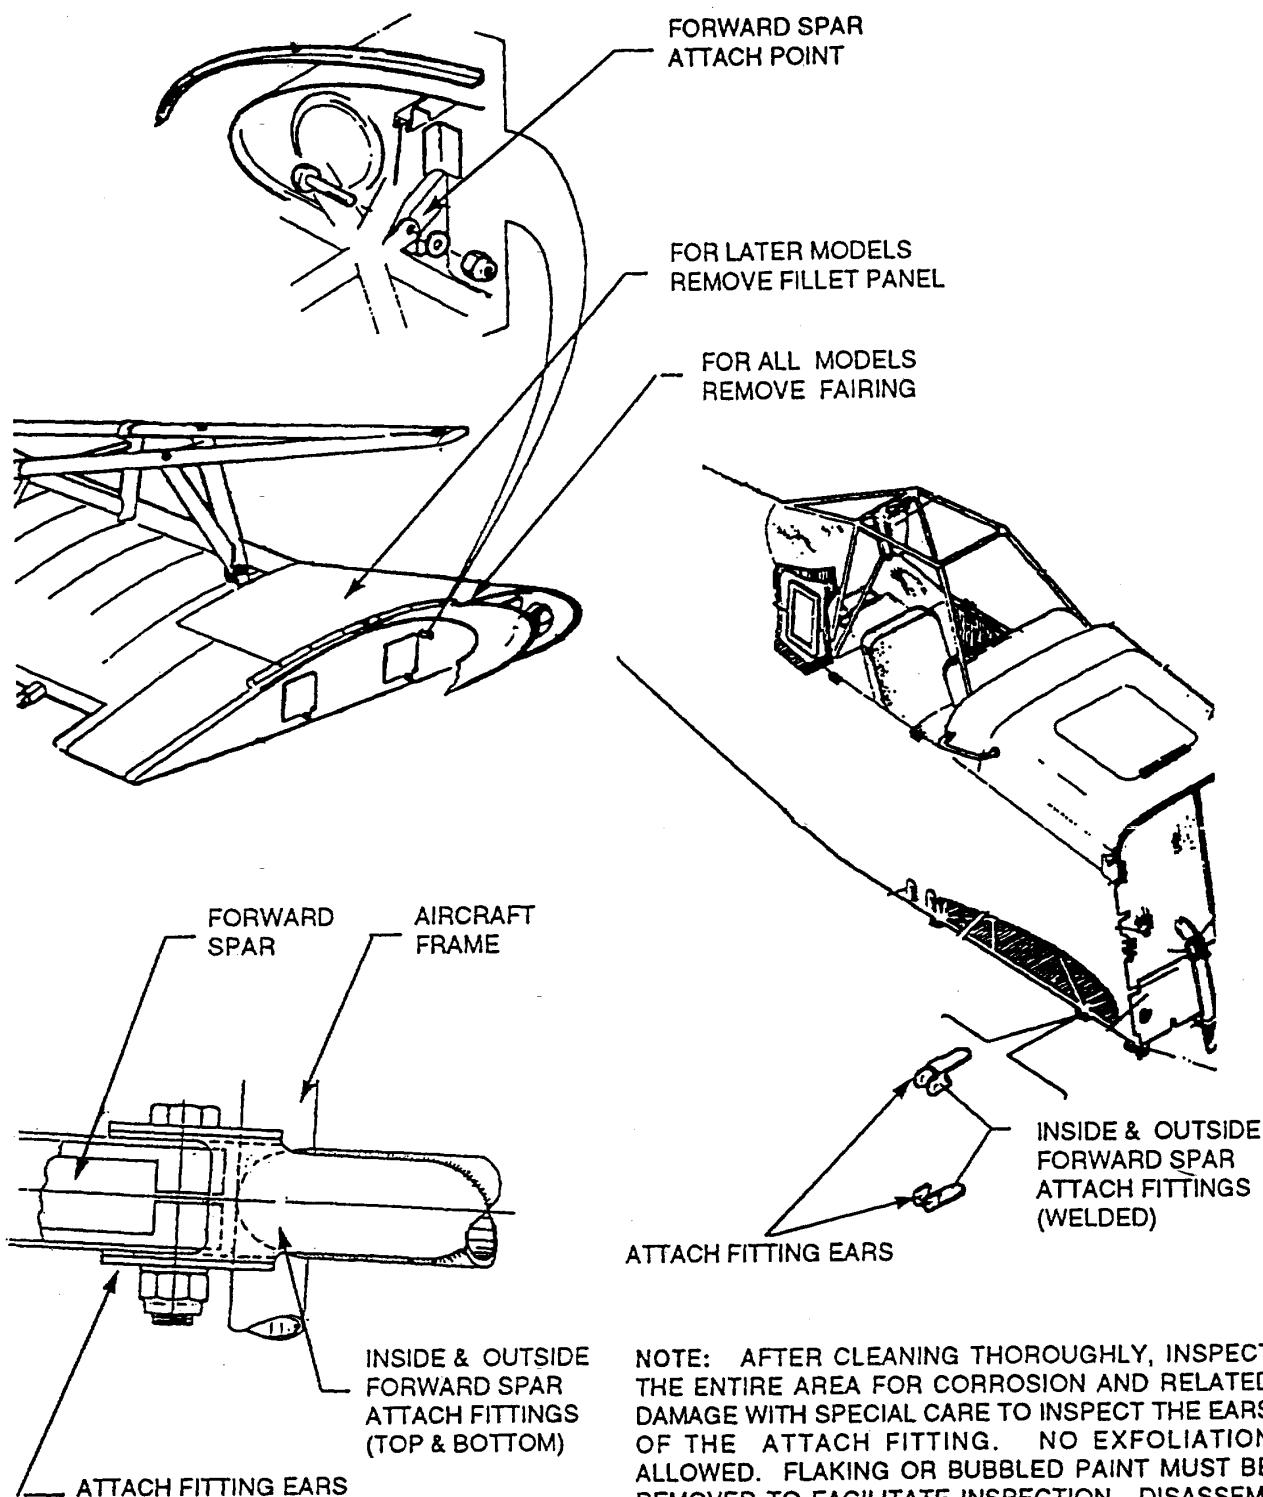
NOTE: AFTER CLEANING THOROUGHLY, INSPECT THE ENTIRE AREA FOR CORROSION AND RELATED DAMAGE WITH SPECIAL CARE TO INSPECT THE EARS OF THE ATTACH FITTING. NO EXFOLIATION ALLOWED. FLAKING OR BUBBLED PAINT MUST BE REMOVED TO FACILITATE INSPECTION. DISASSEMBLY WILL BE AS REQUIRED BASED ON CONDITION. RETURN TO SERVICE INCLUDES PRIME, PAINT AND RUST INHIBITOR.

Side View of the Front Wing Fitting
and Landing Gear Fittings

(a) Gain access to the left and right wing forward spar fuselage attach fittings by removing the screws retaining the wing fairing. Dismantle the wing fillet by removing the screws on the aft edge top and bottom and removing the wing fairing (see FIGURE 1 of the Appendix to this AD).

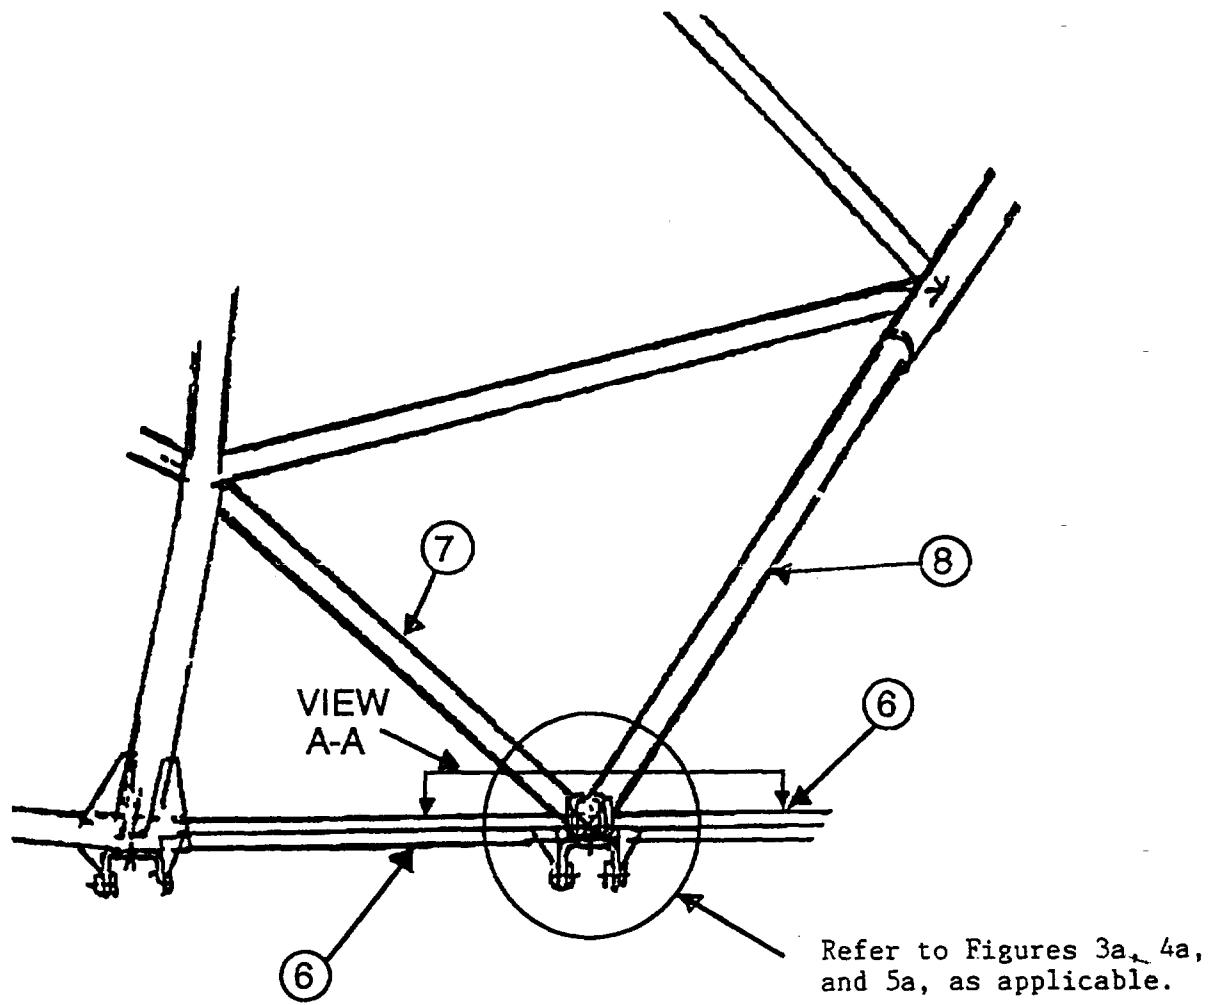
Figure 2

PA-25
S/N - ALL

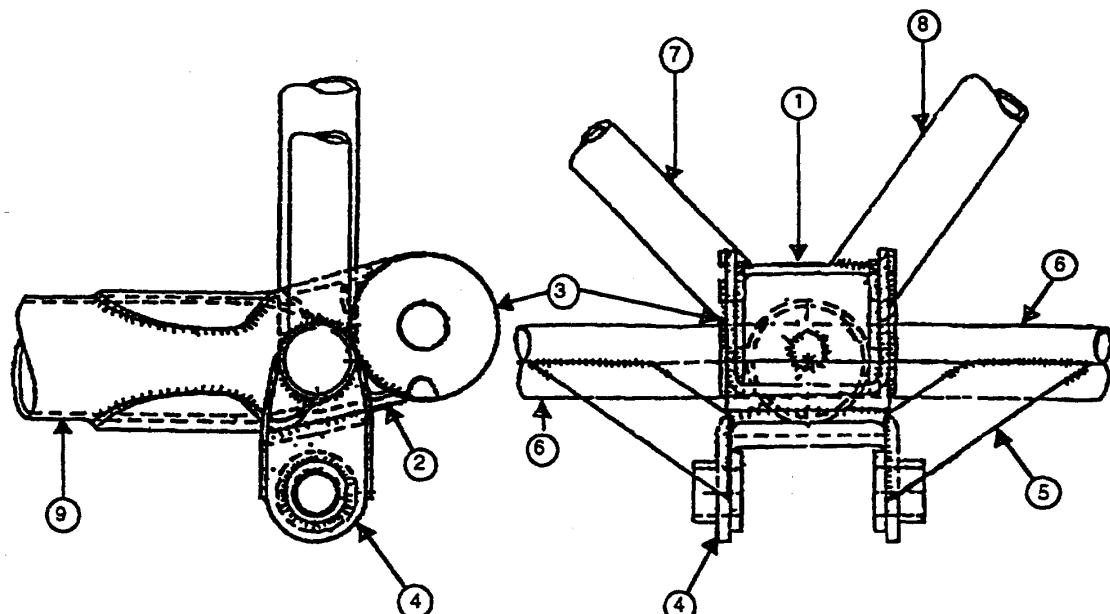
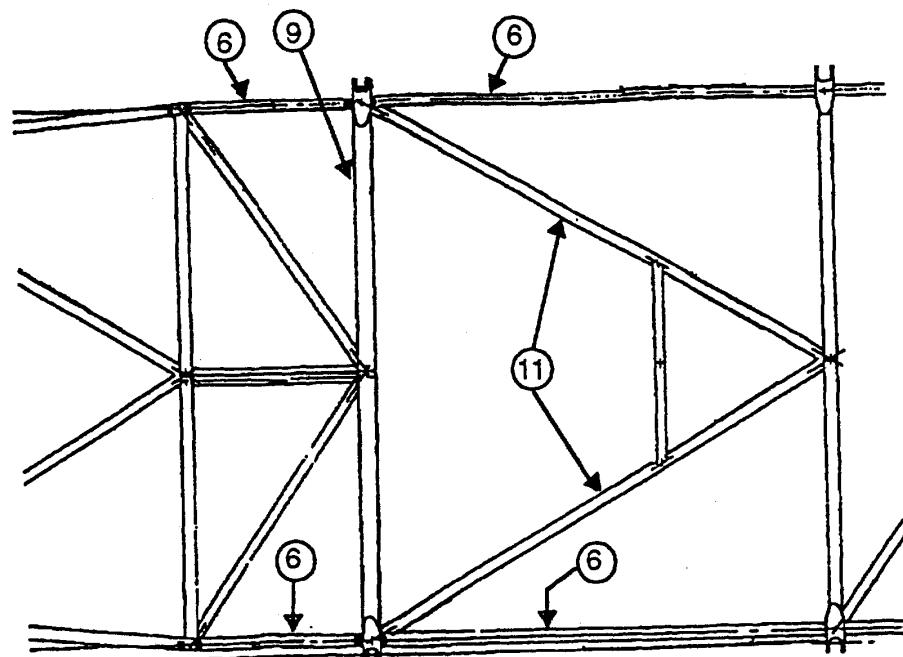
Figure 3a

PA-25-235
(S/N - 25-2000 To 25-2985)

(e) Replacement parts required by this AD shall be of those referenced and specified in either Figures 3a and 3b, 4a and 4b, or 5a and 5b (as applicable), included as part of the Appendix of this AD.

1. Add couplant to the outside inspection surface (Refer to Figures 3a, 4a and 5a, as applicable). Add the appropriate gain to obtain the backwall echo from the inspection surface. If the gain setting is adjusted, re-check the thickness values on the steel shims. To assure proper coupling to the test sample, twist the probe clockwise and counter-clockwise (with a 45-degree twist) and maintain contact with the test surface. During the articulation of the probe, observe the A-trace on the screen and stop the probe twist at the point of adequate back surface signal amplitude to trigger the thickness gate

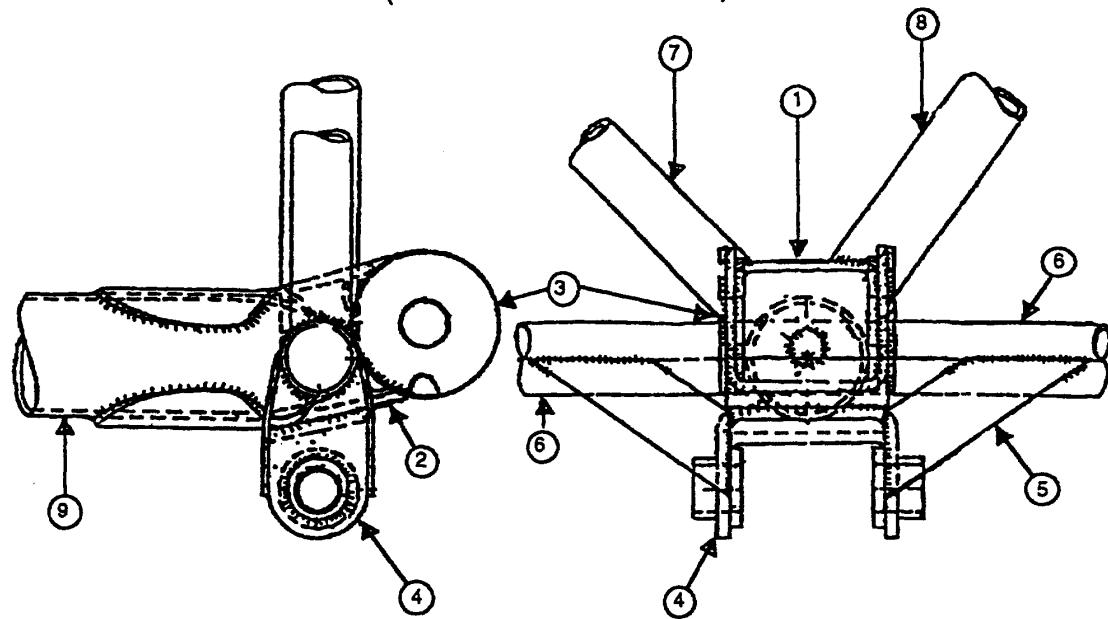
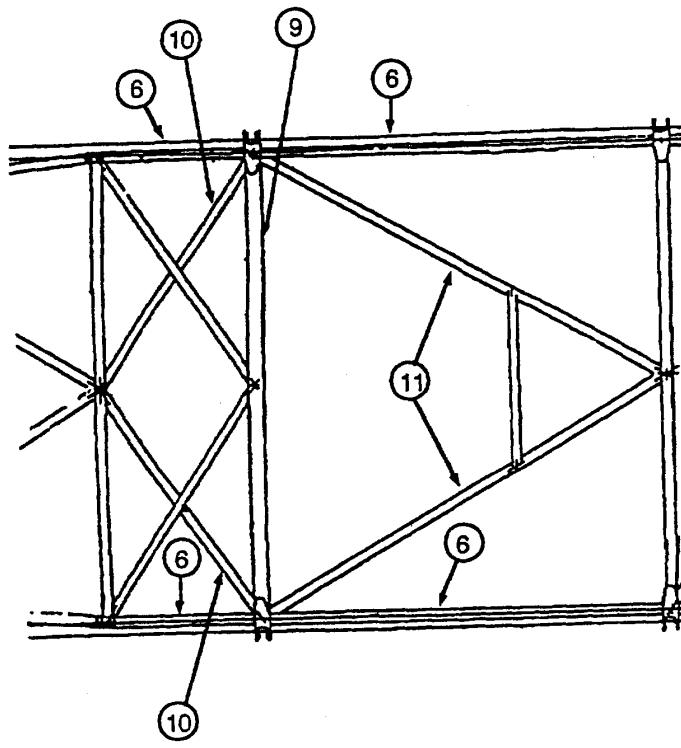
Figure 4a

PA-25-235, PA-25-260
S/N - 25-2986 and Up
