14 CFR Part 39**[Docket No. 95-NM-22-AD]****Airworthiness Directives; Boeing Model 747-100, -200, -300, and SP Series Airplanes****AGENCY:** Federal Aviation Administration, DOT.**ACTION:** Notice of proposed rulemaking (NPRM).

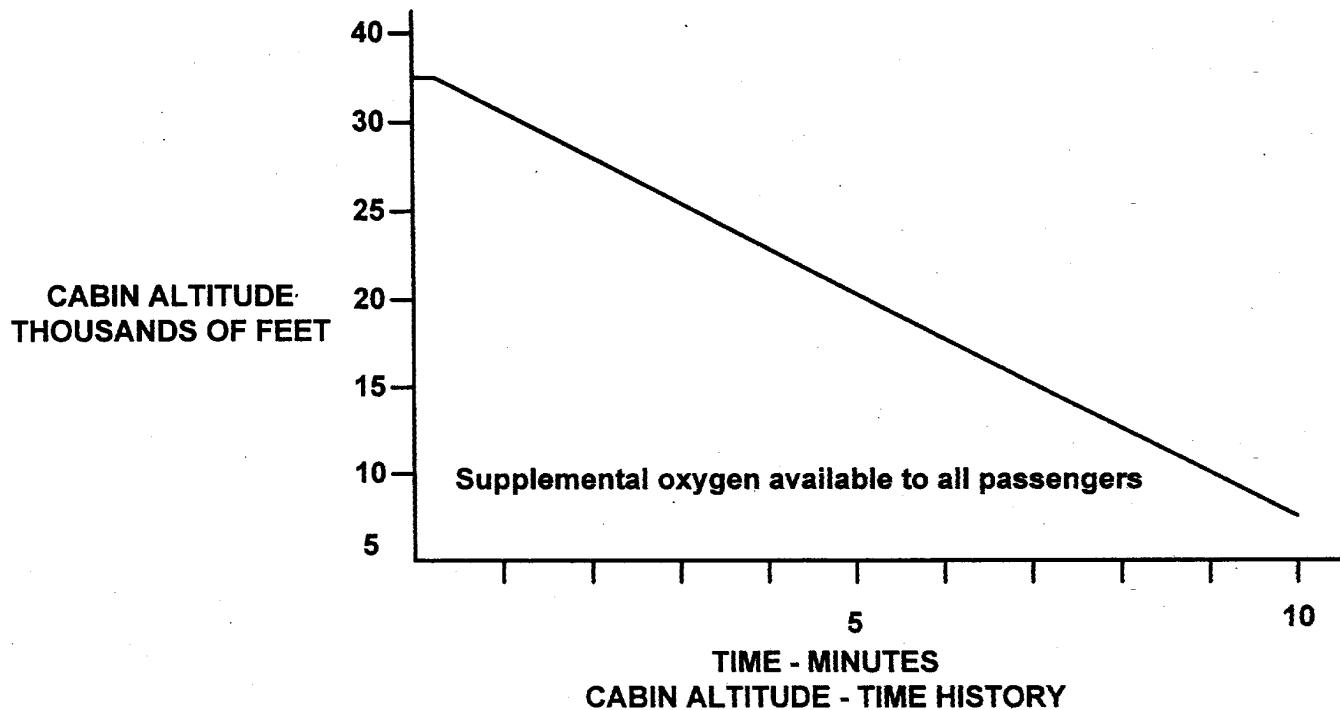
Figure 4

NOTE: For figure 4 , time starts at the moment cabin altitude exceeds 8,000 feet during depressurization. If depressurization analysis shows that the cabin altitude limit of this curve is exceeded, the following alternate limitations apply: After depressurization, the maximum cabin altitude exceedence is limited to 40,000 feet. The maximum time the cabin altitude may exceed 25,000 feet is 2 minutes; time starting when the cabin altitude exceeds 25,000 feet and ending when it returns to 25,000 feet.
