[Docket No. 94-NM-28-AD; Amendment 39-9292; AD 95-13-12]

Airworthiness Directives; Boeing Model 767 Series Airplanes Equipped With General Electric CF6-80C2 Series Engines

ACTION: Final rule.

95-13-12 Boeing: Amendment 39-9292.

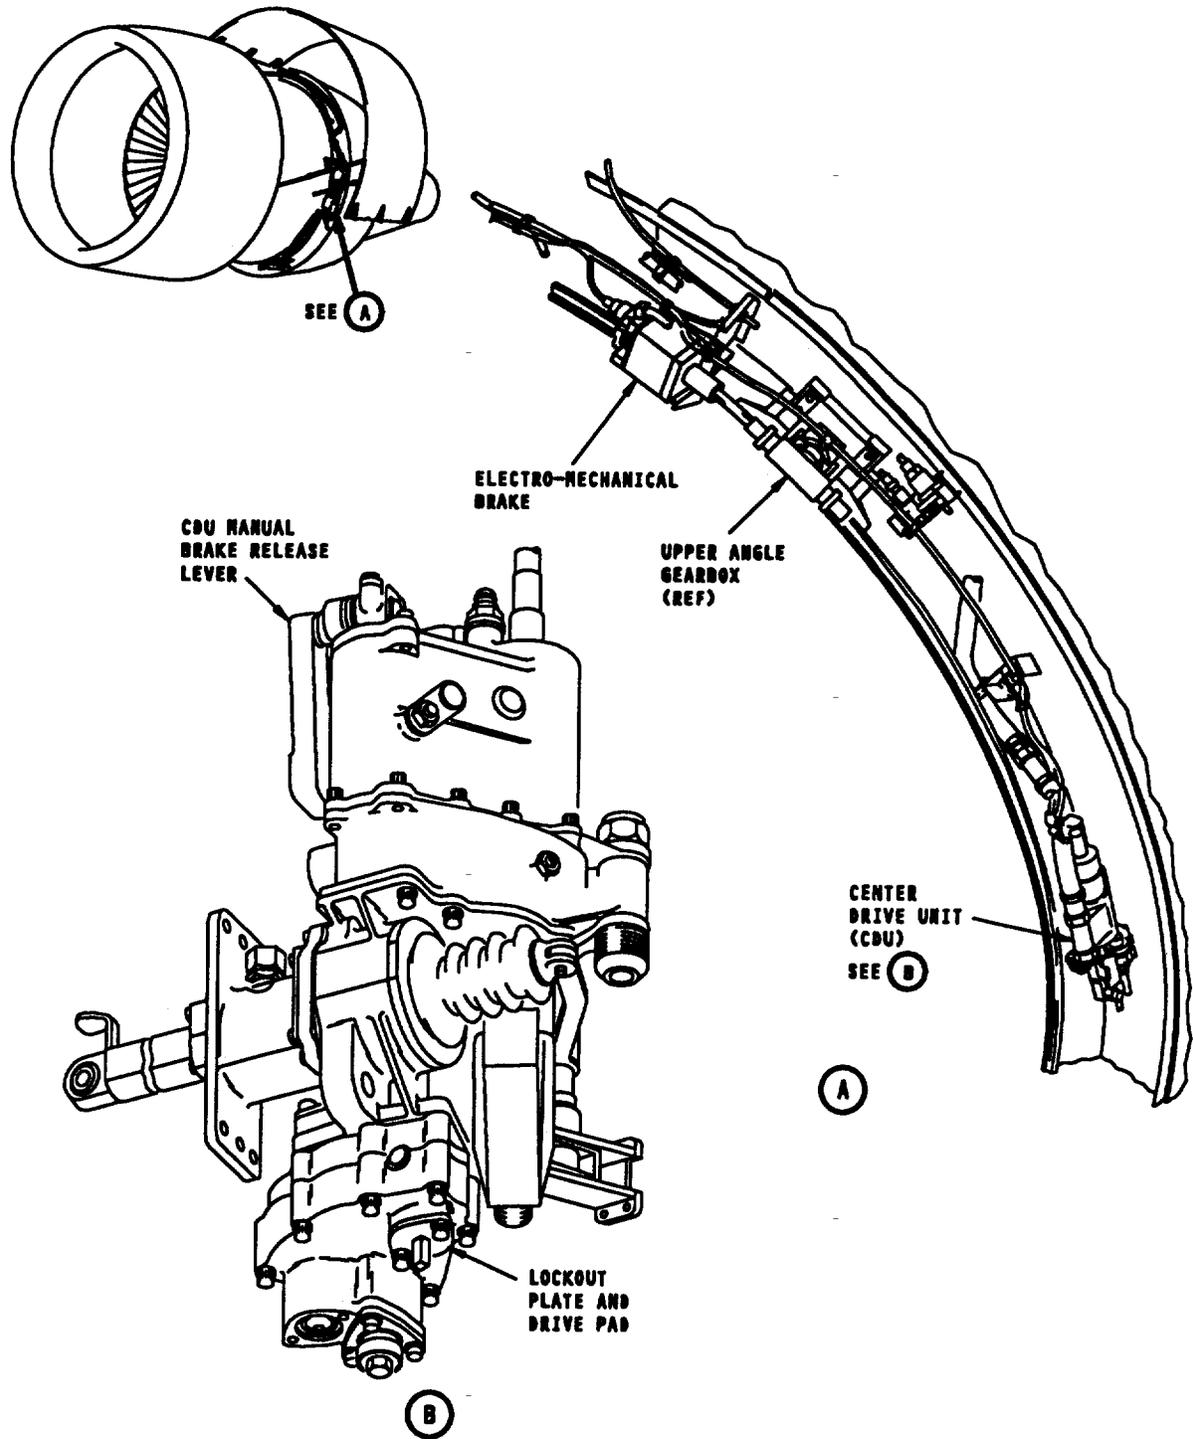
Electro-Mechanical Brake and CDU Cone Brake Torque Check
Figure 1

2. Electro-Mechanical Brake and CDU Cone Brake Torque Check (Fig. 1)

(1) The electro-mechanical brake system is working correctly if the torque is reached before you turn the wrench 450 degrees (1-1/4 turns).

(2) If the flexshaft turns more than 450 degrees before you reach the specified torque, you must replace the long flexshaft between the CDU and the upper angle gearbox.

(3) If you do not get 90 pound-inches of torque, you must replace the electro-mechanical brake.

(1) If the wrench does not return to within 30 degrees of initial starting point, you must replace the long flexshaft between the CDU and upper angle gearbox.

(a) If the torque is less than 15 pound-inches, you must replace the CDU.

mechanical brake and the cone brake of the center drive unit in accordance with Appendix 1 (including Figure 1) of this AD.
