[Docket No. 95-NM-153-AD; Amendment 39-9366; AD 95-18-52]

Airworthiness Directives; Lockheed Model L-1011-385 Series Airplanes

ACTION: Final rule; request for comments.

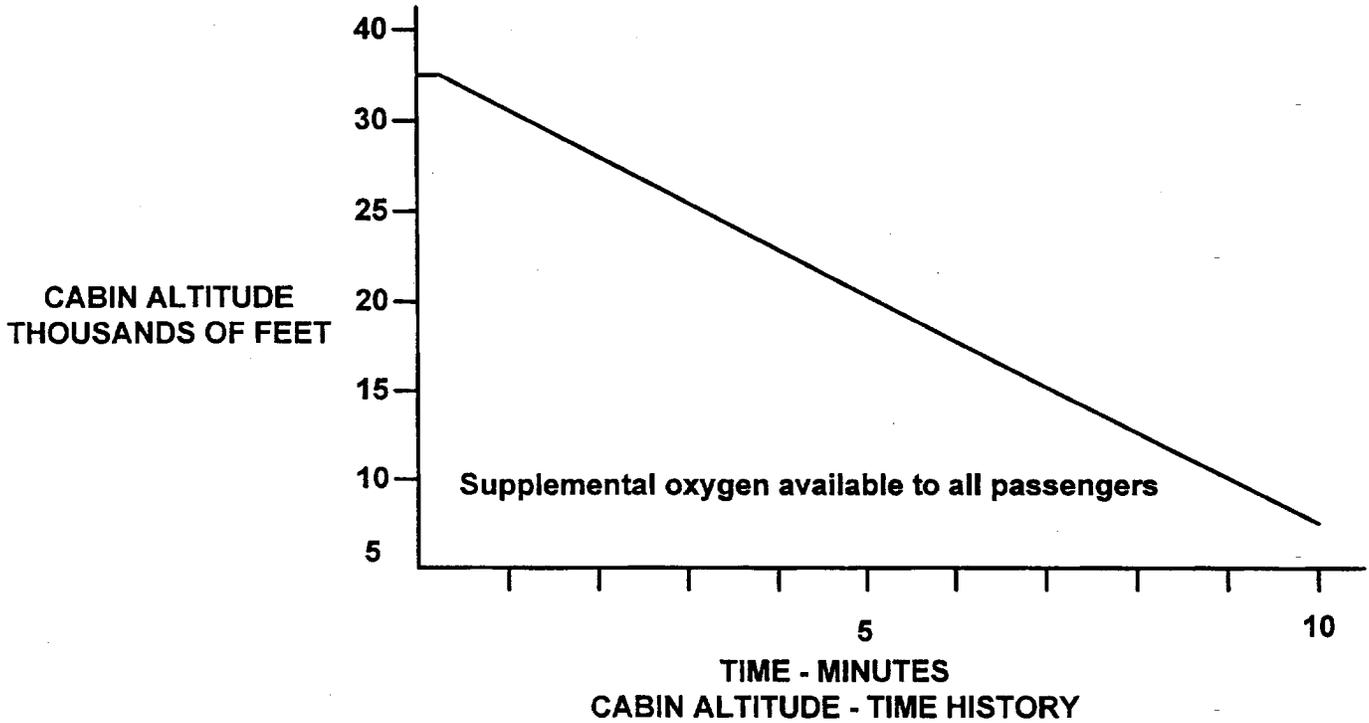
Figure 4

NOTE: For figure 4 , time starts at the moment cabin altitude exceeds 8,000 feet during depressurization. If depressurization analysis shows that the cabin altitude limit of this curve is exceeded, the following alternate limitations apply: After depressurization, the maximum cabin altitude exceedence is limited to 40,000 feet. The maximum time the cabin altitude may exceed 25,000 feet is 2 minutes; time starting when the cabin altitude exceeds 25,000 feet and ending when it returns to 25,000 feet.
