Federal Register

Tuesday, January 9, 1996

[Docket No. 95-SW-33-AD; Amdt. 39-9484; AD 96-01-08]

#### Airworthiness Directives; Bell Helicopter Textron, A Division of Textron Canada Ltd. Model 222, 222B, 222U, and 230 Helicopters

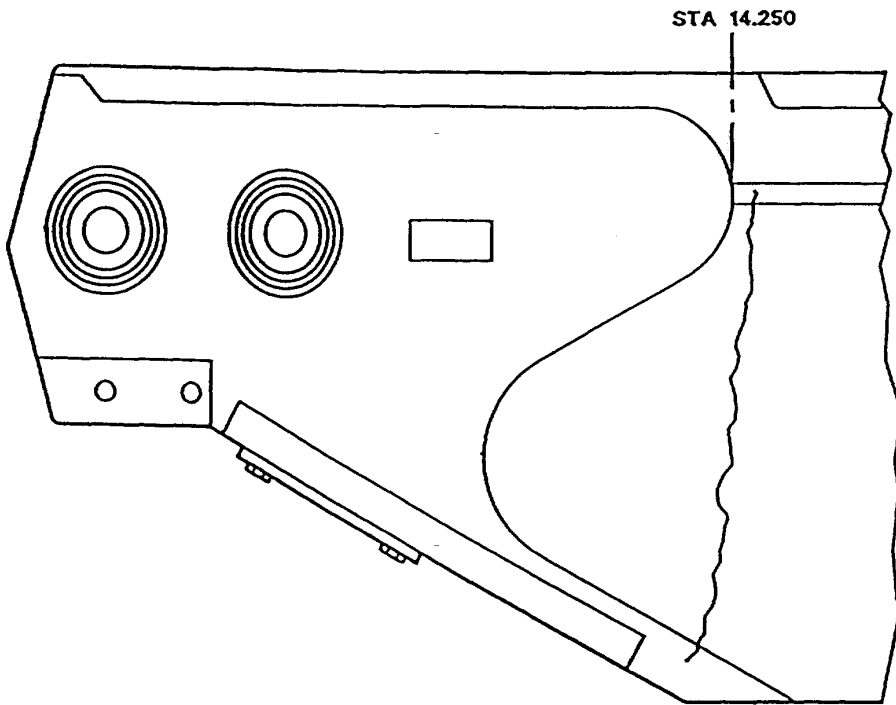
*Compliance:* Required before further flight, unless accomplished previously. To prevent failure of a tail rotor blade (blade) due to a fatigue crack (see Figure 1), loss of the tail rotor and tail rotor gear box, and subsequent loss of control of the helicopter, accomplish the following:

FIGURE 1. SKIN CRACK IN TAIL ROTOR BLADE

(2) If any crack is discovered, remove the blade and replace it with an airworthy blade.

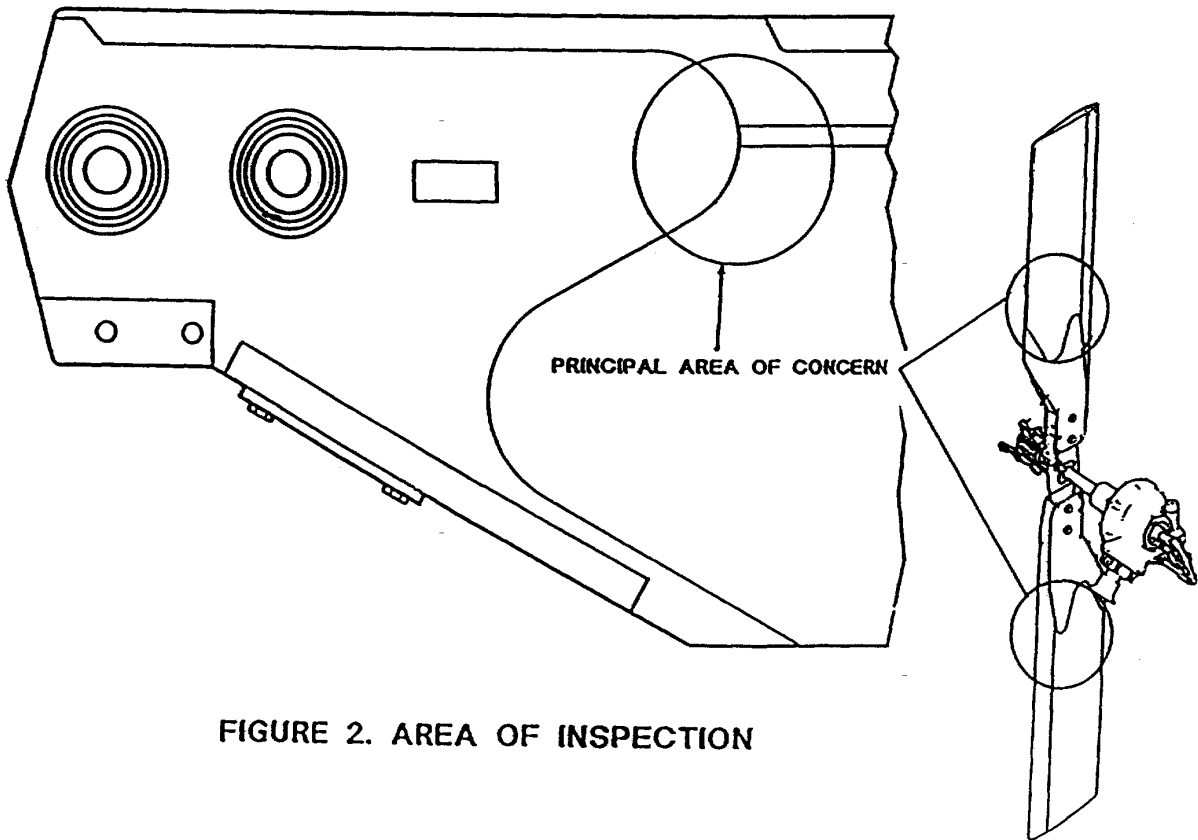
(a) Clean the painted surfaces of the blades in an area approximately 6 inches spanwise on either side of the doubler tip. Visually check both surfaces of each blade for cracks by pushing the blade tip away from the surface being checked until it contacts the flapping stop and then holding the blade firmly against the stop. Pay particular attention to the area reaching from the doubler tip to 1 inch outboard, centering on an area 2 inches aft of the blade leading edge (see Figure 2).

FIGURE 2. AREA OF INSPECTION

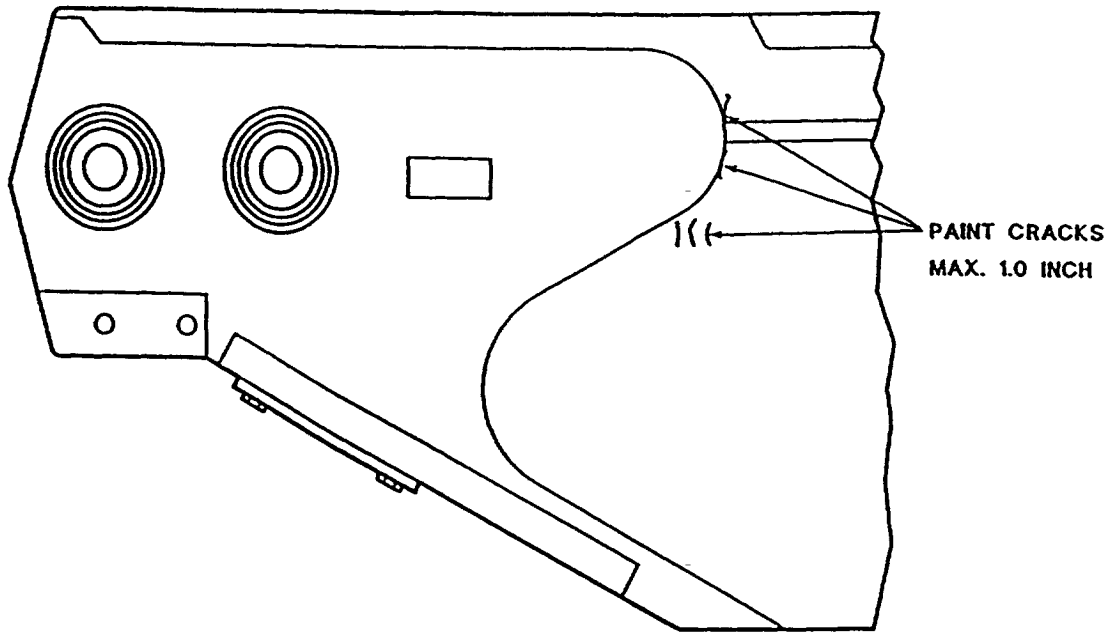
FIGURE 3.

(c) If the visual check described in paragraph (a) reveals any crack outboard of the doubler tip (Station 14.250), or any chordwise crack inboard of the doubler tip that is longer than 1 inch (see Figure 3), accomplish the following:

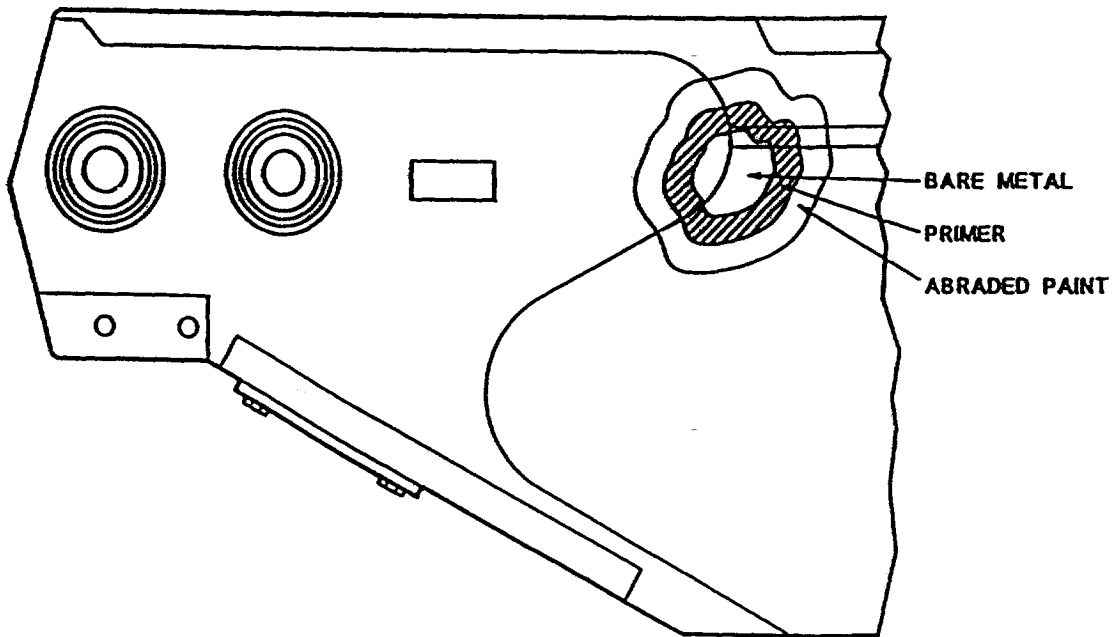
FIGURE 4.

(1) Remove the paint from the skin in the cracked area using the following procedures (see Figure 4):

(3) Using spanwise or circular sanding motions, continue hand-sanding the remaining greenish- or yellow-colored primer in the cracked area using a 320 or 400 grit paper until sufficient metal has been exposed to allow inspection (see area indicated in Figure 4).

(2) Using a 180 or 220 grit abrasion paper, sand by hand with spanwise strokes until greenish- or yellow-colored primer or bare metal begins to be exposed.

(d) Inspect the blade skin for cracks in the area that was exposed in accordance with paragraph (c) using a 10-power or higher magnifying glass.

(1) If no crack is found in the blade skin, coat the bare metal area with a lightweight oil or an equivalent corrosion preventive compound.
