Federal Register

[Docket No. 95-SW-33-AD; Amdt. 39-9484; AD 96-01-08]

Airworthiness Directives; Bell Helicopter Textron, A Division of Textron Canada Ltd. Model 222, 222B, 222U, and 230 Helicopters

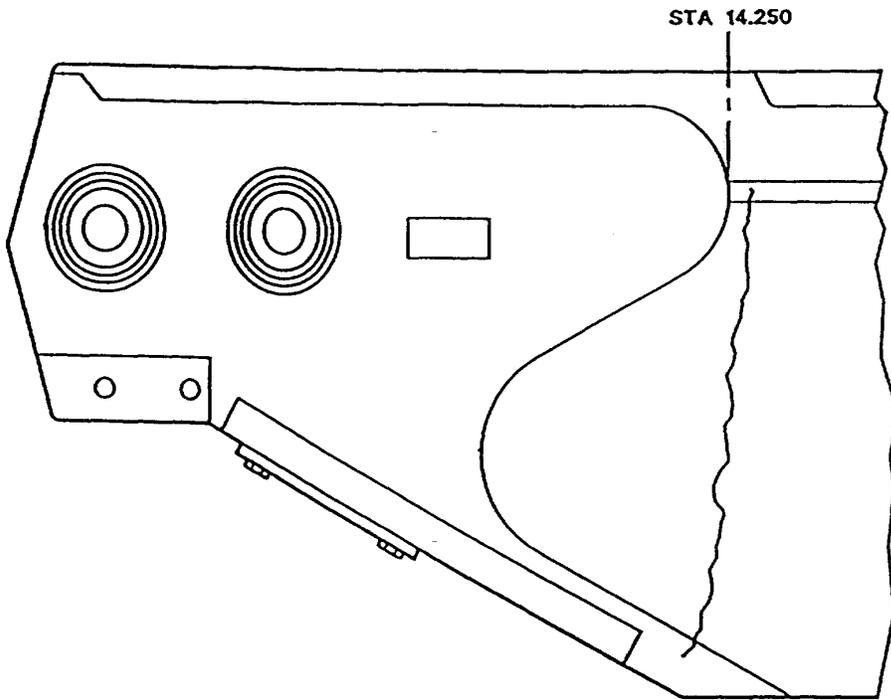
Compliance: Required before further flight, unless accomplished previously. To prevent failure of a tail rotor blade (blade) due to a fatigue crack (see Figure 1), loss of the tail rotor and tail rotor gear box, and subsequent loss of control of the helicopter, accomplish the following:

FIGURE 1. SKIN CRACK IN TAIL ROTOR BLADE

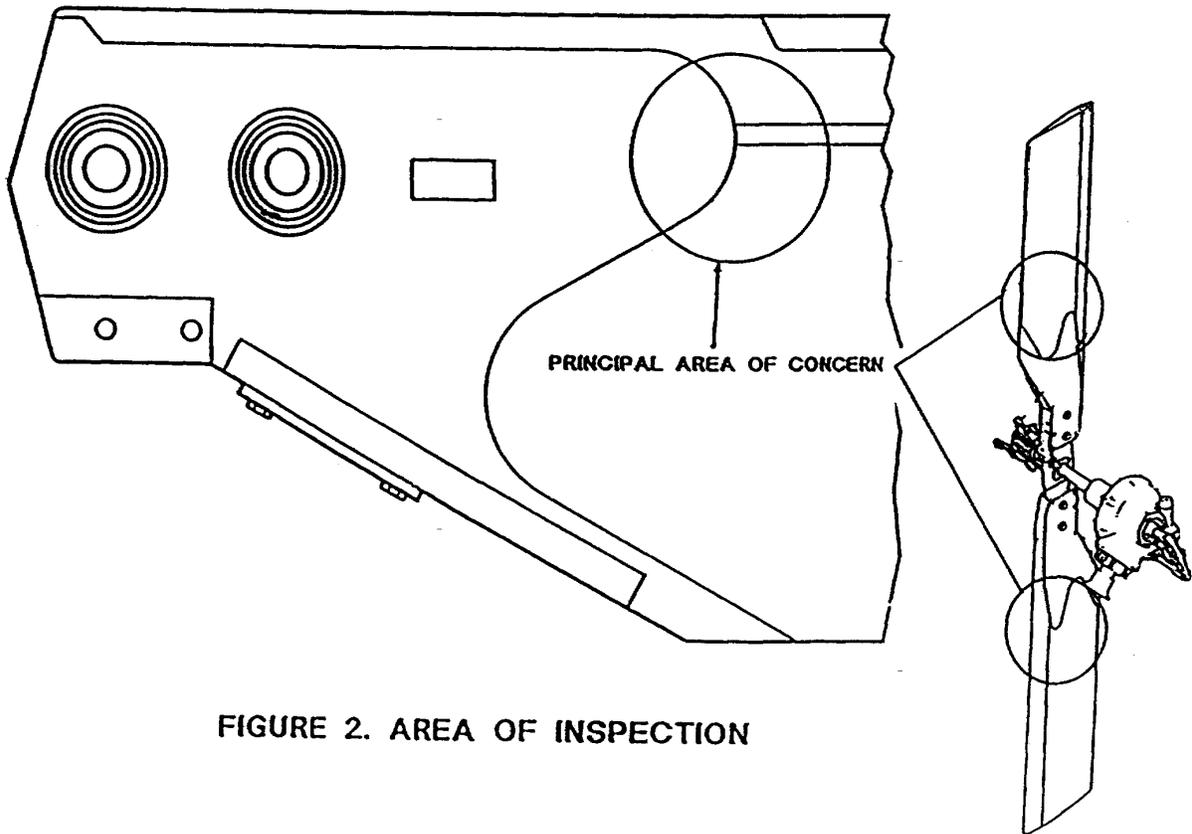
(a) Clean the painted surfaces of the blades in an area approximately 6 inches spanwise on either side of the doubler tip. Visually check both surfaces of each blade for cracks by pushing the blade tip away from the surface being checked until it contacts the flapping stop and then holding the blade firmly against the stop. Pay particular attention to the area reaching from the doubler tip to 1 inch outboard, centering on an area 2 inches aft of the blade leading edge (see Figure 2).

FIGURE 2. AREA OF INSPECTION

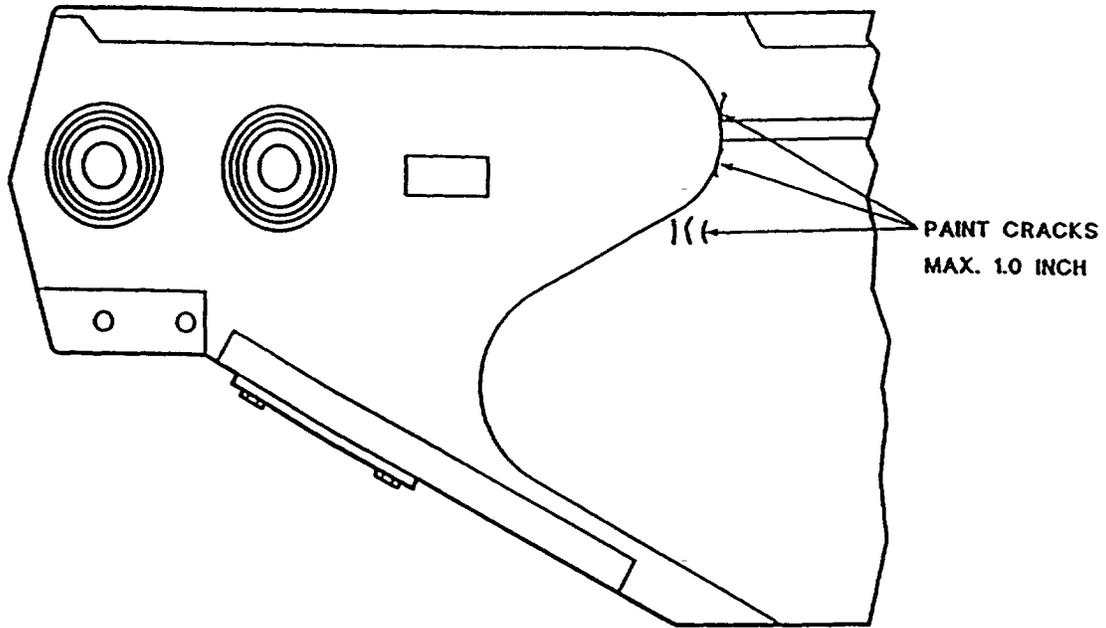
FIGURE 3.

(c) If the visual check described in paragraph (a) reveals any crack outboard of the doubler tip (Station 14.250), or any chordwise crack inboard of the doubler tip that is longer than 1 inch (see Figure 3), accomplish the following:
