14 CFR Part 39

[Docket No. 94-NM-28-AD; Amendment 39-9528; AD 95-13-12 R1]

Airworthiness Directives; Boeing Model 767 Series Airplanes Equipped With General Electric CF6-80C2 Series Engines

ACTION: Final rule; correction.

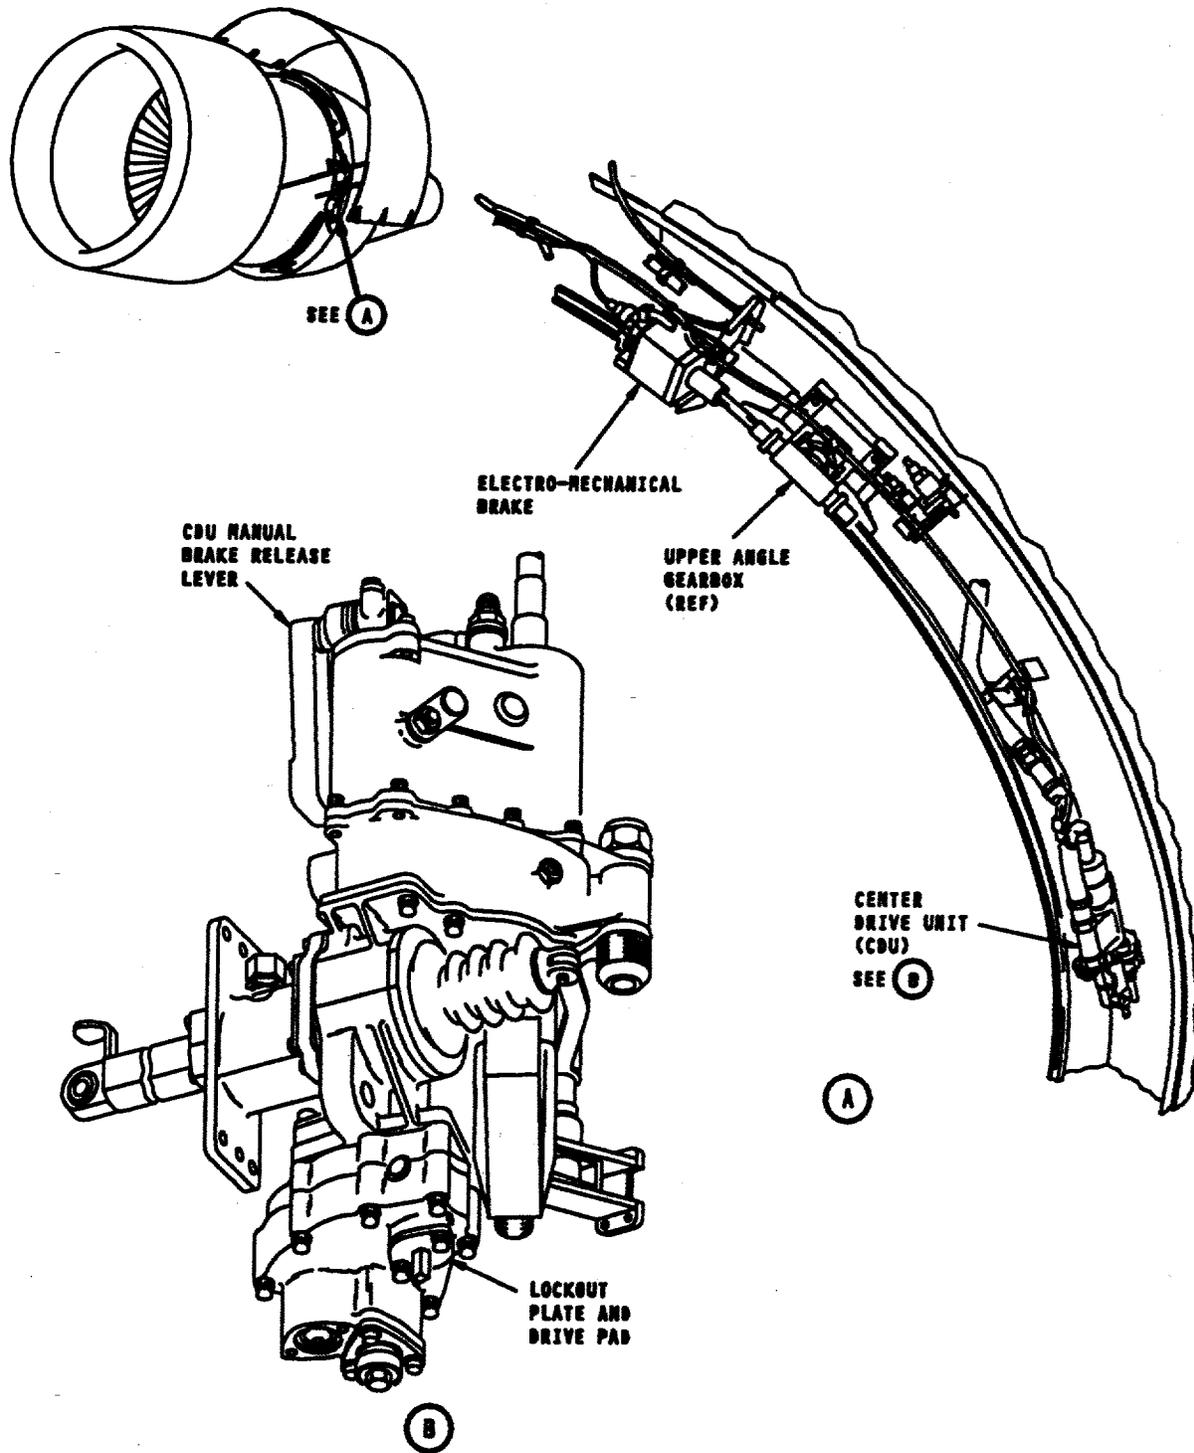
**Electro-Mechanical Brake and CDU Cone Brake Torque Check
Figure 1**

Since the issuance of that AD, the manufacturer has advised the FAA that a torque check value specified in Appendix 1 of the AD requires clarification. The procedures originally provided to the FAA for accomplishment of a torque check of the cone brake of the center drive unit (CDU) indicate that operators should not use more than 130 pound-inches of torque when performing the check. While using 130 pound-inches of torque would not damage the CDU, the manufacturer has advised the FAA that 100 pound-inches of torque is the appropriate value. Accomplishing the torque check up to 100 pound-inches is intended to identify a CDU having a decaying torque level due to a soft shaft problem, while at the same time not exposing the brake to unnecessarily high torque/stress levels.

Note: You will need a 24-inch extension to provide adequate clearance for the torque wrench.
 - (e) Apply 90 pound-inches of torque to the system.
 - (1) The electro-mechanical brake system is working correctly if the torque is reached before you turn the wrench 450 degrees (1 1/4 turns).

- (2) If the flexshaft turns more than 450 degrees before you reach the specified torque, you must replace the long flexshaft between the CDU and the upper angle gearbox.
- (3) If you do not get 90 pound-inches of torque, you must replace the electro-mechanical brake.
- (f) Release the torque by turning the wrench in the opposite direction until you read zero pound-inches.
 - (1) If the wrench does not return to within 30 degrees of initial starting point, you must replace the long flexshaft between the CDU and upper angle gearbox.
 - (3) Fully retract the thrust reverser.
- C. Do a check of the torque of the CDU cone brake:
 - (1) Pull up on the manual release handle to unlock the electro-mechanical brake.
 - (2) Pull the manual brake release lever on the CDU to release the cone brake.

(a) If the torque is less than 15 pound-inches, you must replace the CDU.

(d) Within 4,000 flight hours after accomplishing the modification required by paragraph (c) of this AD, or within 4,000 flight hours after the effective date of this AD, whichever occurs later; and thereafter at intervals not to exceed 4,000 flight hours; perform operational checks of the electro-mechanical brake and the cone brake of the center drive unit in accordance with Appendix 1 (including Figure 1) of this AD.
