[Docket No. 96-CE-46-AD; Amendment 39-9884; AD 97-01-13]

**Airworthiness Directives; Cessna Aircraft Company 100, 200, 300, and 400 Series Airplanes**

97-01-13 Cessna Aircraft Company:

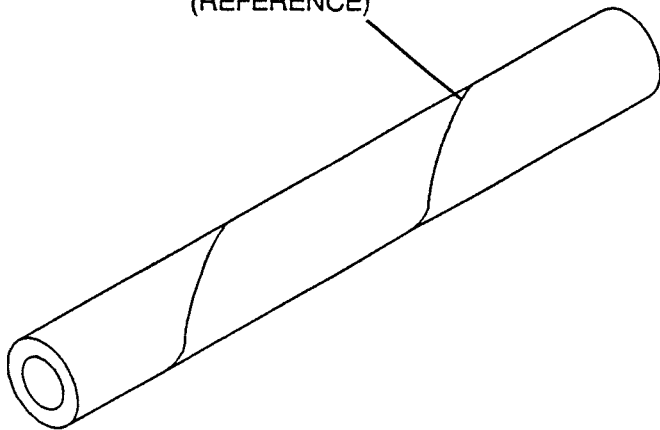
REINFORCEMENT  
WRAPPED IN ONLY ONE  
(DIAGONAL) DIRECTION  
(REFERENCE)

The FAA has recently received several incident reports of fuel flow blockage to the engines of certain Cessna 208 series airplanes. Examination of the Cessna part number (P/N) S51-10 rubber hoses installed on these airplanes revealed a deterioration to the point of delamination of the inner tube from the external wrap. This rubber hose is utilized on fuel, oil, and hydraulic hoses on Cessna 100, 200, 300, and 400 series airplanes. This kind of deterioration eventually causes the rubber hose to collapse, which could result in failure of the fuel, oil, or hydraulic systems.

Note 2: Figure 1 of this AD is included to show the diagonal or spiral external reinforcement wrap on the hose that is referenced in the check required by paragraph (b) of this AD.

OLD STYLE S51-10 HOSE  
WITH REINFORCEMENT  
WRAPPED IN ONLY ONE  
(DIAGONAL) DIRECTION THE  
LENGTH OF THE HOSE  
(REMOVE AND REPLACE WITH  
REPLACEMENT STYLE HOSE)

(c) Prior to further flight after the check required by paragraph (b) of this AD, replace any Cessna P/N S51-10 that has a diagonal or spiral pattern external reinforcement wrap with a Cessna P/N S51-10 hose that has a criss-cross pattern external wrap. Accomplish this replacement in accordance with the ACCOMPLISHMENT INSTRUCTIONS of the applicable service bulletin in paragraph (b) of this AD.

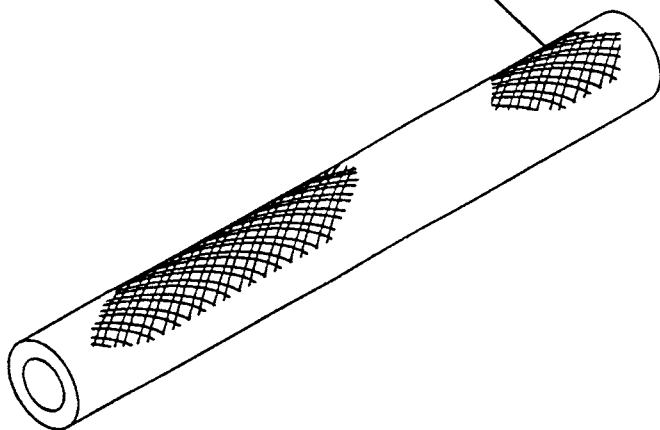
CRISSCROSS  
OR BRAIDED  
REINFORCEMENT  
(REFERENCE)

REPLACEMENT STYLE S51-10  
HOSE WITH A CRISS-CROSS  
OR BRAIDED REINFORCEMENT  
PATTERN
