[Docket No. 97-SW-60-AD]

#### Airworthiness Directives; Sikorsky Aircraft-Manufactured Model CH-54A Helicopters

**ACTION:** Notice of proposed rulemaking (NPRM).

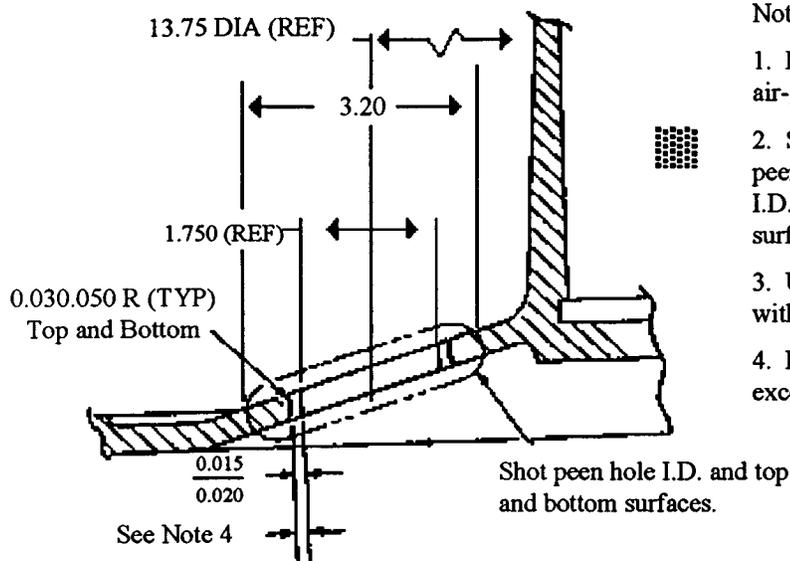
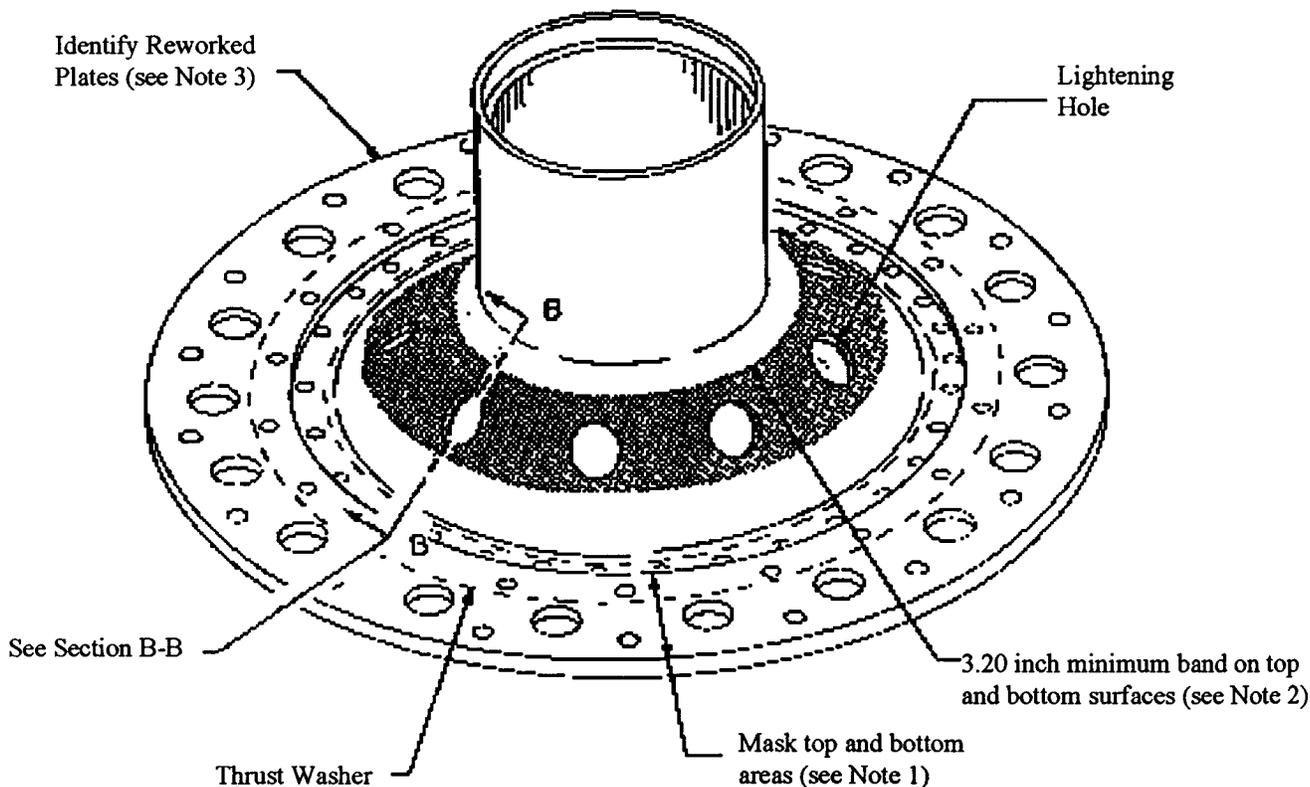
Rework of Second Stage  
Lower Planetary Plate (6435-20229-102)  
Figure 1

To prevent failure of the second stage lower planetary plate (plate), P/N 6435-20229-102, due to fatigue cracking, which could lead to failure of the main gearbox, failure of the drive system, and subsequent loss of control of the helicopter, accomplish the following:

(a) On or before accumulating 1,300 hours time-in-service (TIS) conduct a fluorescent magnetic particle inspection of the plate, P/N 6435-20229-102, in the circumferential and longitudinal directions using the wet continuous method. Pay particular attention to the area around the 9 lightening holes.

(i) Locate the center of each 1.750 inch-diameter lightning hole and machine holes 0.015 to 0.020 oversize on a side (0.030 to 0.040 diameter oversize). Machined surface roughness must not exceed 63 microinches AA rating (see Figure 1).

(ii) Radius each hole 0.030 to 0.050 inches on each edge as shown in Figure 1.

(iii) Mask the top and bottom surfaces of the plate to expose 3.20 inch minimum width circumferential band as shown in Figure 1.

(viii) Identify the reworked plate by adding "TS-107" after the part number using a low-stress depth-controlled impression-stamp with a full fillet depth of not more than 0.003 inch (see Figure 1).

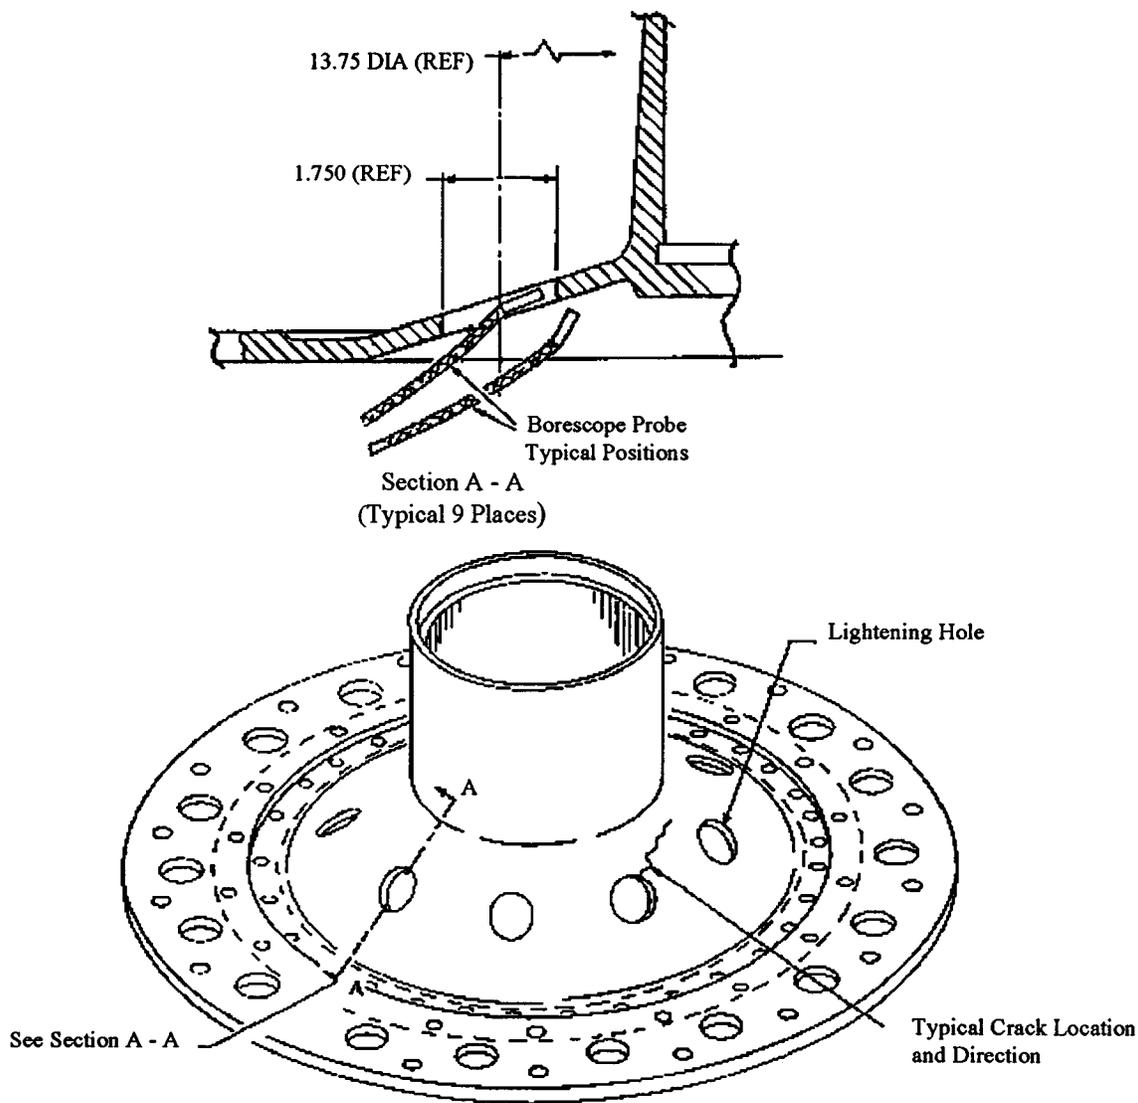
Borescope Inspection of  
Second Stage Lower Planetary Plate  
Figure 2

not to exceed 70 hours TIS, accomplish the following:  
(1) Inspect the plate for a crack in the area around all nine lightening holes using a

Borescope or equivalent inspection method (see Figure 2).  
(2) If a crack is found, replace the plate with an airworthy plate.
