Southern California Edison Company, et al.; San Onofre Nuclear Generating Station, Units 2 and 3; Issuance of Director's Decision Under 10 CFR 2.206

Director's Decision Under 10 CFR 2.206

A. Request for an Investigation to Determine if SONGS Unit 2 Has Experienced Eggcrate Degradation Similar to Unit 3

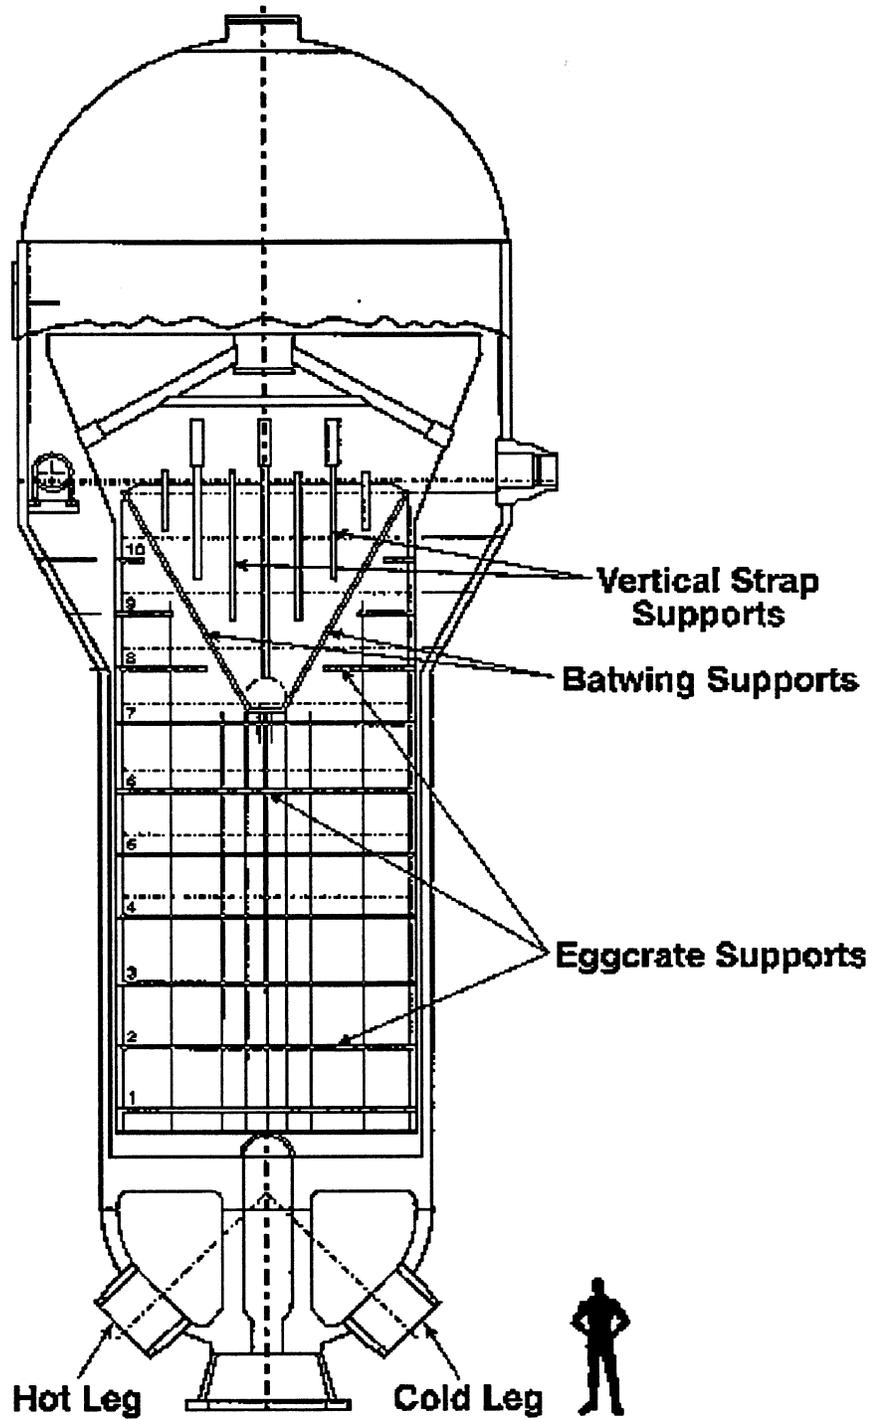
Figure 1

For the individual steam generator tube analysis, the licensee calculated the maximum loads that could occur assuming that adequate support was not available at two consecutive eggcrate levels (see Figure 1). The staff finds this assumption conservative and acceptable because the licensee has removed from service all tubes where two consecutive eggcrate levels were found degraded to the point where adequate support could not be assured.

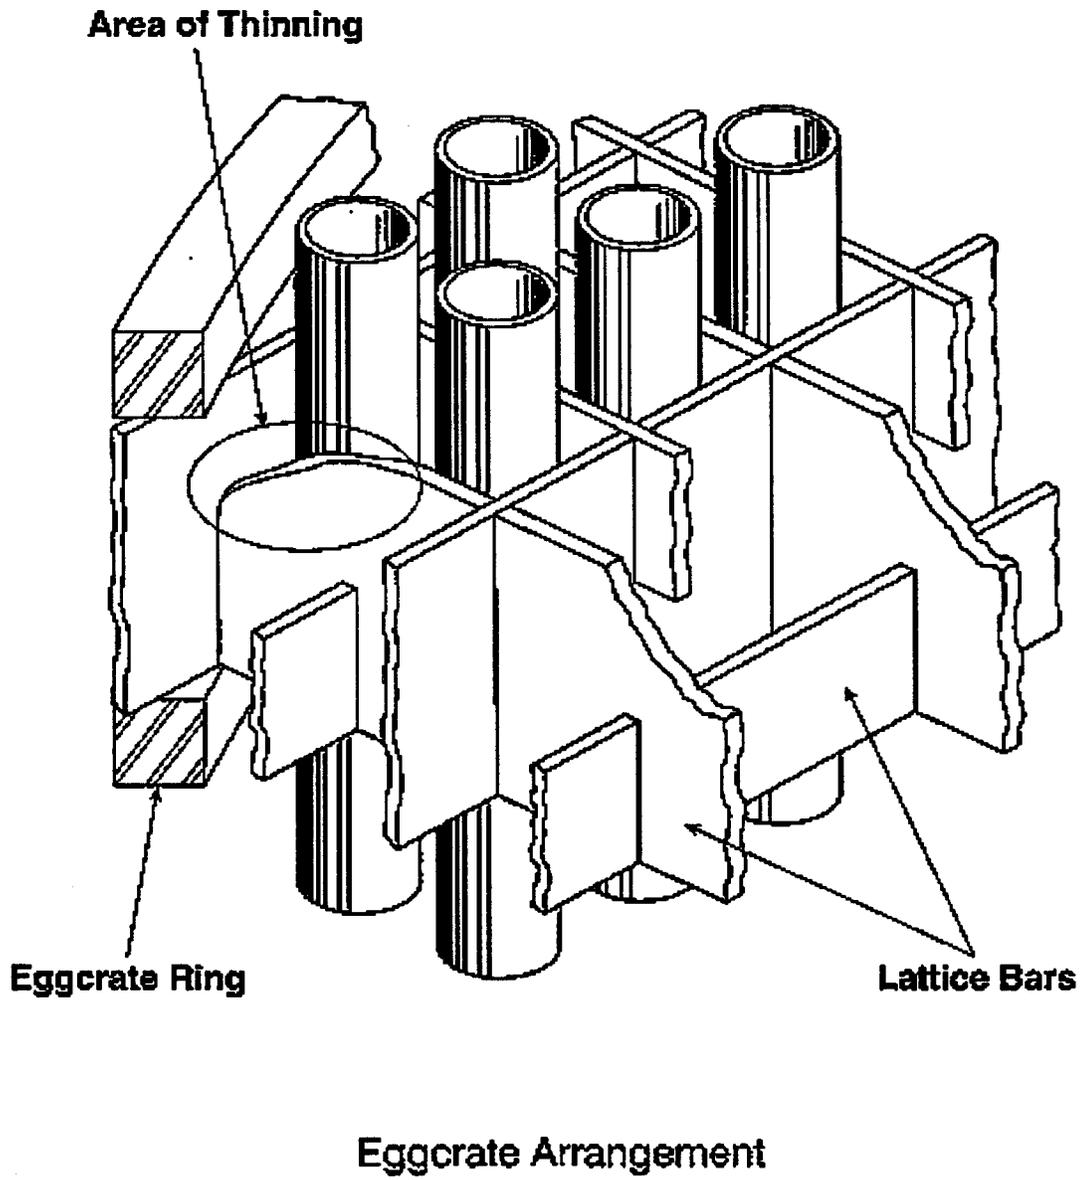
Figure 3

The eggcrate supports consist of 1- and 2-inch carbon steel strips interlocked perpendicular to each other as shown in Figure 3. The eggcrate supports limit lateral motion of the tubes and, at the same time, allow free flow of fluid around the tubes.

During the 1997 refueling outage for SONGS Unit 3, the licensee discovered that portions of the eggcrate supports had experienced degradation, ranging from minor wastage of the eggcrate material to severe thinning in localized areas. The significant degradation observed during this refueling outage was confined mainly to the periphery locations of the eggcrate supports. The secondary sides of the steam generators in both units were inspected during their 1997 refueling outages and during their 1998 mid-cycle outages and, as discussed below, significant degradation was limited to the periphery locations of the SONGS Unit 3 eggcrate supports.

The licensee has extensively researched the cause of the eggcrate degradation and has concluded that the degradation was caused by a form of flow accelerated corrosion (FAC), a general term describing processes that use assistance from fluid flow to remove the protective oxide layer from base material. Removal of the protective oxide layer exposes the base material to the fluid environment, allowing further material removal through corrosion and/or erosion processes. The carbon steel
