[Docket No. NHTSA-98-4008; Notice 1]

Application for Decision of Inconsequential Noncompliance

General Motors Corporation (GM) has determined that certain 1998 GMC Sonoma pickup trucks, GMC Jimmy and Oldsmobile Bravada sport utility vehicles are equipped with daytime running lamps (DRLs) that fail to meet the spacing requirements of Federal Motor Vehicle Safety Standard (FMVSS) 108—Lamps Reflective Devices and Associated Equipment. Pursuant to section 30118 and 30120 of Title 49 of the United States Code, GM applied to the National Highway Traffic Safety Administration (NHTSA) for a decision that the noncompliance is inconsequential to motor vehicle safety. Concurrently, in accordance with 49 CFR 556.4(b)(6), GM has submitted a 49 CFR 573.5 noncompliance notification to the agency.

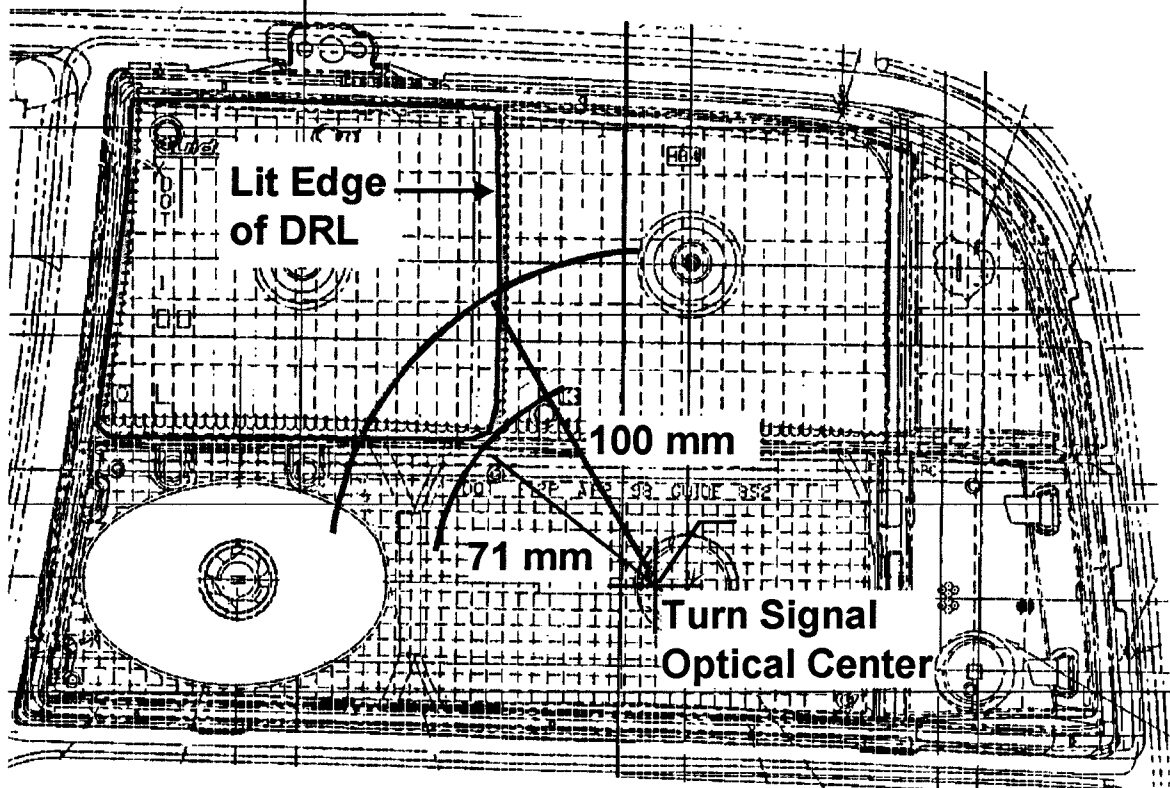
Figure 1: Jimmy, Sonoma, Bravada Lamp Asm.

Depending on the method used, the turn signal of the noncompliant vehicles is either 71 mm (using centroid) or 85 mm (using filament axes) away from the DRL. Therefore the condition is within 15 percent, or using the more conservative figure, within 30 percent of the requirement. (For the purposes of the application all other references to optical center of the turn signal will be based on the centroid, which generates a more conservative estimate of the distance between the turn signal and lighted edge of the DRL.)

4. Regardless of the whether the distance is within 15 percent or 30 percent of the 100 mm requirement, the turn signal and the DRL diagonal to each other. Therefore, the closest lighted edge of the DRL is the corner of the lamp (see figure 1). This portion of the lamp does not significantly contribute to the DRL beam pattern, and therefore does not have a significant potential to mask the turn signal.

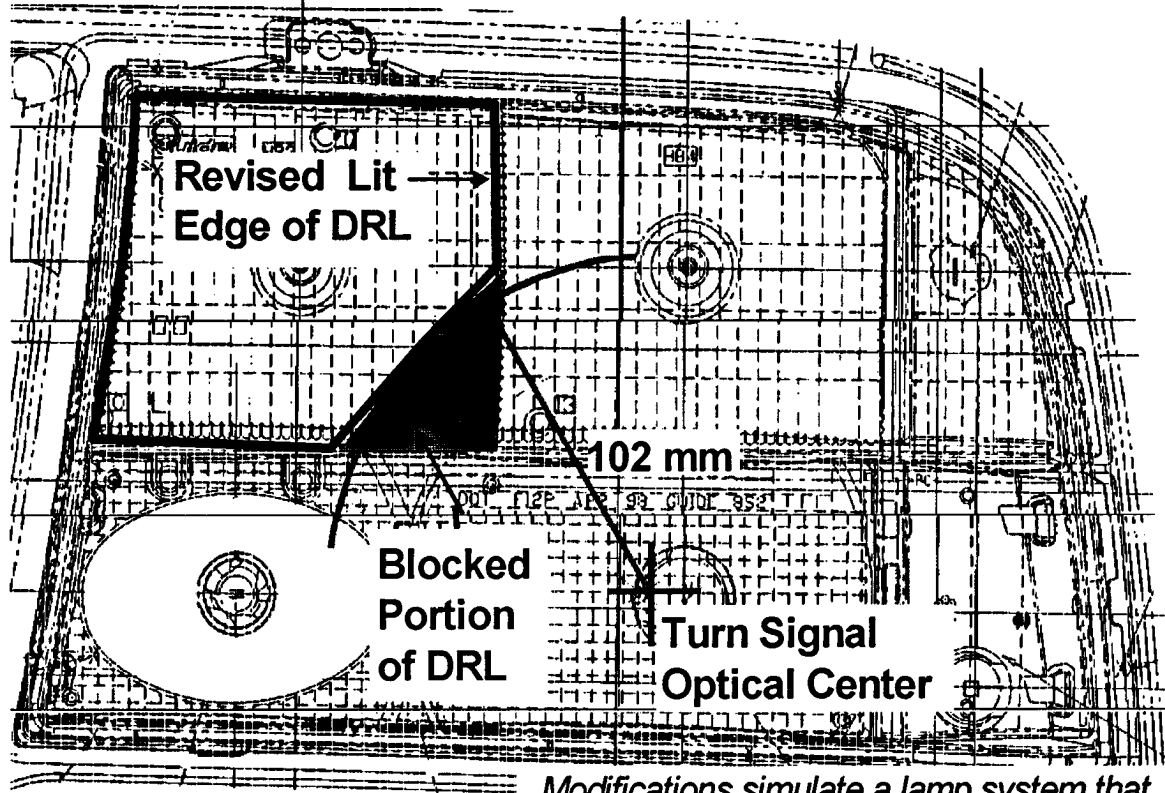
Figure 2: Modified Lamp Assembly

signal output were made using a video-based photometer (digital CCD camera system). First, the photometric output of the turn signal was measured with the DRL activated. Then a portion of the DRL was blocked, as shown in Figure 2, and the output of the turn signal was re-measured with the modified DRL activated. The zonal values of the turn signal changed an average of just 12.7 percent. The largest difference in turn signal output was found in zone 5, closest to the DRL, and it only changed 17.5 percent.

Modifications simulate a lamp system that meets the requirements in FMVSS 108

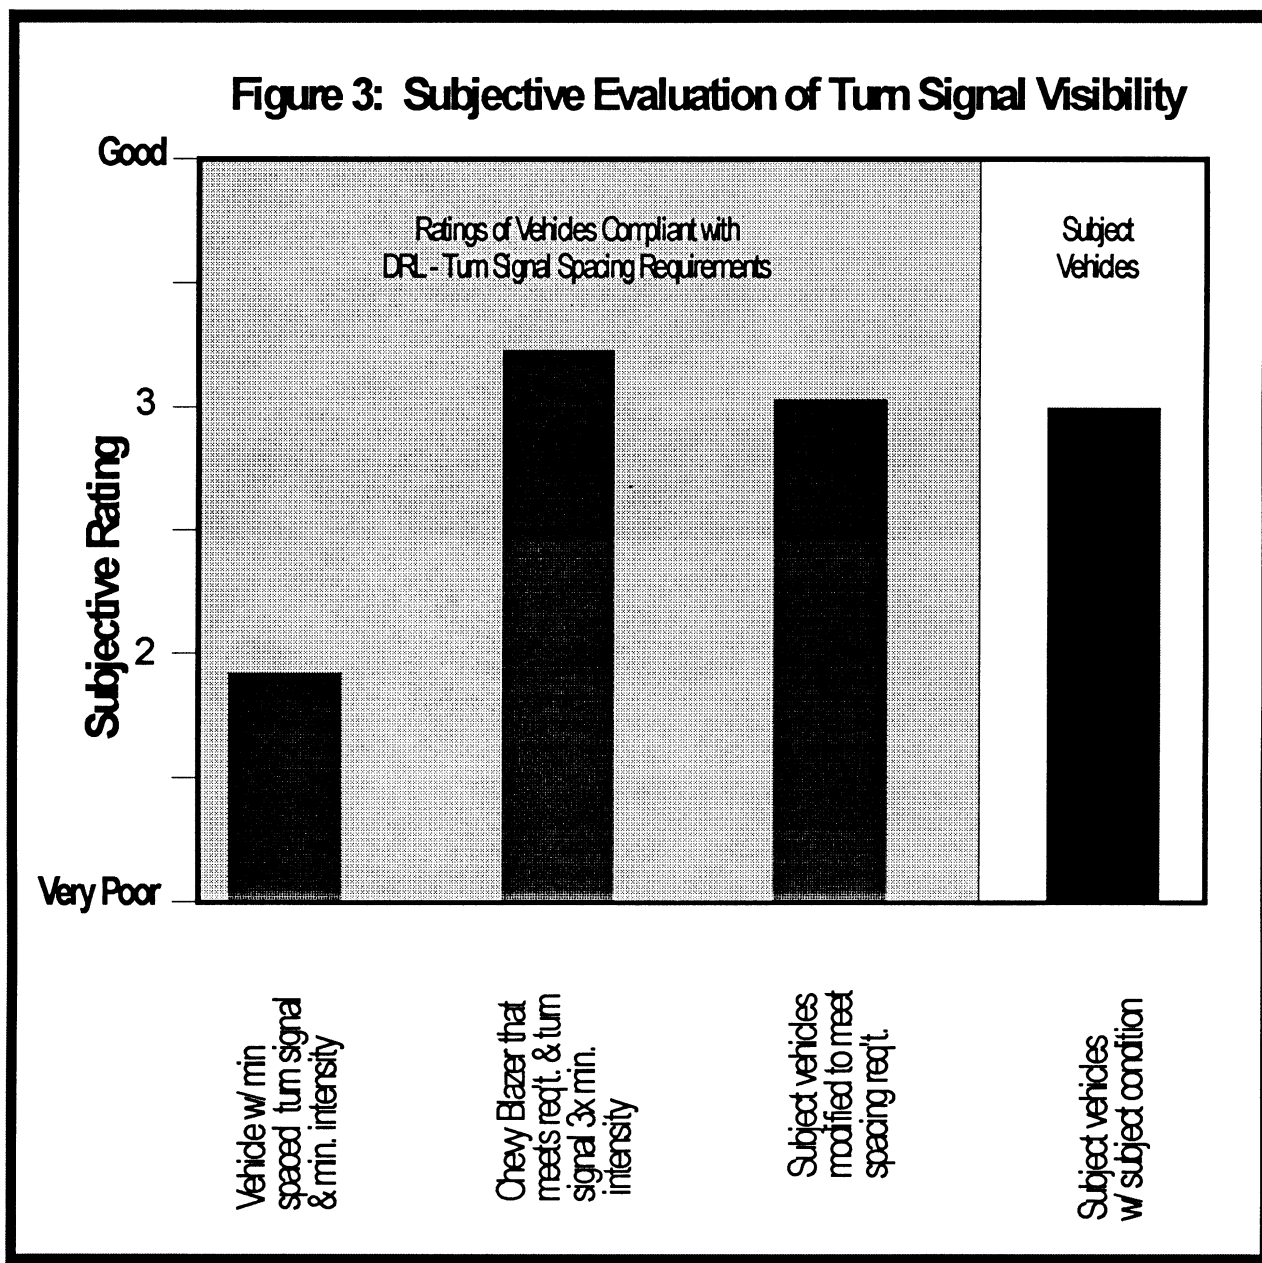
6. Subjective evaluations were run using GM personnel whose jobs do not involve vehicle lighting. They were asked to rate the relative visibility of turn signals on the subject vehicles and other vehicles that meet the FMVSS 108 spacing requirement. The results, shown in figure 3, indicate the visibility of subject turn signals is substantially better than vehicles that just meet the minimum requirement. In addition, the turn signals are rated nearly identical to vehicles modified to be fully compliant to the requirements, and preferred only slightly less than turn signals on the Chevrolet Blazer (which is a similar vehicle whose turn signal/DRL spacing meets the requirements of FMVSS 108). A copy of the report *Subjective*
