[Docket No. 98-SW-25-AD; Amendment 39-10712; AD 98-12-19]

Airworthiness Directives; Robinson Helicopter Company (RHC) Model R44 Helicopters

98-12-19 Robinson Helicopter Company:
Amendment 39-10712. Docket No. 98-SW-25-AD.

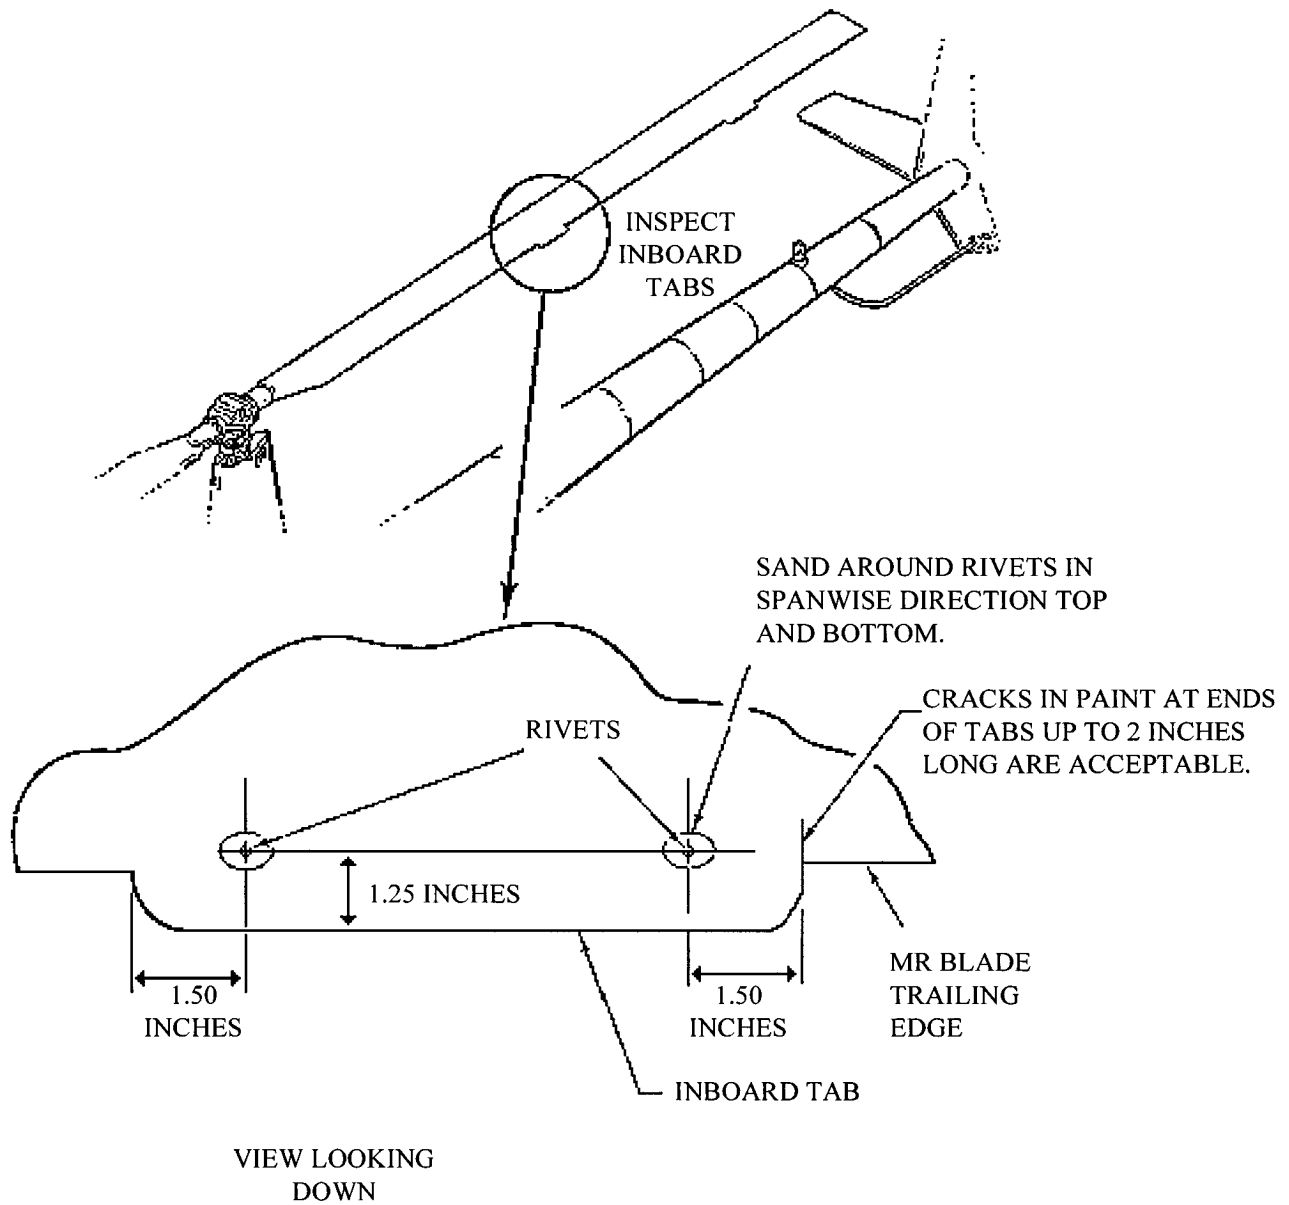
Figure 1

To detect main rotor blade skin fatigue cracks which originate from the inboard trim tab alignment rivet holes, that could result in failure of the main rotor blade and subsequent loss of control of the helicopter, accomplish the following:

(a) Within the next five hours time-in-service (TIS), perform a dye penetrant inspection of the blade skin around both inboard trim tab alignment rivets as follows, referring to Figure 1.

(1) Remove all paint around both rivets, exposing an area of approximately 3/4" in diameter, at the inboard trim tab on top and bottom of each blade (4 places per blade). Use 180 grit or finer abrasive paper, followed by 600 grit or finer paper to eliminate course sanding marks. Sand only in a spanwise direction. Do not use chemical paint strippers.

(2) Inspect the blade skin around the rivets on the upper and lower surfaces (4 locations) using a dye penetrant method.

(b) Clean the sanded areas prepared in accordance with paragraph (a) of this AD with 111-Trichloroethane or methyl ethyl ketone (MEK) and then apply clear lacquer to seal the unpainted areas.

(c) Thereafter, prior to the first flight of each day, or at intervals not to exceed 5 hours TIS, whichever occurs first, using a 5-power or higher magnifying glass, visually inspect the upper and lower blade skin surfaces around the inboard trim tab rivets (4 locations) for cracks.

(d) If a crack is found, replace the main rotor blade with an airworthy main rotor blade before further flight.
