[Docket No. 98-NM-323-AD]

#### **Airworthiness Directives; Boeing Model 757-200, -200PF, and -200CB Series Airplanes Powered by Rolls-Royce RB211-535C/E4/E4B Turbofan Engines**

**ACTION:** Notice of proposed rulemaking (NPRM).

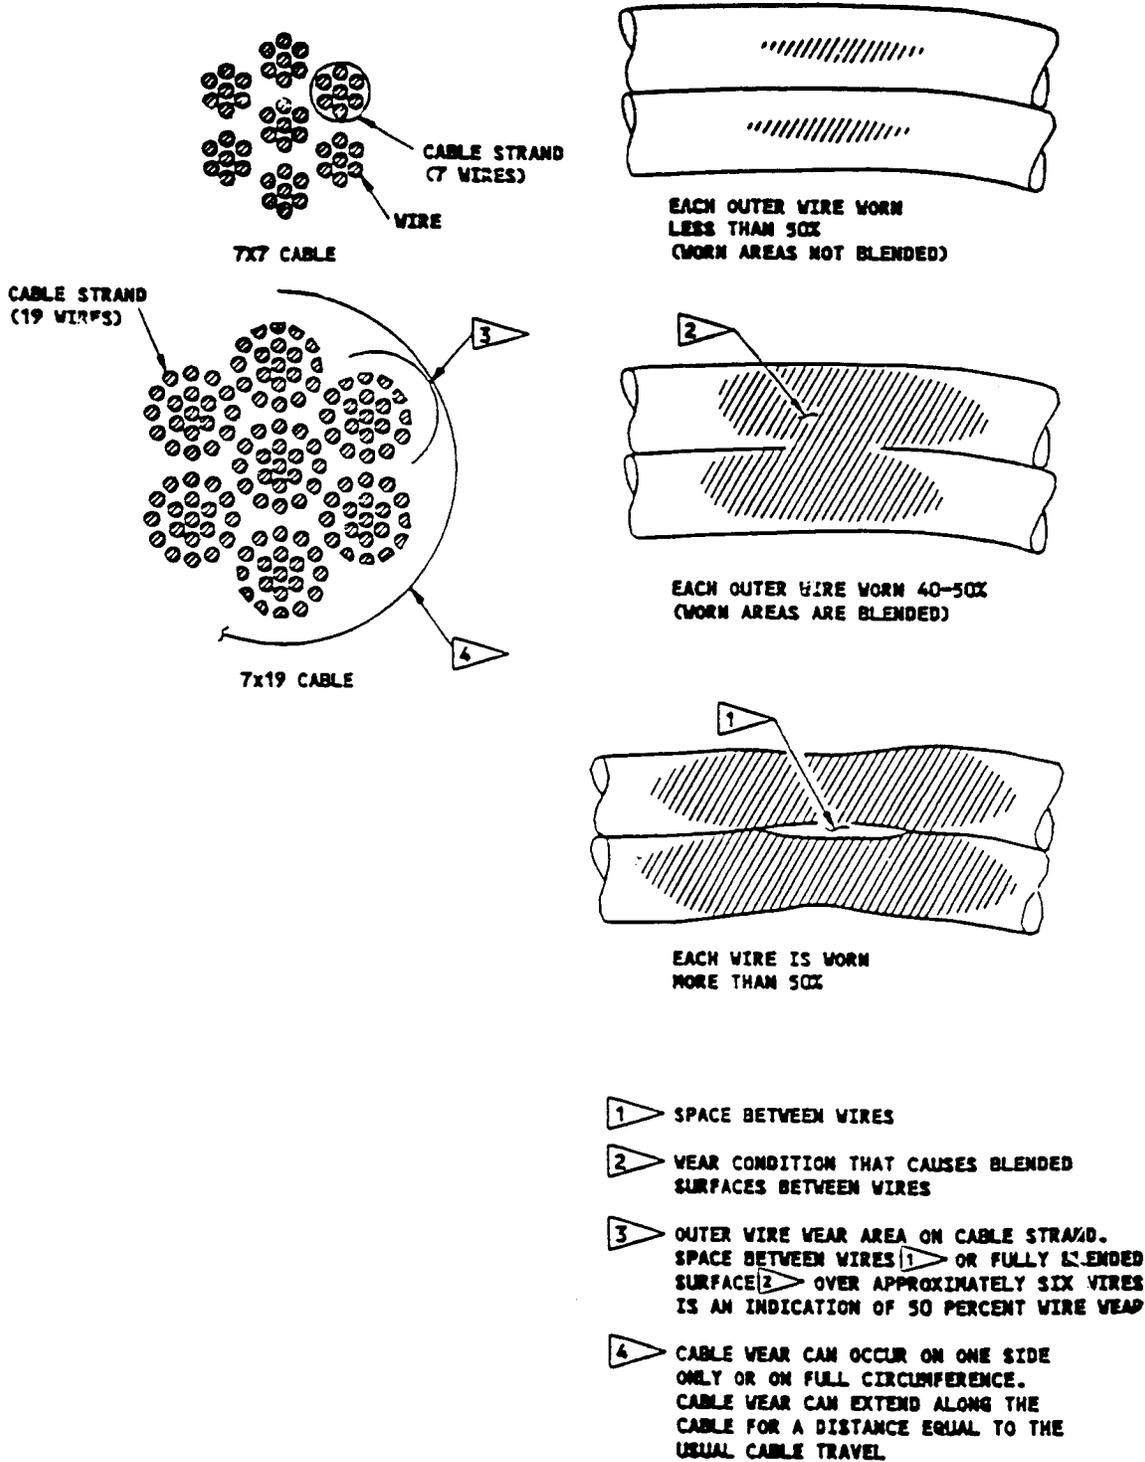
Figure 1.

(1) If one cable strand has worn wires where one wire cross section is decreased by 40 percent or more in an area that goes over a pulley, through a pressure seal, or through a fairlead (see Figure 1).

B. Visually examine the pulley wear pattern (see Figure 2).

(1) An unusual pulley wear pattern.

CABLE TENSION TOO HIGH

PULLEY NOT ALIGNED CORRECTLY

PULLEY TOO LARGE FOR CABLE

CABLE NOT ALIGNED CORRECTLY

PULLEY WILL NOT TURN

CORRECT CONDITION

Pulley Wear Patterns

C. Remove the control cable from the airplane when you find one of these conditions:

F. Remove the pulley from the airplane when you find one of these conditions:
