[Docket No. 97-SW-14-AD; Amendment 39-11062; AD 99-05-14]

Airworthiness Directives; Eurocopter France Model SA. 315B, SA. 316B, SA. 316C, SA. 319B, and SE. 3160 Helicopters

AD 99-05-14 Eurocopter France:

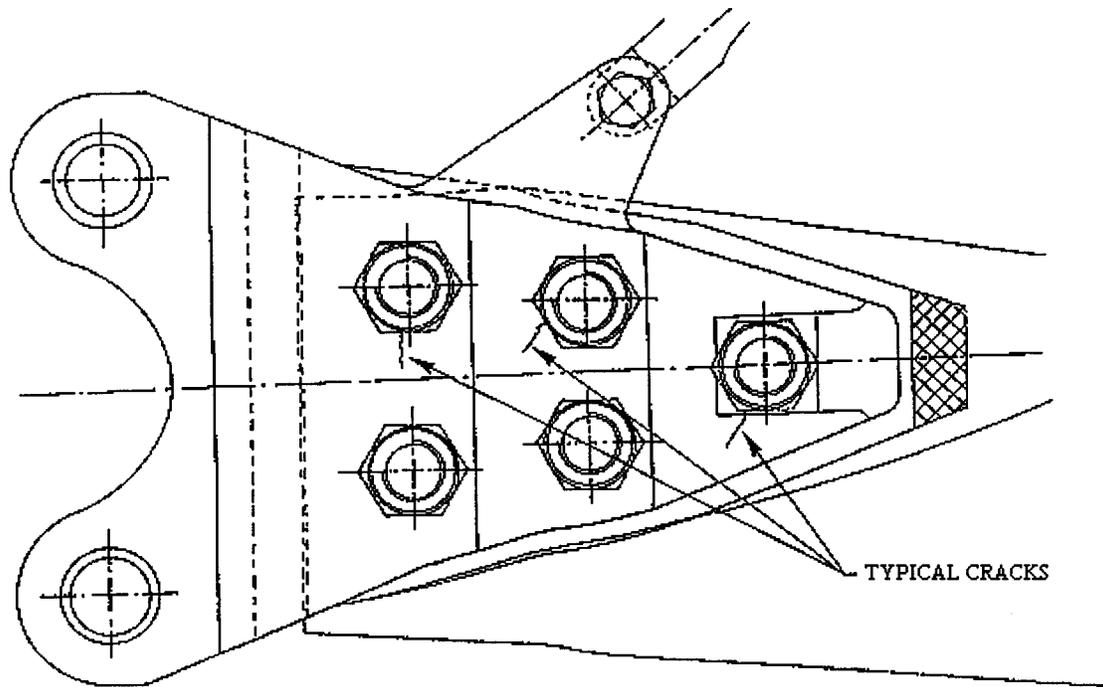
Figure 1

(a) Inspect both upper and lower blade surfaces of each blade cuff for cracks (see Figure 1) as follows:

(2) Inspect the blade cuff for cracks, paying particular attention to the area around the attaching bolts, using a 10-power or higher magnifying glass.

(b) If a crack is detected, remove the blade and replace it with an airworthy blade.
