[Docket No. 97-SW-14-AD; Amendment 39-11062; AD 99-05-14]

#### Airworthiness Directives; Eurocopter France Model SA. 315B, SA. 316B, SA. 316C, SA. 319B, and SE. 3160 Helicopters

#### AD 99-05-14 Eurocopter France:

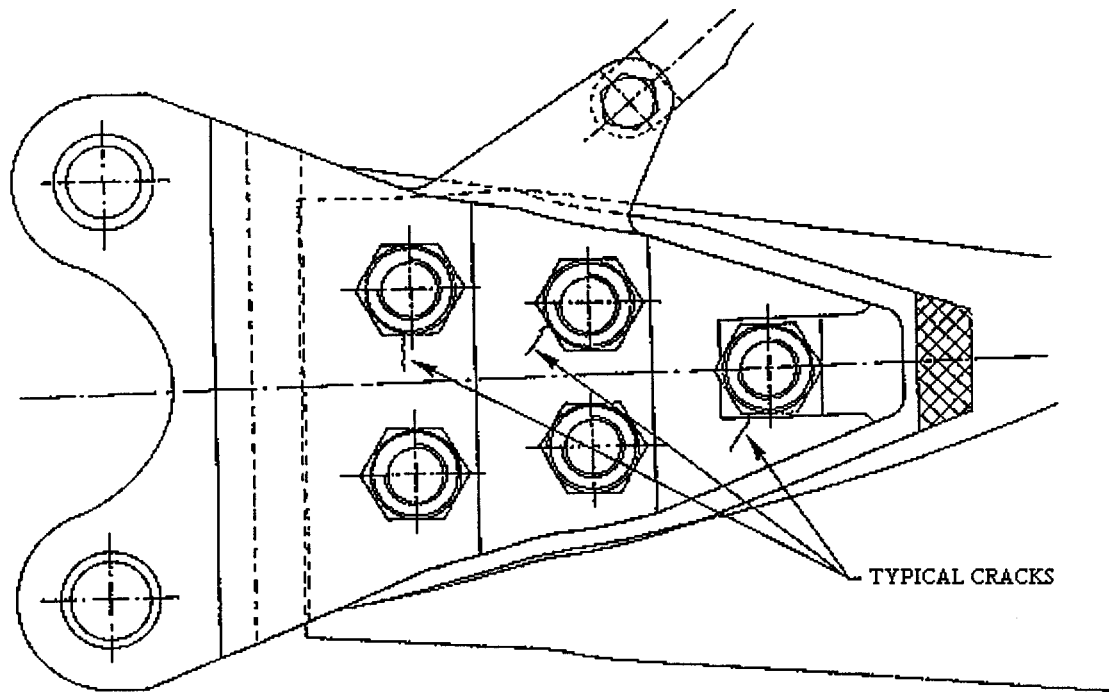
Figure 1

To prevent failure of a main rotor blade (blade) cuff attachment fitting at a bolt hole location, loss of a blade, and subsequent loss of control of the helicopter, accomplish the following:

(a) Inspect both upper and lower blade surfaces of each blade cuff for cracks (see Figure 1) as follows:

(2) Inspect the blade cuff for cracks, paying particular attention to the area around the attaching bolts, using a 10-power or higher magnifying glass.

(b) If a crack is detected, remove the blade and replace it with an airworthy blade.
