[Docket No. 99-SW-09-AD; Amendment 39-11168; AD 99-10-15]

Airworthiness Directives; Eurocopter France Model AS332L2

AD 99-10-15 **Eurocopter France:**

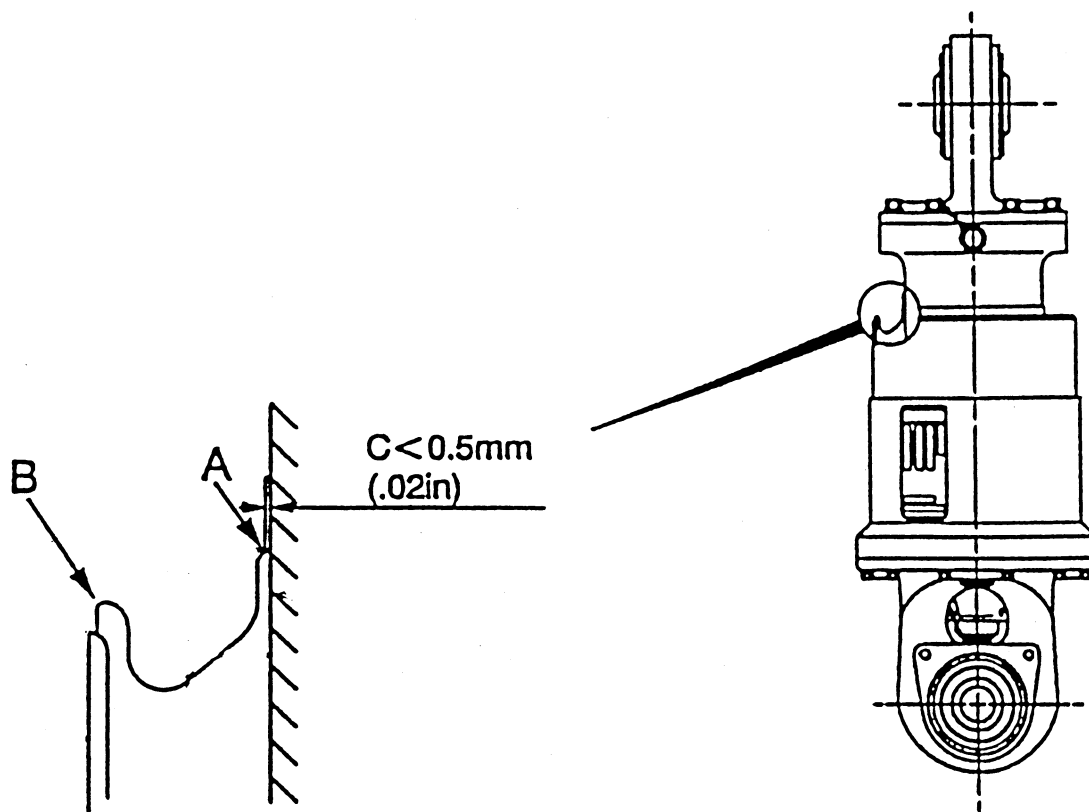
Figure 1

To detect delamination of an elastomeric bearing that could result in failure of a main rotor head drag damper (damper) and subsequent loss of control of the helicopter, accomplish the following:

(a) Within 10 hours time-in-service (TIS), inspect each damper, P/N 332A311980-02, for a tear, crack, or bonding separation in the elastomer as follows: (See Figure 1.)

(1) Separate the elastomer in Area A (outside reinforcement) and in area B (inside reinforcement).

(2) If a tear, crack, or bonding separation is found, replace the damper with an airworthy damper.

(b) Thereafter, prior to the first flight of each day or at intervals not to exceed 20 hours TIS, whichever occurs first, perform the inspection in paragraph (a). If a tear, crack, or bonding separation is found in the elastomer, replace the damper with an airworthy damper.
