[Docket No. NHTSA-98-4430; Notice 1]

Application for Decision of Inconsequential Noncompliance Federal Motor Vehicle Safety Standard 108—Lamps, Reflective Devices and Associated Equipment

General Motors Corporation (GM), has determined that approximately 15,300 1998 GMC Sonoma and Chevrolet S-10 pickup trucks, and GMC Jimmy and Chevrolet Blazer sport utility vehicles, equipped with the "ZR2" option package, fail to meet a requirement of

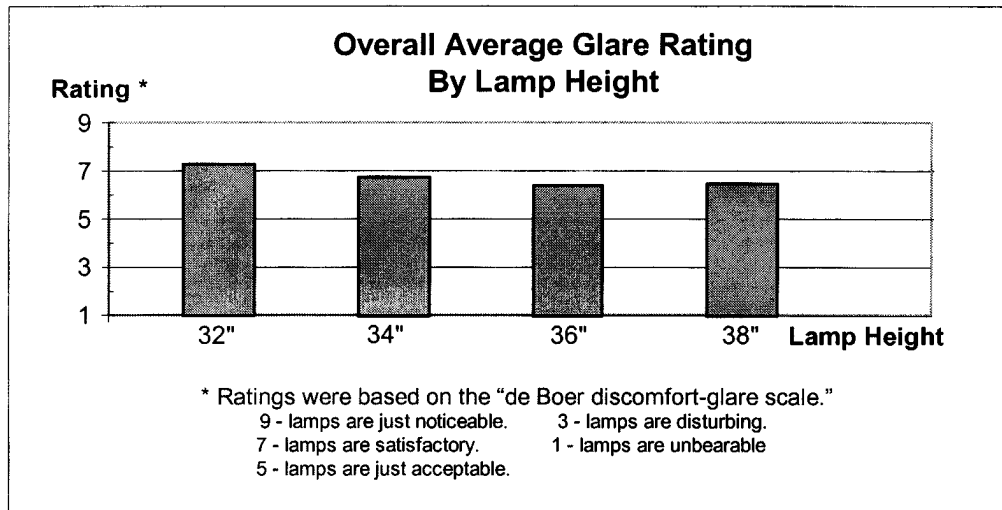
2. In addition to the UMTRI research, GM conducted subjective evaluations that confirm the DRLs on the non-complying vehicles do not cause a consequential increase in glare. Vehicles representative of the subject vehicles were modified to create DRLs with mounting heights of 32, 34, 36 and 38 inches above the ground. Subjects were asked to evaluate the glare in their rearview mirror from the DRLs. The results indicate that there is no significant difference in glare rating when the subject lamps are mounted at 32, 34, 36 or 38 inches above the ground (see chart below). While a final research report is not yet available, a summary of the research can be found in Appendix 2, to the petition. The subject lamps received favorable ratings when evaluated for glare. In the chart above, the lamps mounted at 36 and 38 inches above the ground received an overall rating of 6.4, which is just below a rating of 7 ("lamps are satisfactory") and well above a rating of 5 ("lamps are just acceptable").

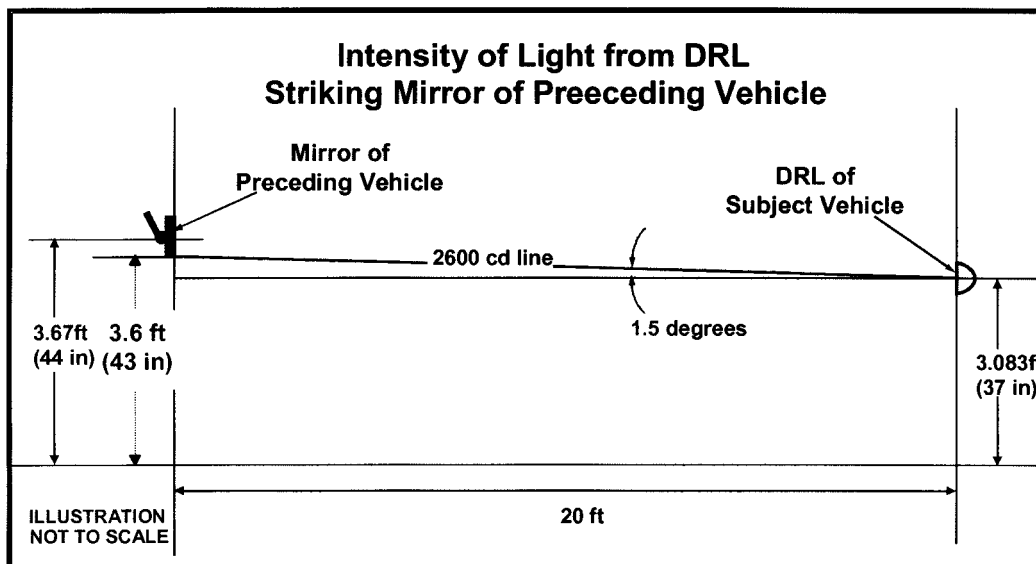
4. The DRLs of the non complying vehicles form a very compact beam pattern. Iso-candela curves show the intensity of the beam pattern quickly drops off as values are measured further from the center of the beam pattern. At approximately 1½ degrees above horizontal, the beam pattern intensity falls below 2600 candela. Therefore, the driver of a preceding vehicles will not see significant light in the rear view mirror (see diagram below).
