DEPARTMENT OF TRANSPORTATION

National Highway Traffic Safety Administration

[Docket No. NHTSA-98-4430; Notice 1]

Application for Decision of Inconsequential Noncompliance Federal Motor Vehicle Safety Standard 108—Lamps, Reflective Devices and Associated Equipment

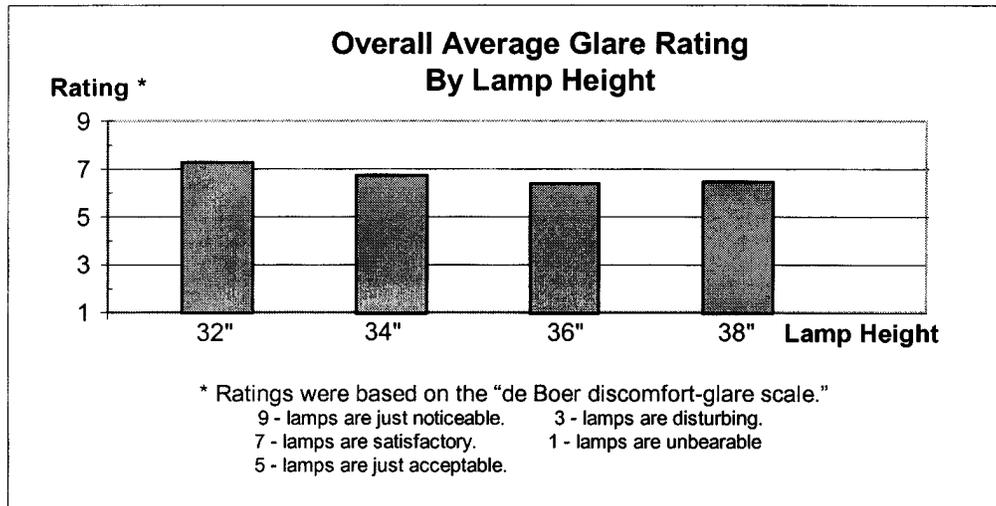
2. In addition to the UMTRI research, GM conducted subjective evaluations that confirm the DRLs on the non-complying vehicles do not cause a consequential increase in glare. Vehicles representative of the subject vehicles were modified to create DRLs with mounting heights of 32, 34, 36 and 38 inches above the ground. Subjects were asked to evaluate the glare in their rearview mirror from the DRLs. The results indicate that there is no significant difference in glare rating when the subject lamps are mounted at 32, 34, 36 or 38 inches above the ground (see chart below). While a final research report is not yet available, a summary of the research can be found in Appendix 2, to the petition. The subject lamps received favorable ratings when evaluated for glare. In the chart above, the lamps mounted at 36 and 38 inches above the ground received an overall rating of 6.4, which is just below a rating of 7 ("lamps are satisfactory") and well above a rating of 5 ("lamps are just acceptable").

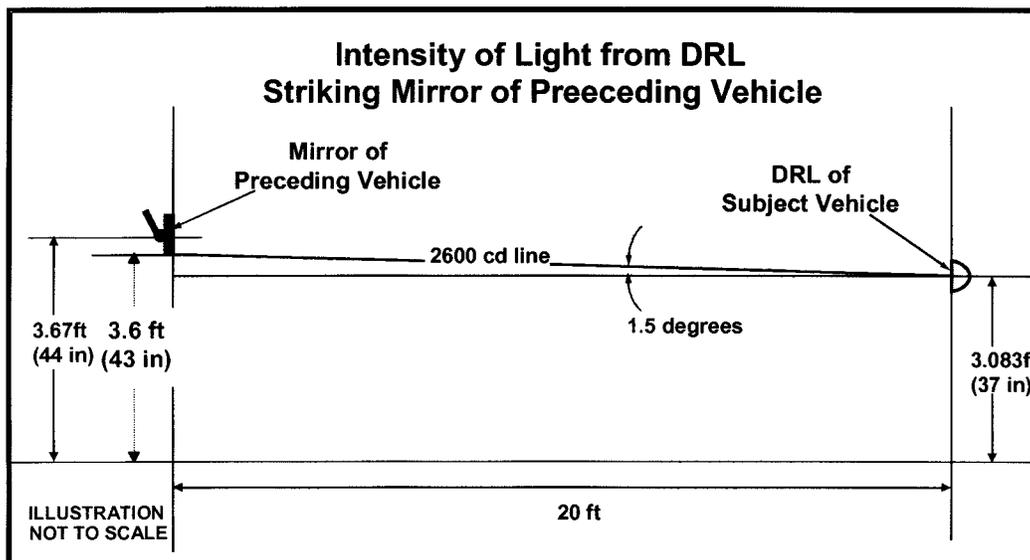
4. The DRLs of the non complying vehicles form a very compact beam pattern. Iso-candela curves show the intensity of the beam pattern quickly drops off as values are measured further from the center of the beam pattern. At approximately 1½ degrees above horizontal, the beam pattern intensity falls below 2600 candela. Therefore, the driver of a preceding vehicles will not see significant light in the rear view mirror (see diagram below).
