[Docket No. 99-SW-23-AD; Amendment 39-11207; AD 99-13-12]

Airworthiness Directives; Bell Helicopter Textron Canada Model 206L, 206L-1, 206L-3, and 206L-4 Helicopters

AD 99-13-12 Bell Helicopter Textron

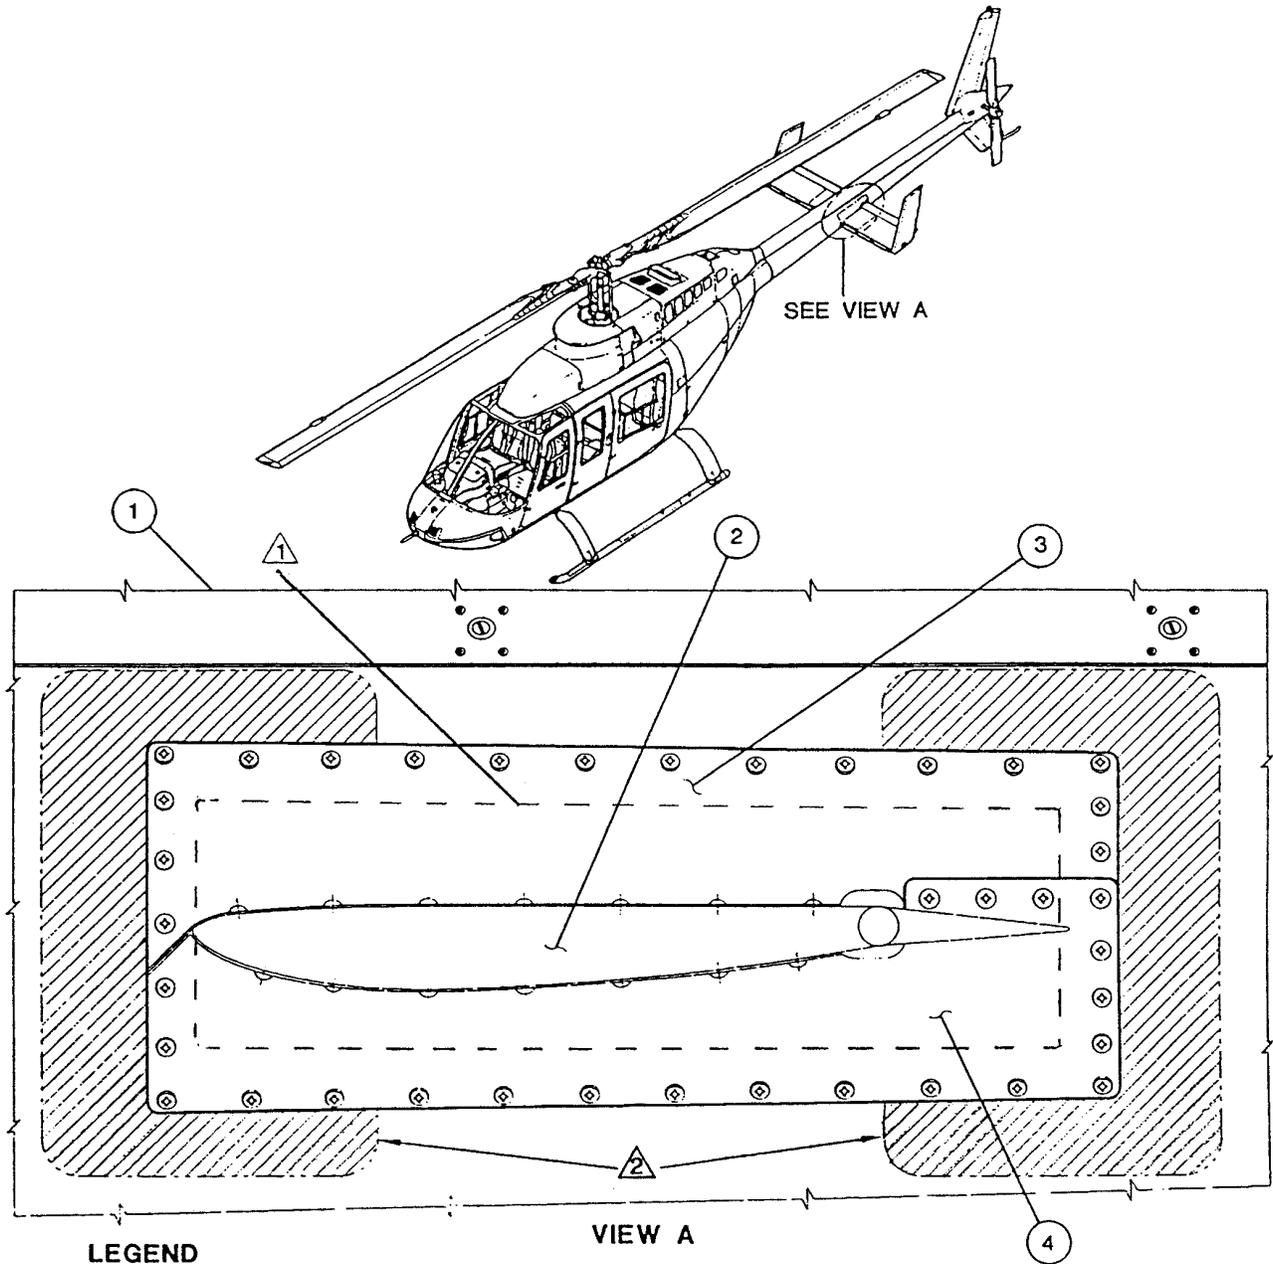
Figure 1

visually inspect for any crack in the shaded areas shown in Figure 1. Use a 10-power or higher magnifying glass. If any crack is found, replace the tailboom with an airworthy tailboom.

(2) Perform a one-time FPI of the edges of the tailboom skins for any crack around the left and right horizontal stabilizer openings (Figure 1). Remove paint and primer to inspect the edges and exterior skin surface in the skin area at least $\frac{3}{4}$ inch around the edges of the horizontal stabilizer openings.

- △2 Inspect for a crack in these two areas on both sides of the tailboom.
- △1 Inspect entire edge of stabilizer opening on both sides of the tailboom.

(3) If a crack is found, replace the tailboom with an airworthy tailboom.

(3) If any crack is found, replace the tailboom with an airworthy tailboom.
