[Docket No. 99-SW-23-AD; Amendment 39-11207; AD 99-13-12]

Airworthiness Directives; Bell Helicopter Textron Canada Model 206L, 206L-1, 206L-3, and 206L-4 Helicopters

AD 99-13-12 Bell Helicopter Textron

Canada: Amendment 39-11207. Docket No. 99-SW-23-AD. Supersedes Priority Letter AD 99-02-01, Docket No. 98-SW-83-AD.

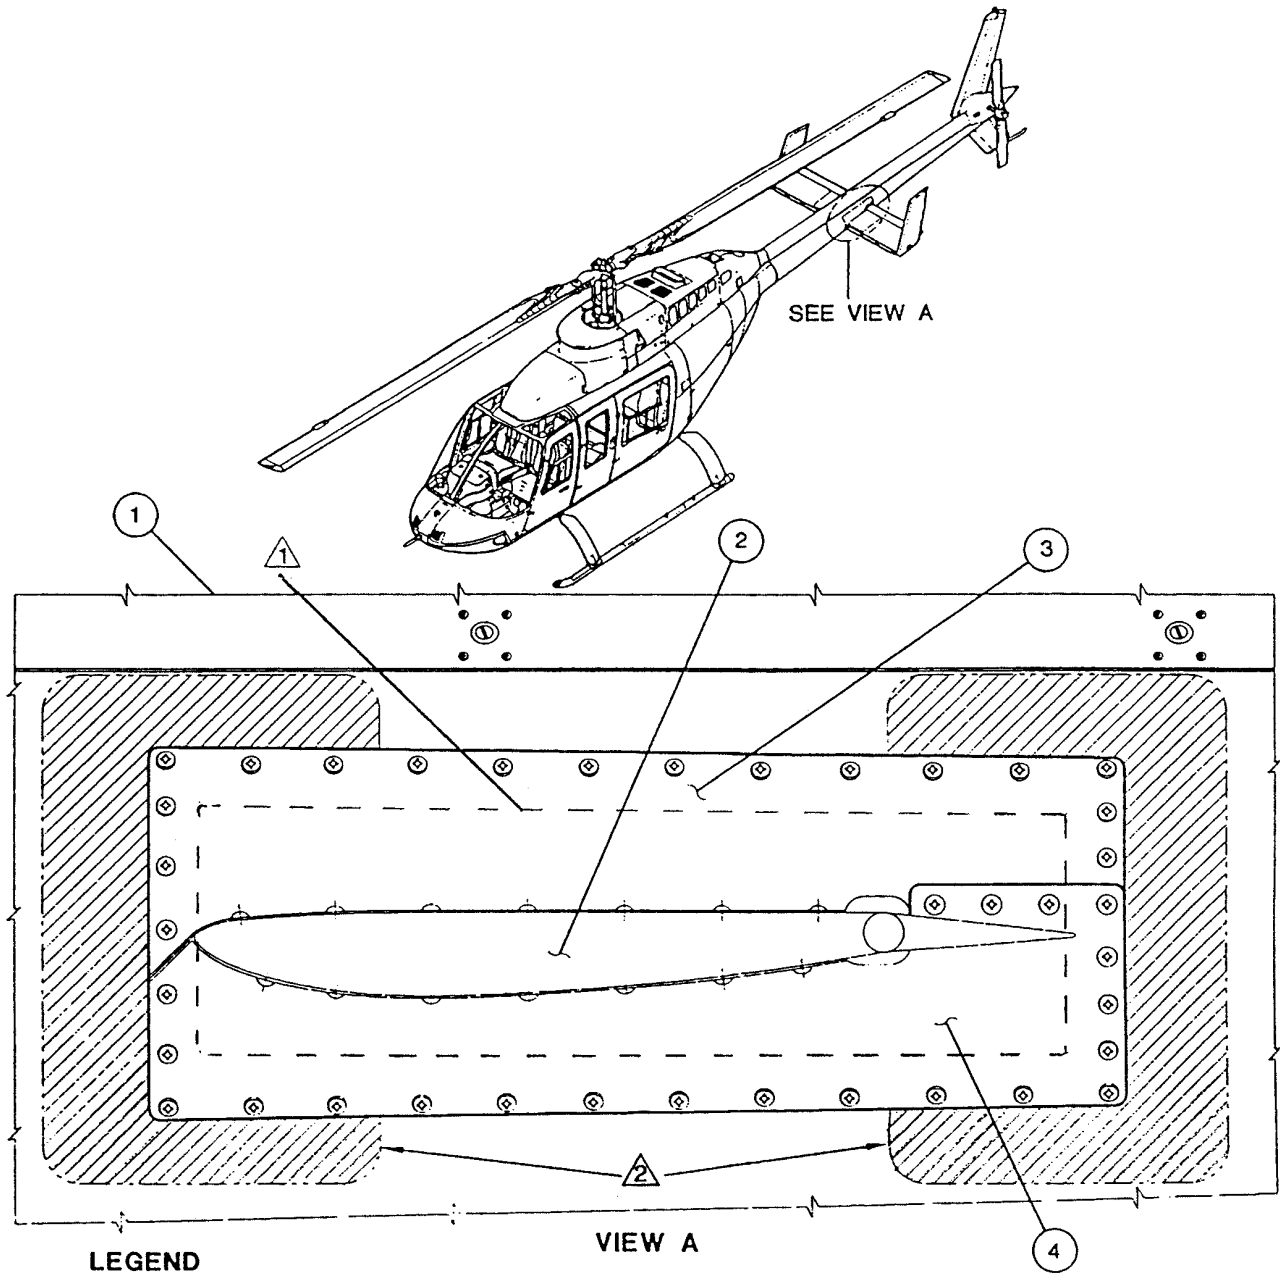
Transport Canada, which is the airworthiness authority for Canada, has notified the FAA that an unsafe condition may exist on BHTC Model 206L, 206L-1, 206L-3, and 206L-4 helicopters. Transport Canada advises that cracks were found on the tailboom skins in the area of the horizontal stabilizer.

- △₂ Inspect for a crack in these two areas on both sides of the tailboom.
- △₁ Inspect entire edge of stabilizer opening on both sides of the tailboom.

visually inspect for any crack in the shaded areas shown in Figure 1. Use a 10-power or higher magnifying glass. If any crack is found, replace the tailboom with an airworthy tailboom.

(b) At intervals not to exceed 5 hours TIS, visually conduct a preflight check of the shaded areas shown in Figure 1 for any crack. If any crack is found, replace the tailboom with an airworthy tailboom. The visual check may be performed by an owner/operator (pilot) holding at least a private pilot

(2) Perform a one-time FPI of the edges of the tailboom skins for any crack around the left and right horizontal stabilizer openings (Figure 1). Remove paint and primer to inspect the edges and exterior skin surface in the skin area at least $\frac{3}{4}$ inch around the edges of the horizontal stabilizer openings.

(3) If a crack is found, replace the tailboom with an airworthy tailboom.
