[Docket No. 97-SW-59-AD; Amendment 39-11235; AD 99-15-14]

#### Airworthiness Directives; Sikorsky Aircraft-Manufactured Model CH-54B Helicopters

##### **AD 99-15-14 Blue Bird Helicopters:**

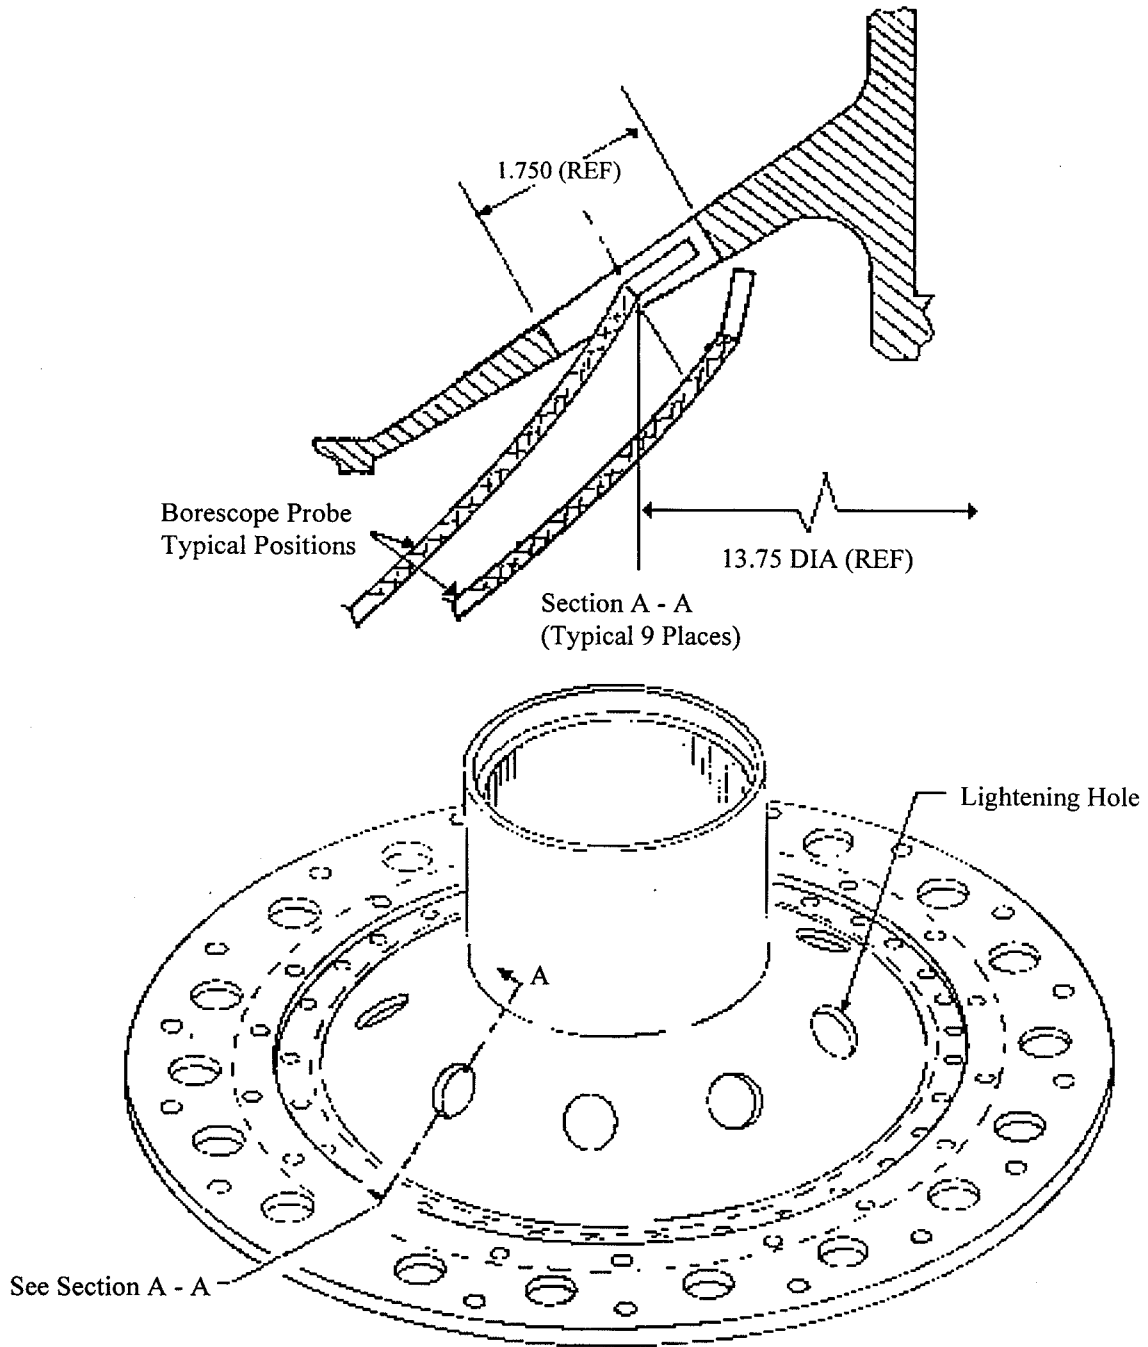
Borecope Inspection of Second Stage  
Lower Planetary Plate Lightning Holes  
Figure 1

(2) Within the next 100 hours TIS after the effective date of this AD, and thereafter at intervals not to exceed 200 hours TIS, conduct a borescope inspection of the plate for cracks in the area of the nine lightening holes (see Figure 1). If a crack is found, replace the plate with an airworthy plate. The plate, P/N 6435-20516-101, is part of the main gearbox second stage planetary set (P/N 6435-20514-041), which is a serialized matched set, and must be replaced as a set.
