Federal Register

[Docket No. 98-SW-33-AD]

Airworthiness Directives; Aircraft Belts, Inc. Model CS, CT, FM, FN, GK, GL, JD, JE, JT, JU, MD, ME, MM, MN, NB, PM, PN, RG, and RH Seat Restraint Systems

ACTION: Notice of proposed rulemaking (NPRM).

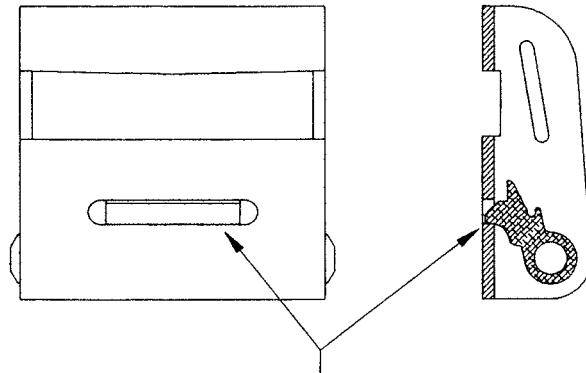
RIGHT

(3) After the lever is completely closed, examine the slot in the bottom of the buckle. The locking mechanism should be firmly seated against the edge of the slot as shown in Figure 1.

THE LEDGE OF THE LOCKING MECHANISM MUST BE FIRMLY SEATED ON THE BOTTOM EDGE AS SHOWN.

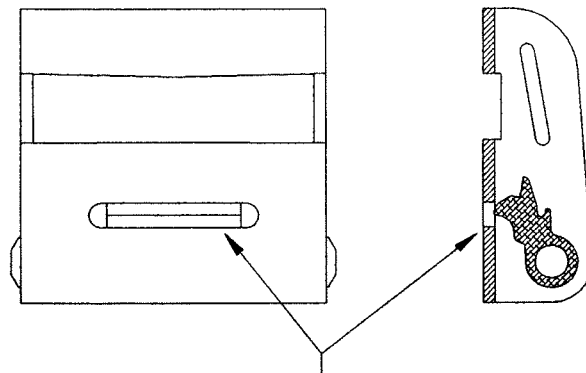
WRONG

To prevent failure of the seat restraint system due to the buckle assembly (buckle) locking mechanism not engaging properly, which could result in the seat restraint system failing to properly secure the occupant during turbulence or landing, accomplish the following:

THE LEDGE OF THE LOCKING MECHANISM IS NOT FIRMLY SEATED ON THE BOTTOM EDGE,

(b) If the locking mechanism does not seat properly, replace the buckle with an airworthy buckle.
