Federal Register

[Docket No. 98-SW-33-AD]

Airworthiness Directives; Aircraft Belts, Inc. Model CS, CT, FM, FN, GK, GL, JD, JE, JT, JU, MD, ME, MM, MN, NB, PM, PN, RG, and RH Seat Restraint Systems

ACTION: Notice of proposed rulemaking (NPRM).

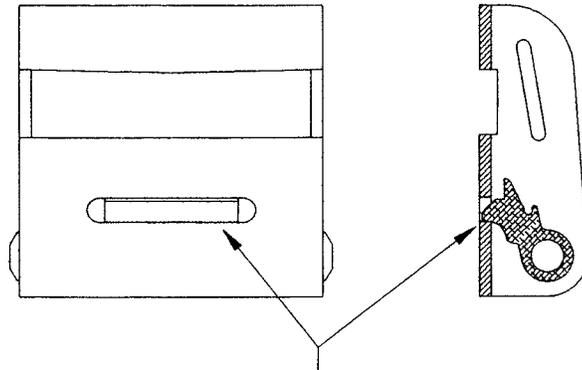
RIGHT

(3) After the lever is completely closed, examine the slot in the bottom of the buckle. The locking mechanism should be firmly seated against the edge of the slot as shown in Figure 1.

THE LEDGE OF THE LOCKING MECHANISM MUST BE FIRMLY SEATED ON THE BOTTOM EDGE AS SHOWN.

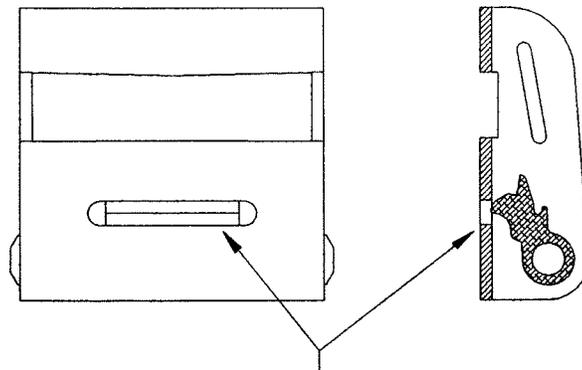
WRONG

THE LEDGE OF THE LOCKING MECHANISM IS NOT FIRMLY SEATED ON THE BOTTOM EDGE,

(b) If the locking mechanism does not seat properly, replace the buckle with an airworthy buckle.
