Federal Register

Friday, September 10, 1999

[Docket No. 98-NM-323-AD]

#### Airworthiness Directives; Boeing Model 757-200, -200PF, and -200CB Series Airplanes Powered by Rolls-Royce RB211-535C/E4/E4B Turbofan Engines

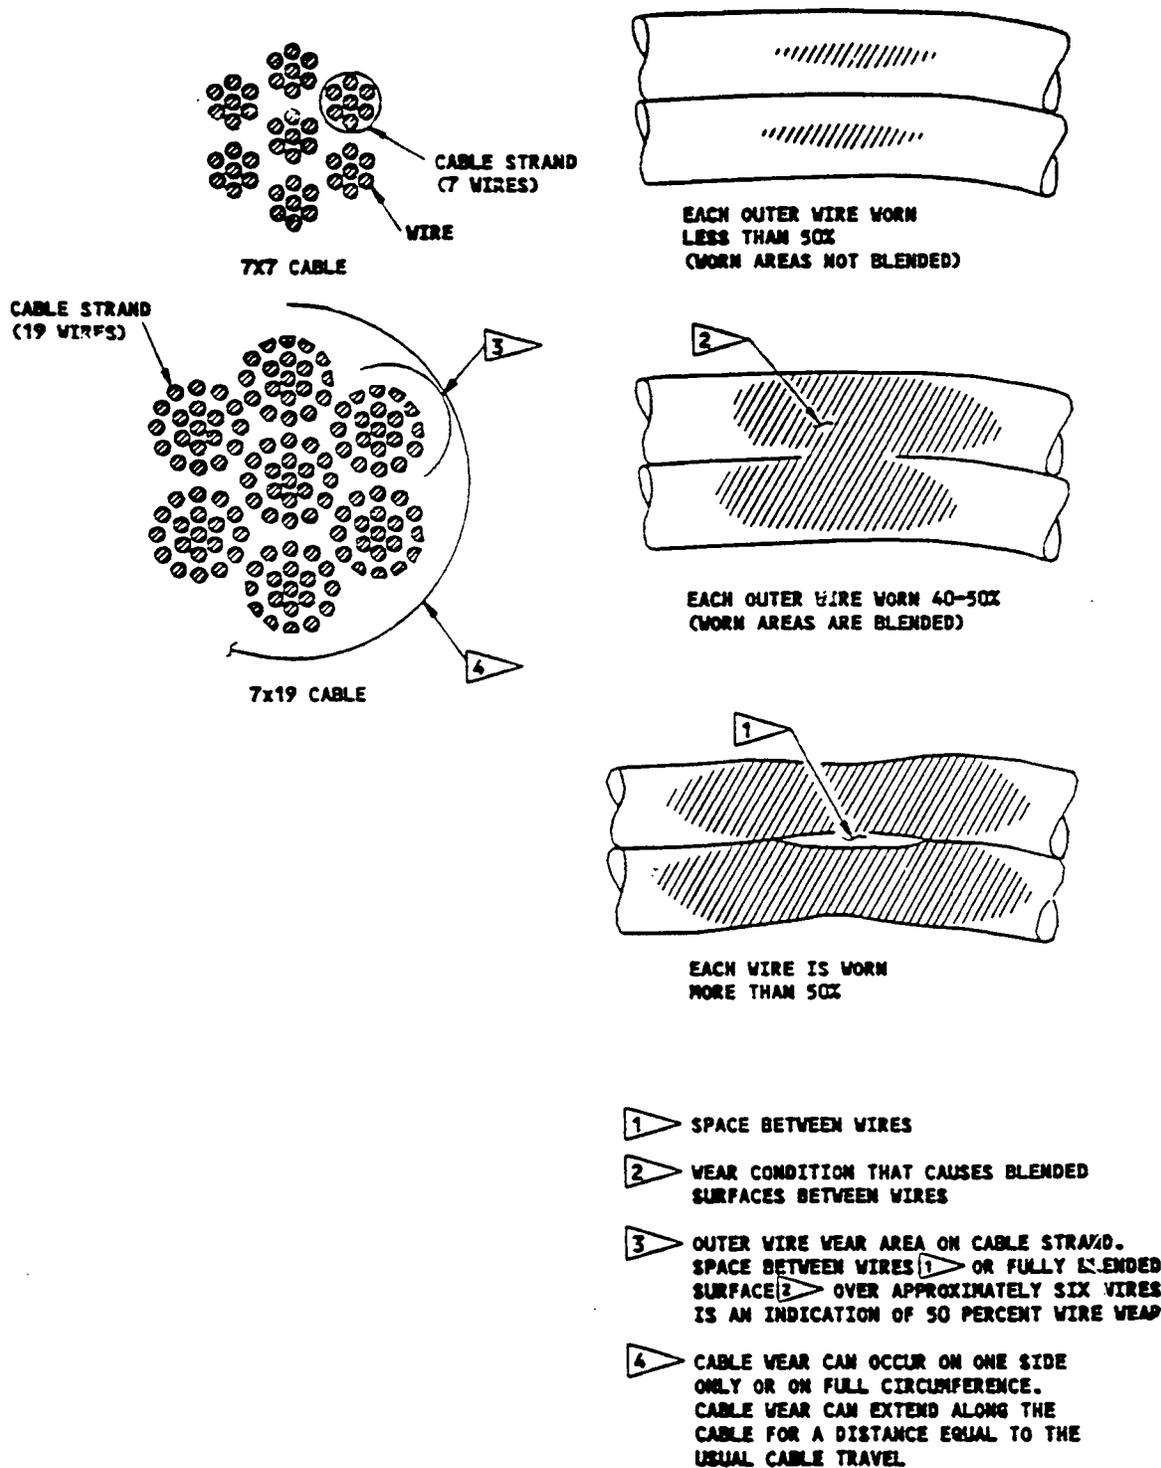
FIGURE 1

(1) One cable strand had worn wires where one wire cross section is decreased by more than 40 percent (see Figure 1),

B. Perform a detailed visual inspection of the cable runs to detect incorrect routing, kinks in the wire rope, or other damage. Replace the cable assembly if:
