[Docket No. 99-CE-13-AD; Amendment 39-11479; AD 99-26-19]

#### Airworthiness Directives; The New Piper Aircraft, Inc. J-2 Series Airplanes That Are Equipped With Wing Lift Struts

99-26-19 The New Piper Aircraft, Inc.:  
Amendment 39-11479; Docket No. 99-CE-13-AD.

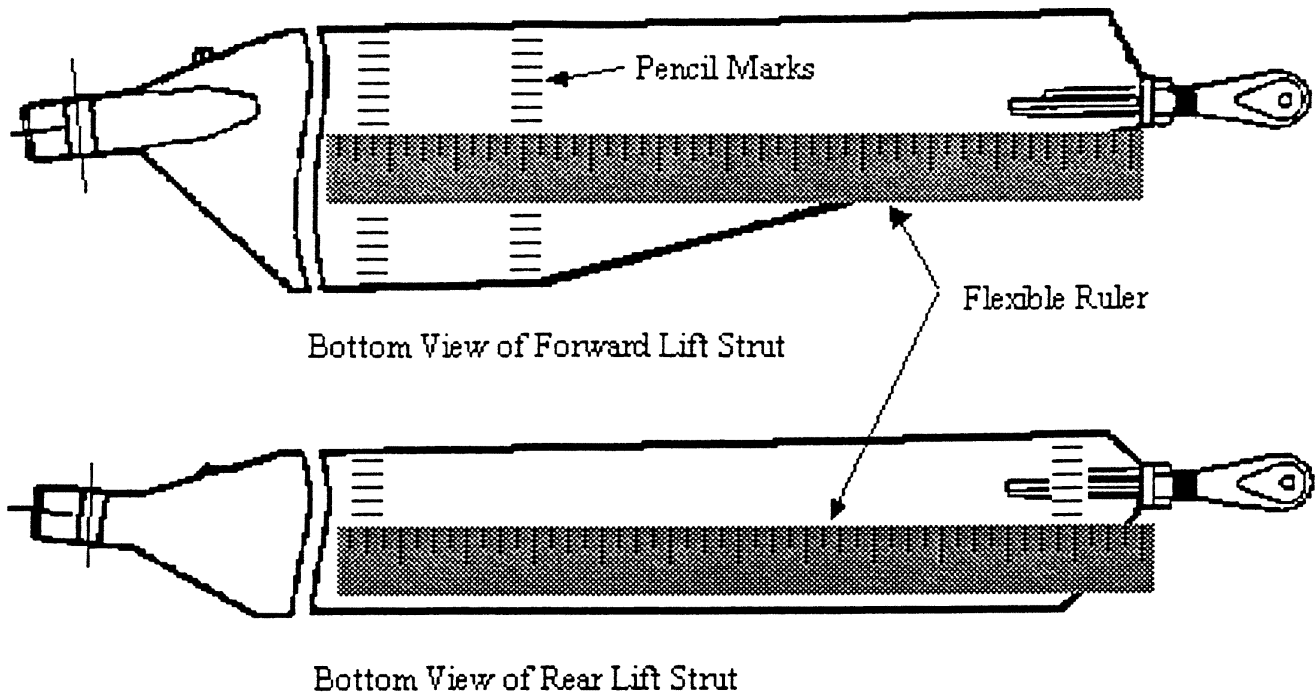
2. Using a flexible ruler, draw a  $\frac{1}{4}$ -inch grid on the surface of the first 11 inches from the lower end of the strut as shown in Piper Service Bulletin No. 528D or 910A, as applicable. This can be done using a soft (#2) pencil and should be done on both faces of the strut. As an alternative to drawing a complete grid, make two rows of marks spaced every  $\frac{1}{4}$ -inch across the width of the strut. One row of marks should be about 11 inches from the lower end of the strut, and the second row should be several inches away where the strut starts to narrow. Lay the flexible ruler between respective tick marks of the two rows and use tape or a rubber band to keep the ruler in place. See Figure 1.
