#### PART 982—HAZELNUTS GROWN IN OREGON AND WASHINGTON

**SUMMARY:** This amendment supersedes Airworthiness Directive (AD) 75-23-08 R5, which currently requires repetitively inspecting and replacing or repairing the exhaust system on certain Cessna Aircraft Company (Cessna) 300 and 400 series airplanes. The requirements of this AD replace the inspections and replacements that are required by AD 75-23-08 R5 with inspections and replacements containing new simplified procedures for all 300 and 400 series airplanes (models affected by the current AD plus additional models). This AD also revises the inspection intervals and requires replacing certain unserviceable parts and removing the exhaust system for a detailed inspection. This AD is the result of numerous incidents and accidents relating to the exhaust systems on Cessna 300 and 400 series airplanes dating from the middle 1970's to the present, including six incidents since issuance of AD 75-23-08 R5 where exhaust problems were cited. The actions specified by this AD are intended to detect and correct cracks and corrosion in the exhaust system, which could result in exhaust system failure and a possible uncontrollable in-flight f

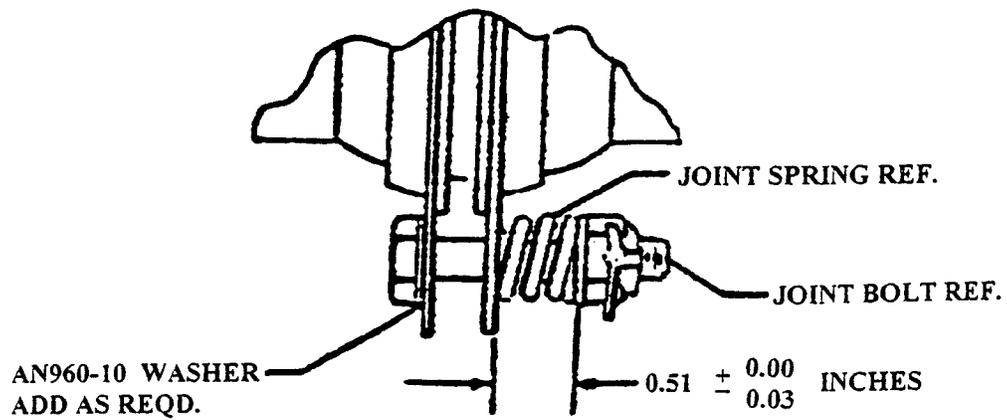
FIGURE 1 to the Appendix

Typical Exhaust Joint Spring Installation

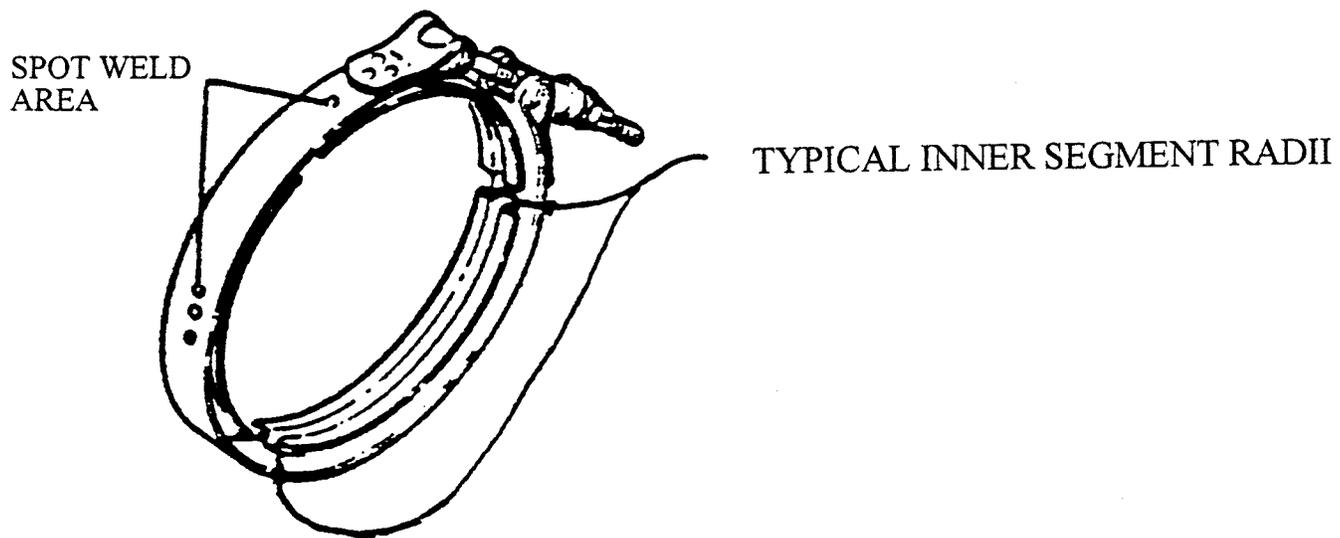
FIGURE 3 to the Appendix

Multi-Segment "V" Band Clamp

(i) Visually inspect the outer band in the area of the spot weld for cracks (see Figure

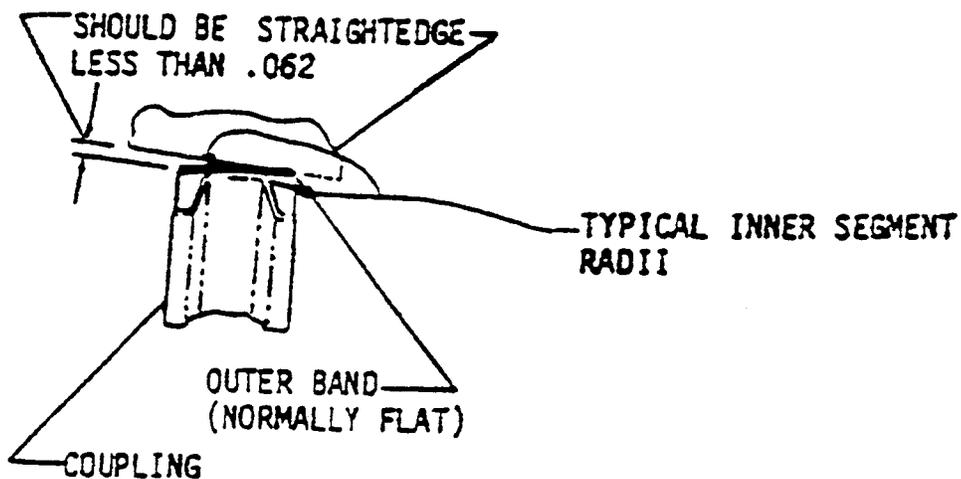
FIGURE 4 to the Appendix

Multi-Segment "V" Band Clamp Outer Band Flatness Check

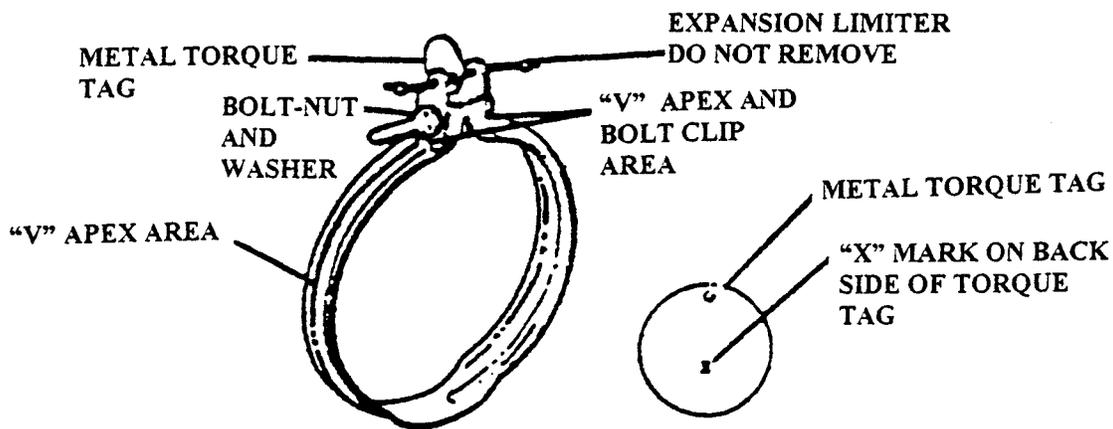
**One-Piece "V" Band Type Clamp****FIGURE 5 to the Appendix***Inspection of the Exhaust System Aft of the Slip Joints*

(iv) Visually inspect the one-piece "V" band clamp (overboard exhaust to turbocharger) with a light and mirror, in the area of the clamp surfaces adjacent to the intersection of the "V" apex and bolt clips, and the entire length of the "V" apex of the clamp for signs of cracks or fractures. If cracks or fractures are visible, replace the clamp (see Figure 5 of this Appendix). See Cessna service manual(s) and revisions for correct installation procedures
