SUMMARY: This amendment supersedes Airworthiness Directive (AD) 75-23-08 R5, which currently requires repetitively inspecting and replacing or repairing the exhaust system on certain Cessna Aircraft Company (Cessna) 300 and 400 series airplanes. The requirements of this AD replace the inspections and replacements that are required by AD 75-23-08 R5 with inspections and replacements containing new simplified procedures for all 300 and 400 series airplanes (models affected by the current AD plus additional models). This AD also revises the inspection intervals and requires replacing certain unserviceable parts and removing the exhaust system for a detailed inspection. This AD is the result of numerous incidents and accidents relating to the exhaust systems on Cessna 300 and 400 series airplanes dating from the middle 1970's to the present, including six incidents since issuance of AD 75-23-08 R5 where exhaust problems were cited. The actions specified by this AD are intended to detect and correct cracks and corrosion in the exhaust system, which could result in exhaust system failure and a possible uncontrollable in-flight fire with pilot and/or passenger injury.

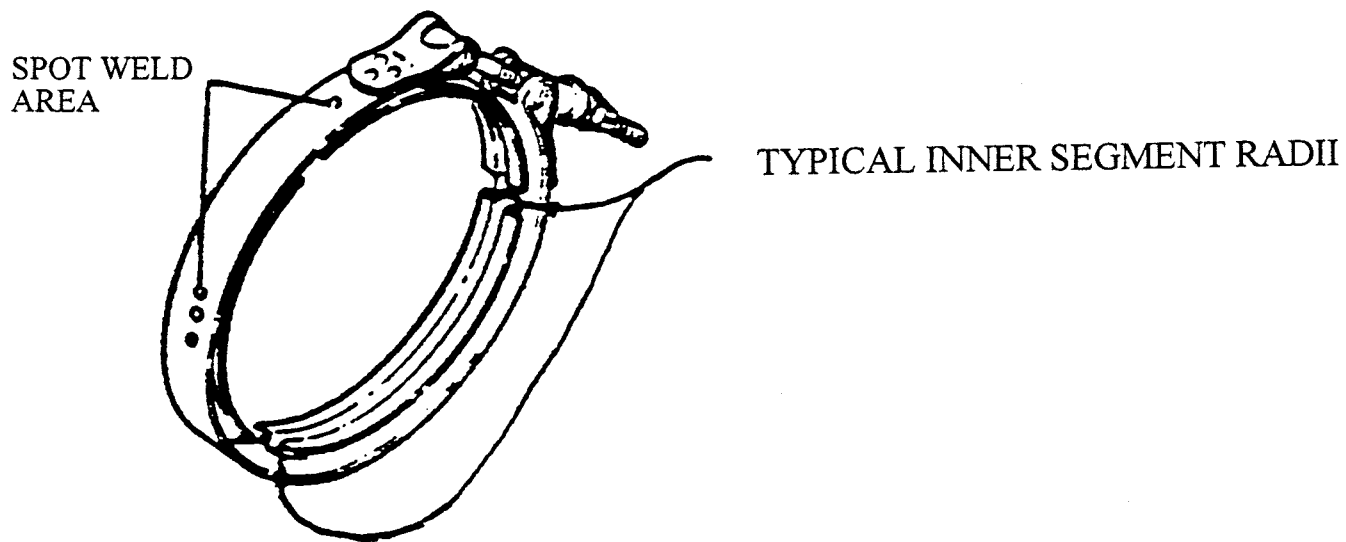
FIGURE 3 to the Appendix

Multi-Segment "V" Band Clamp
