[Docket No. 98-SW-69-AD; Amendment 39-11528; AD 2000-02-09]

**Airworthiness Directives; Agusta S.p.A. (Agusta) Model AB412 Helicopters**

**AD 2000-02-09 Agusta:** Amendment 39-11528. Docket No. 98-SW-69-AD.

**Applicability:** Model AB412 helicopters with rescue hoist, part number BL10300-60 or BL10300-59, installed, certificated in any category.

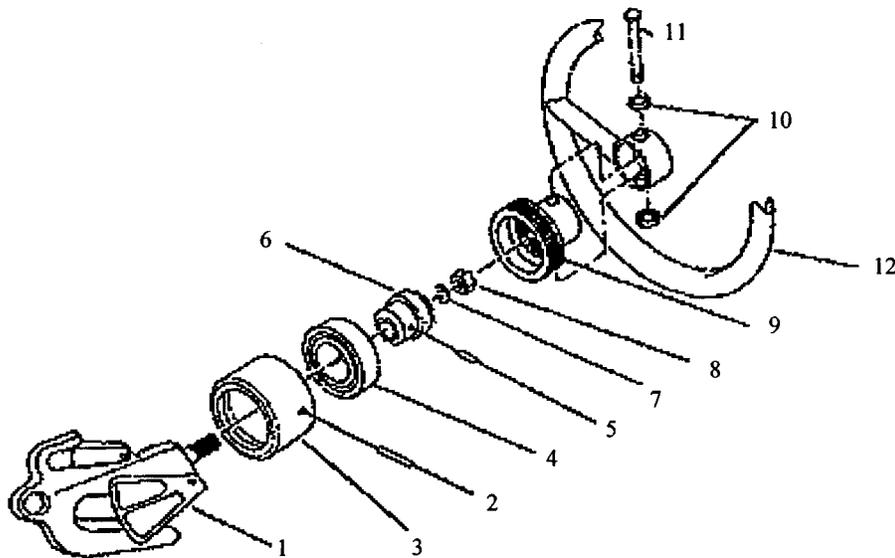
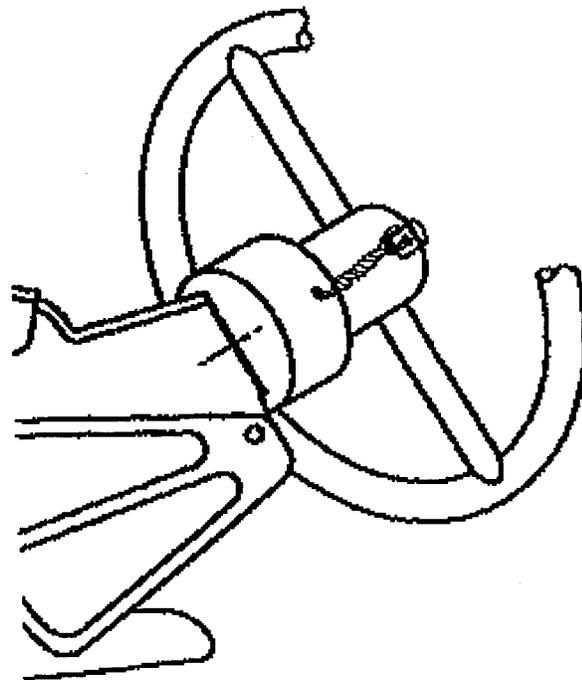
Figure 1

To prevent separation of the rescue hoist hook assembly from the helicopter due failure of the rescue hoist hook assembly retention pin (retention pin), accomplish the following:

(3) Inspect the pin, P/N NAS516C4-6 or P/N MS171524, installed on the housing, P/N BL1357-1, and verify the absence of any rotation between the housing and the adapter, P/N BL1355, (Figure 1).

(4) Inspect the rescue hoist hook to ensure it rotates freely relative to the housing (number 3 on Figure 1).

Inspect the retention pin for scratches or deformations. If a scratch or deformation is found, replace the retention pin with an airworthy retention pin.

(2) Remove the safety wire and remove and discard the retention pin. Retain the two washers, P/N AN960C816L, for reuse (Figure 1).

(3) Install a zero-hours time-in-service (TIS) retention pin, P/N BL2395, and the two washers, P/N AN960C816L, (Figure 1). Safety wire the retention pin to the hook assembly using safety wire, P/N MS 20995C32.

(1) Referring to Figure 1, remove the safety wire and the retention pin. Retain the two washers, P/N AN960C816L, for re-use.

(2) Install the retention pin and the two washers, P/N AN960C816L, (Figure 1). Safety wire the retention pin to the hook assembly using safety wire, P/N MS20995C32.
