2000-02-21 British Aerospace Regional Aircraft [Formerly Jetstream Aircraft Limited; British Aerospace (Commercial Aircraft) Limited]: Amendment 39-11539. Docket 99-NM-309-AD.

Airworthiness Directives; Boeing Model 767 Series Airplanes Equipped With General Electric Model CF6-80C2 Series Engines

2000-02-20 Boeing: Amendment 39-11538. Docket 98-NM-231-AD. Supersedes AD 95-13-12 R1, Amendment 39-9528.

Thrust Reverser Electro-Mechanical Brake and CDU Cone Brake Test

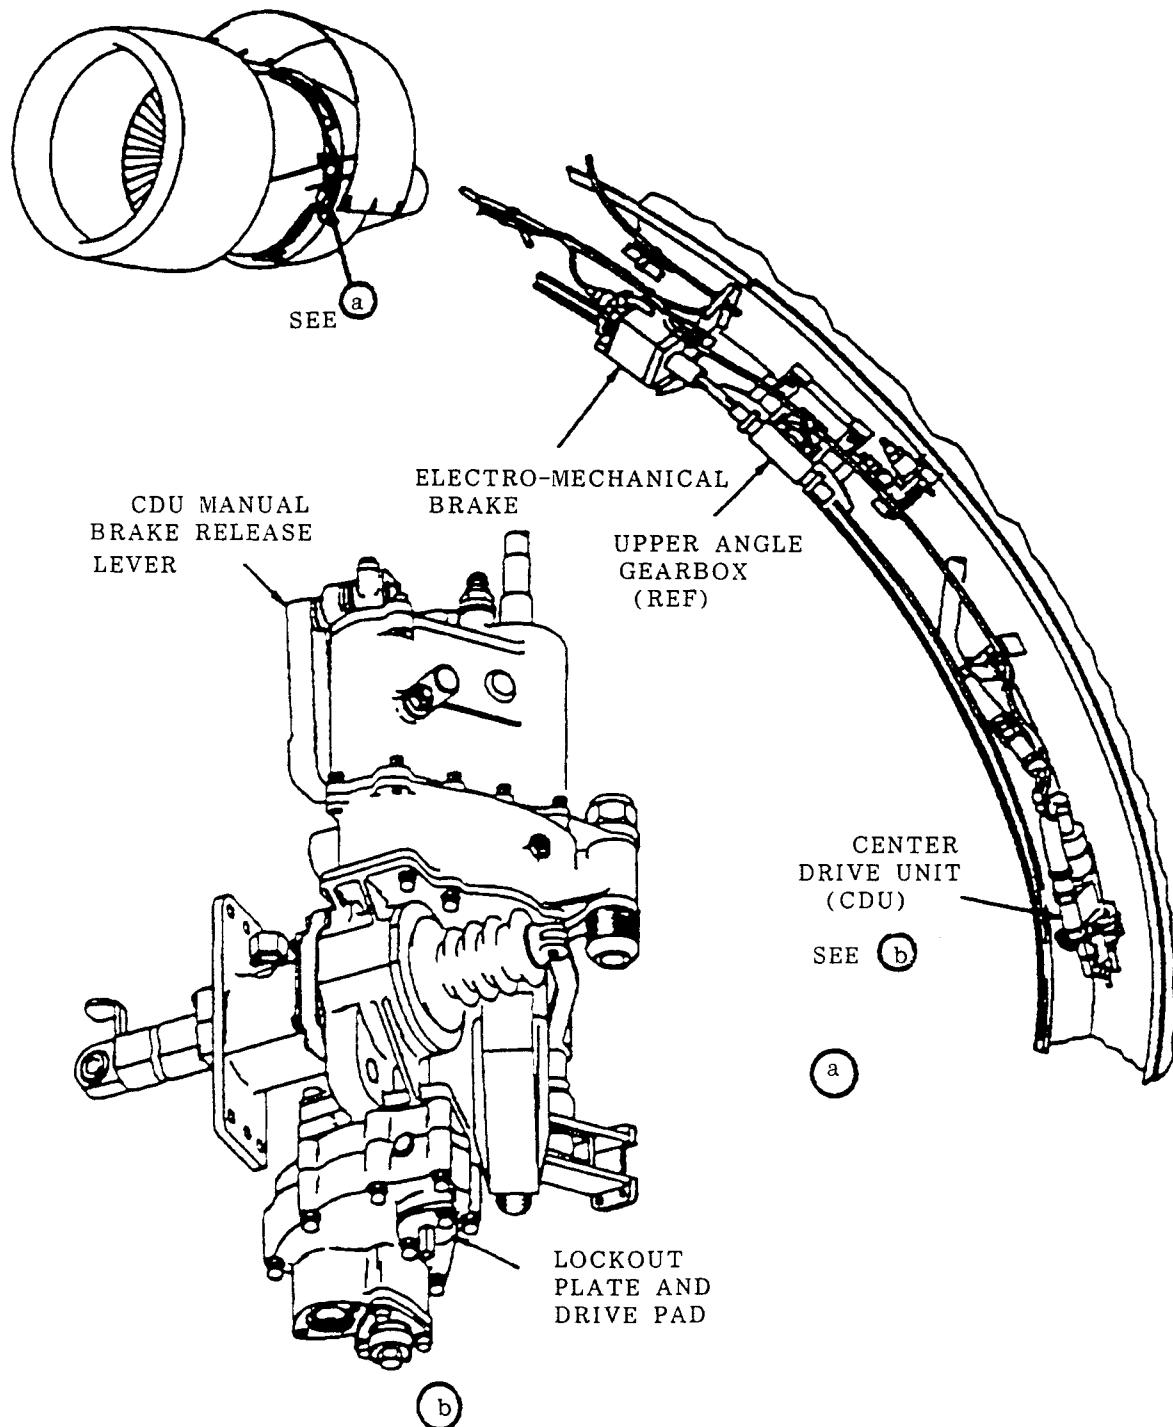
Electro-Mechanical Brake and CDU Cone Brake Torque Check
Figure 1

2. Electro-Mechanical Brake and CDU Cone Brake Torque Check (Fig. 1)

(1) The electro-mechanical brake system is working correctly if the torque is reached before you turn the wrench 450 degrees ($1\frac{1}{4}$ turns).

(2) If the flexshaft turns more than 450 degrees before you reach the specified torque, you must replace the long flexshaft between the CDU and the upper angle gearbox.

(3) If you do not get 90 pound-inches of torque, you must replace the electro-mechanical brake.

(a) If the torque is less than 15-pound-inches, you must replace the CDU.
