[Docket No. 99-NM-76-AD; Amendment 39-11540; AD 2000-02-22]

#### **Airworthiness Directives; Boeing Model 747-400 Series Airplanes Equipped with Rolls-Royce RB211-524G/H and RB211-524G-T/H-T Engines**

**ACTION:** Final rule; request for comments.

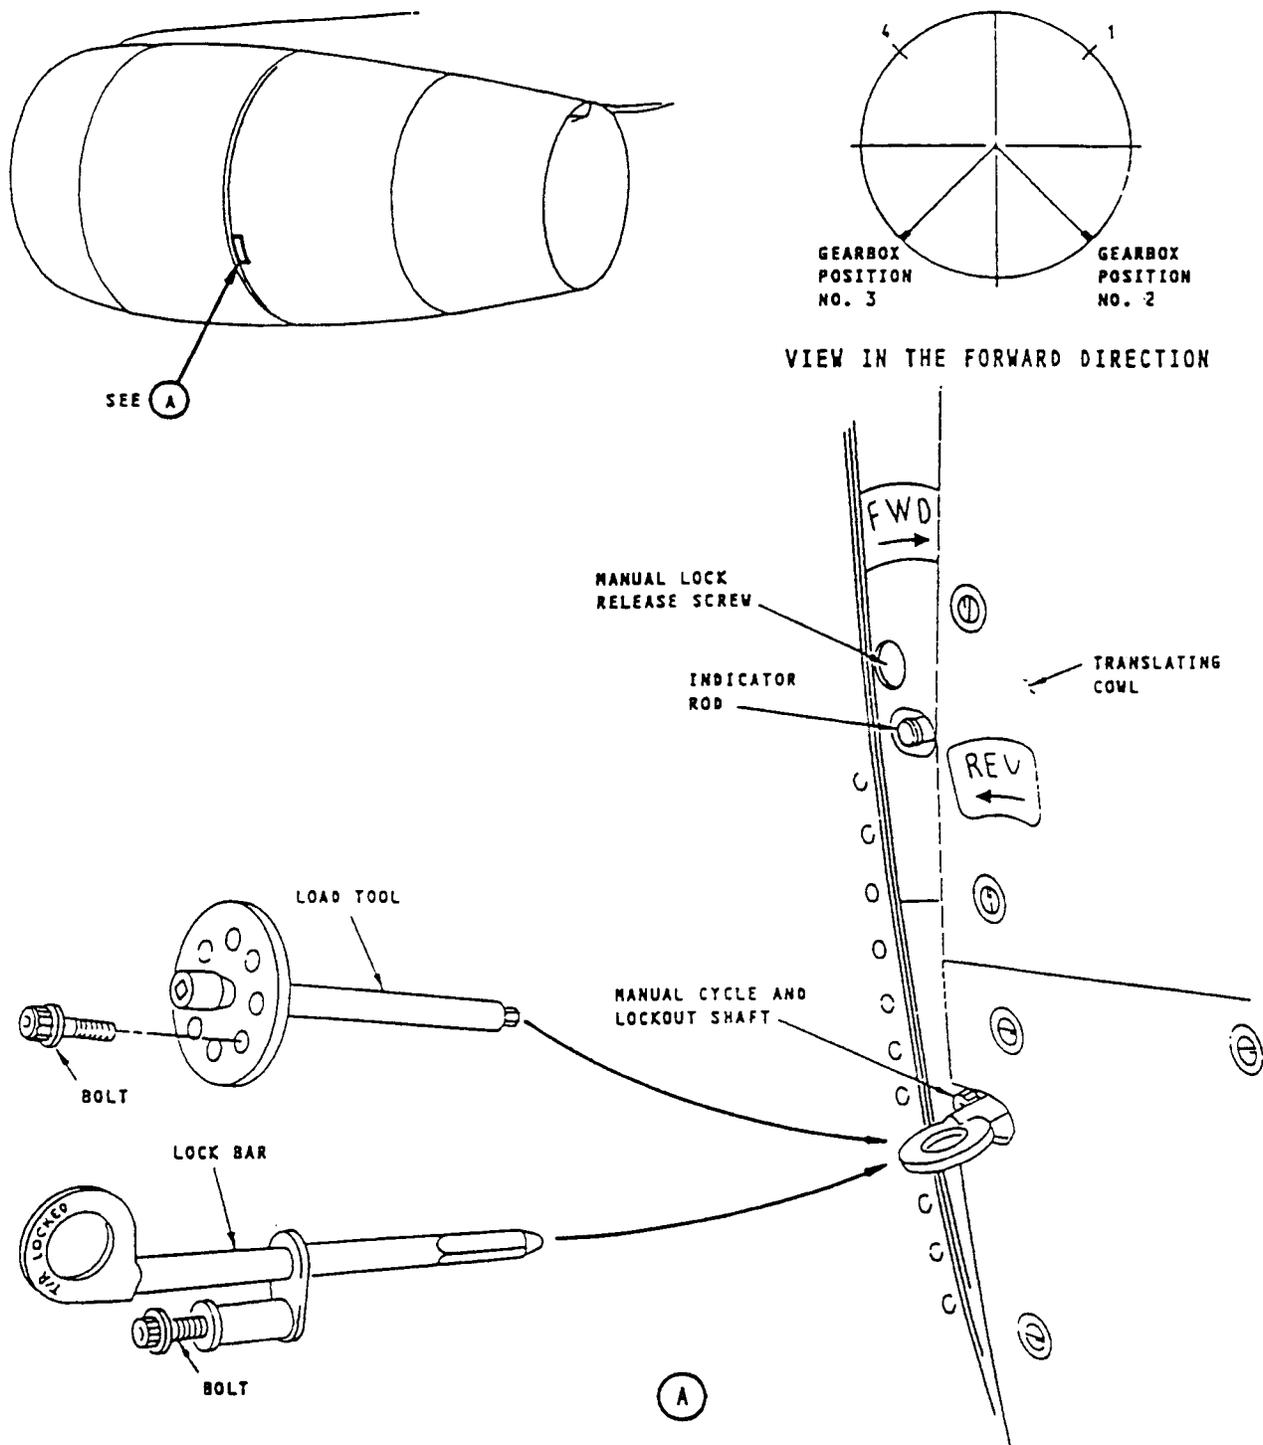
Lock Bar/Load Tool Installation and Gearbox Manual Lock Release  
Figure 1

**NOTE:** GEARBOX POSITION NO. 3 IS SHOWN.  
GEARBOX POSITION NO. 2 IS THE SAME.
