[Docket No. 99-NM-76-AD; Amendment 39-11540; AD 2000-02-22]

Airworthiness Directives; Boeing Model 747-400 Series Airplanes Equipped with Rolls-Royce RB211-524G/H and RB211-524G-T/H-T Engines

2000-02-22 Boeing: Amendment 39-11540. Docket 99-NM-76-AD.

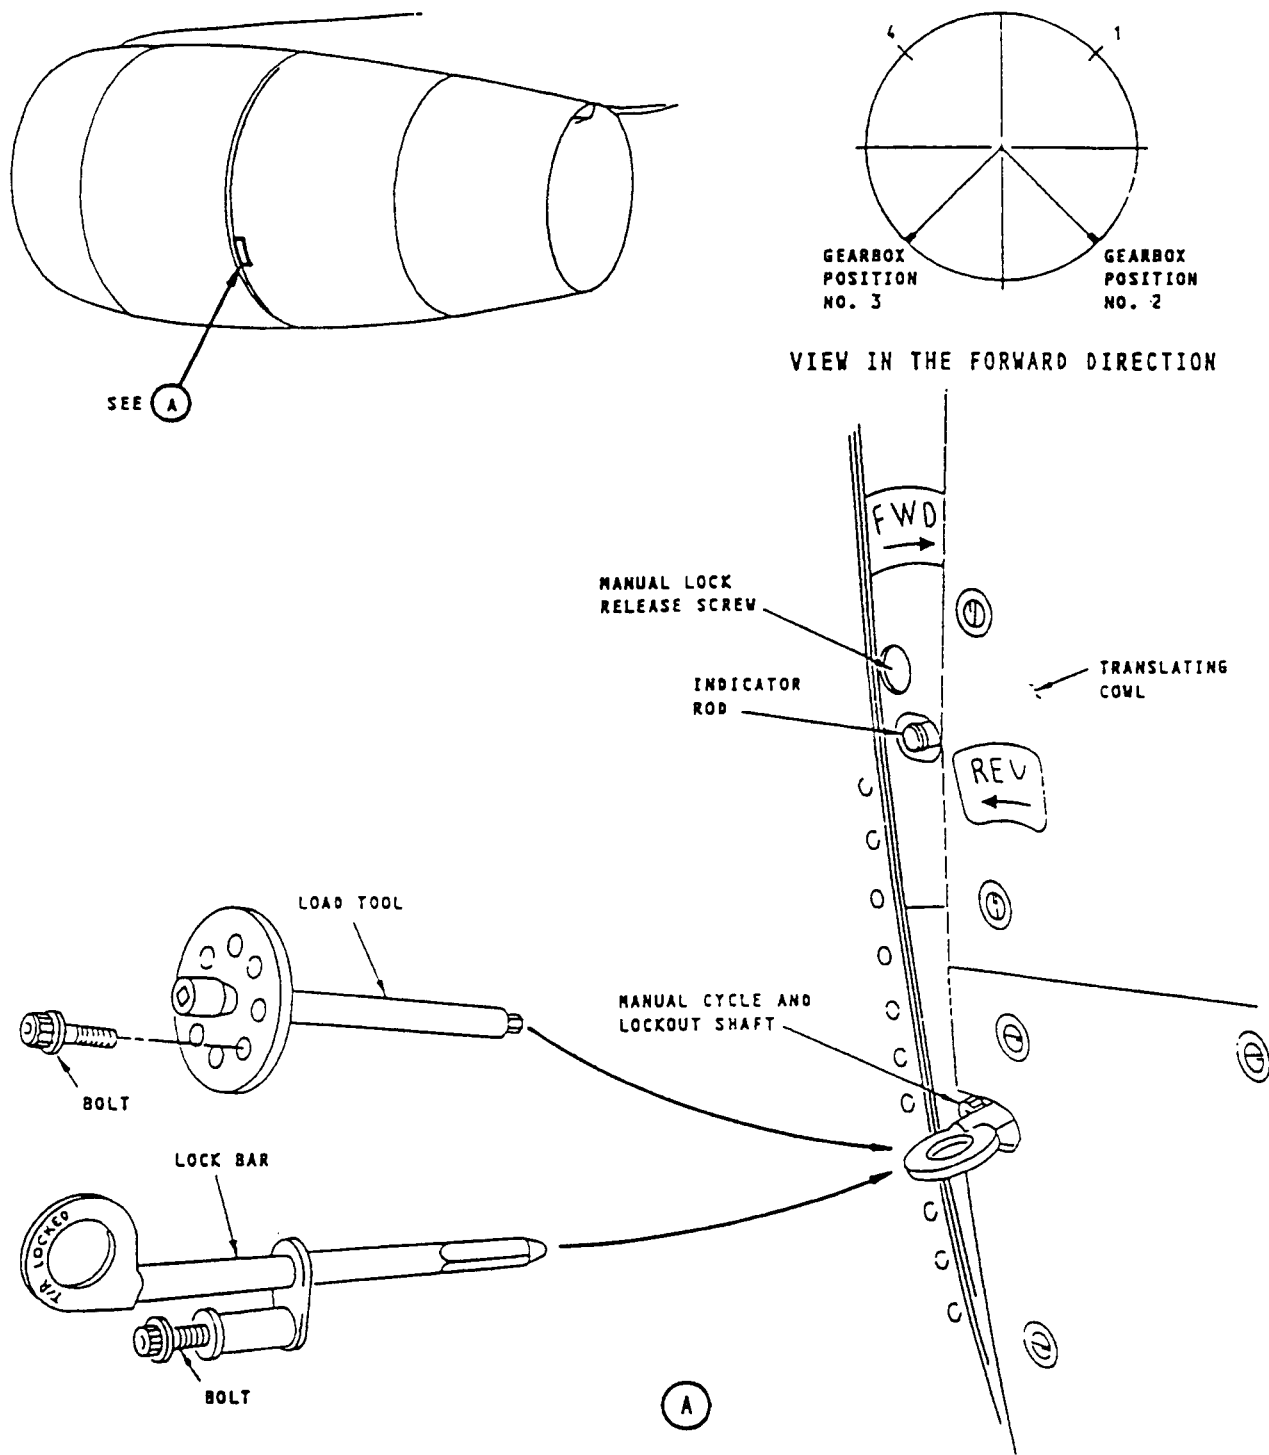
Lock Bar/Load Tool Installation and Gearbox Manual Lock Release
Figure 1

NOTE: GEARBOX POSITION NO. 3 IS SHOWN.
GEARBOX POSITION NO. 2 IS THE SAME.
