[Docket No. 2000-NM-67-AD; Amendment 39-11618; AD 2000-05-09]

Airworthiness Directives; Boeing Model 757-200, -200PF, and -200CB Series Airplanes Powered by Rolls-Royce RB211-535C/E4/E4B Turbofan Engines

2000-05-09 Boeing: Amendment 39-11618. Docket 2000-NM-67-AD. Supersedes AD 99-27-06, Amendment 39-11487.

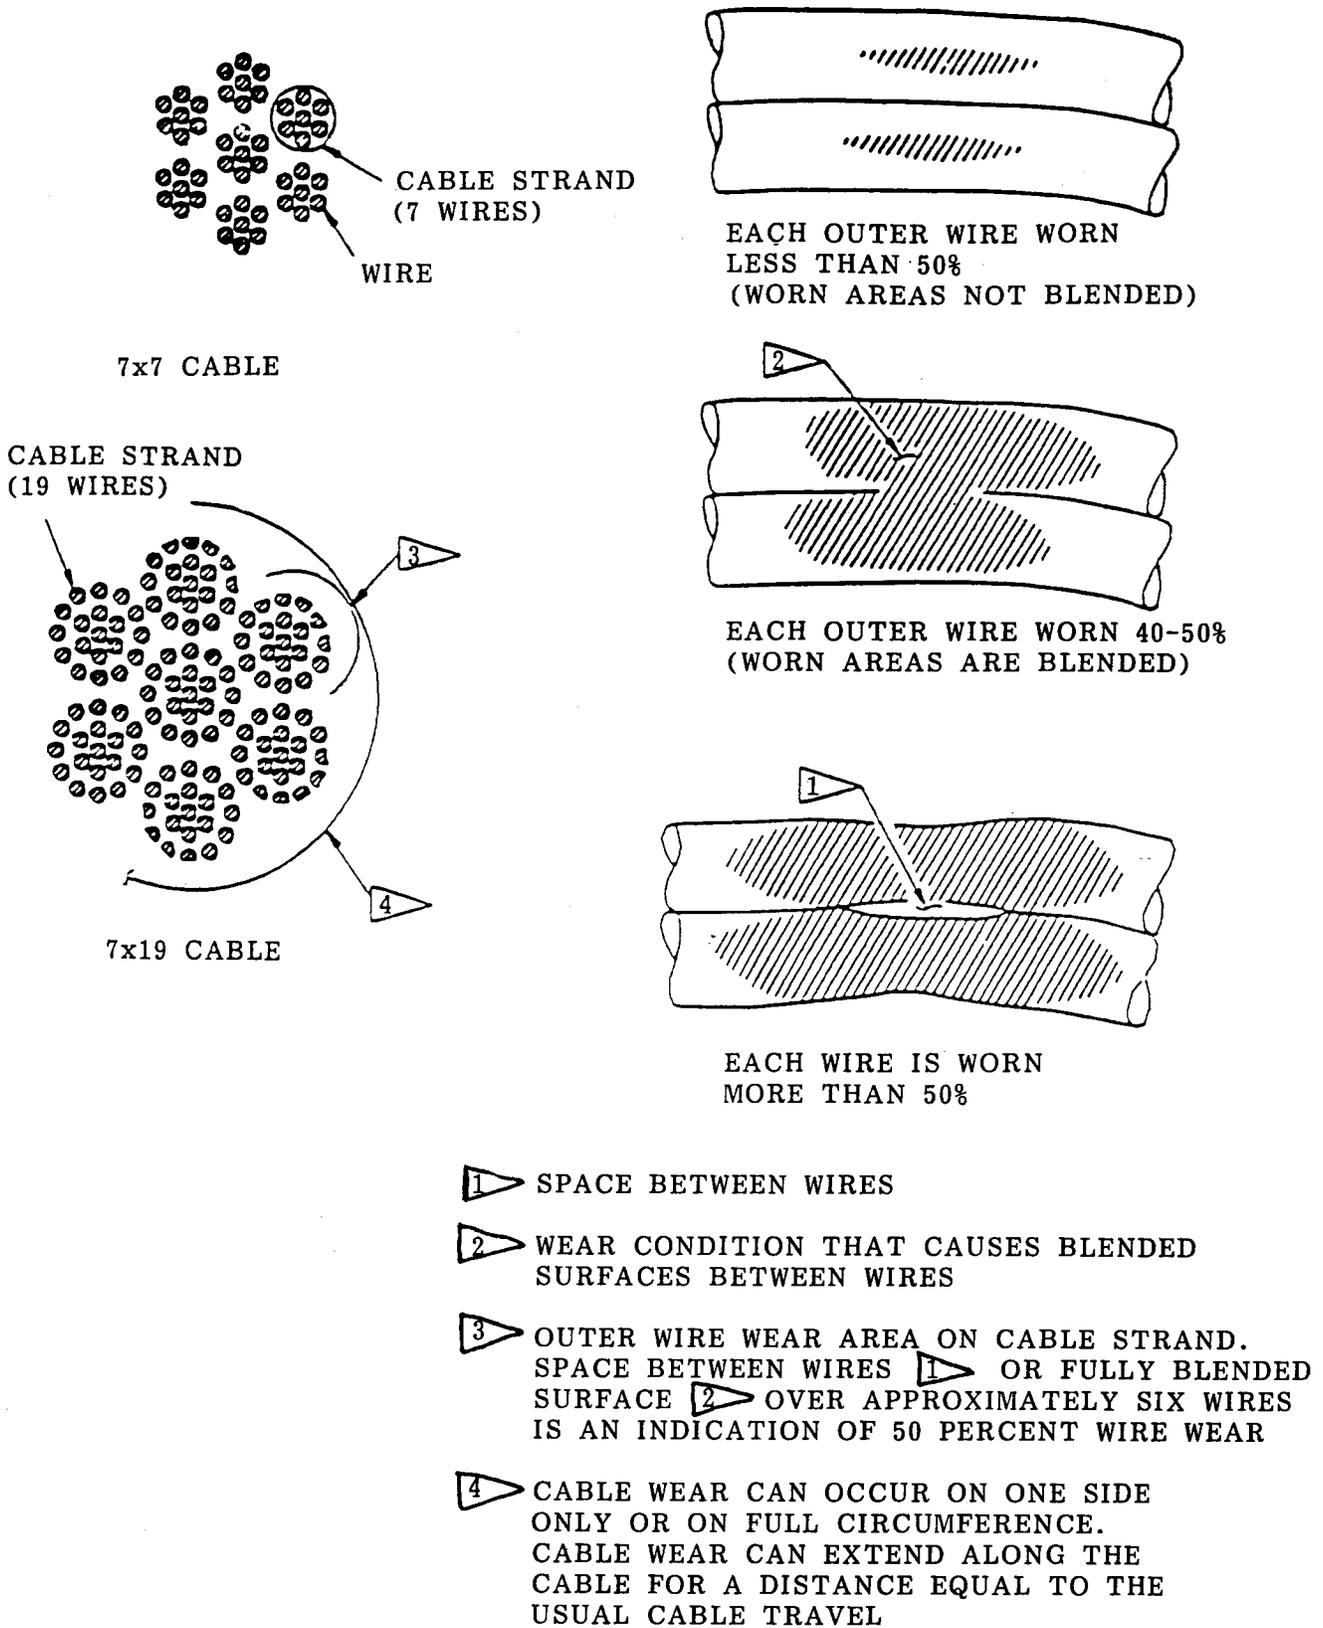
FIGURE 1

- (1) One cable strand had worn wires where one wire cross section is decreased by more than 40 percent (see Figure 1),
- (2) A kink is found, or
- (3) Corrosion is found.

B. Perform a detailed visual inspection of the cable runs to detect incorrect routing, kinks in the wire rope, or other damage. Replace the cable assembly if:
