[Docket No. 99-NM-22-AD; Amendment 39-11640; AD 2000-05-30]

#### Airworthiness Directives; Boeing Model 747 Series Airplanes

**2000-05-30 Boeing:** Amendment 39-11640. Docket 99-NM-22-AD.

**Thrust Control Cable Inspection Procedure**

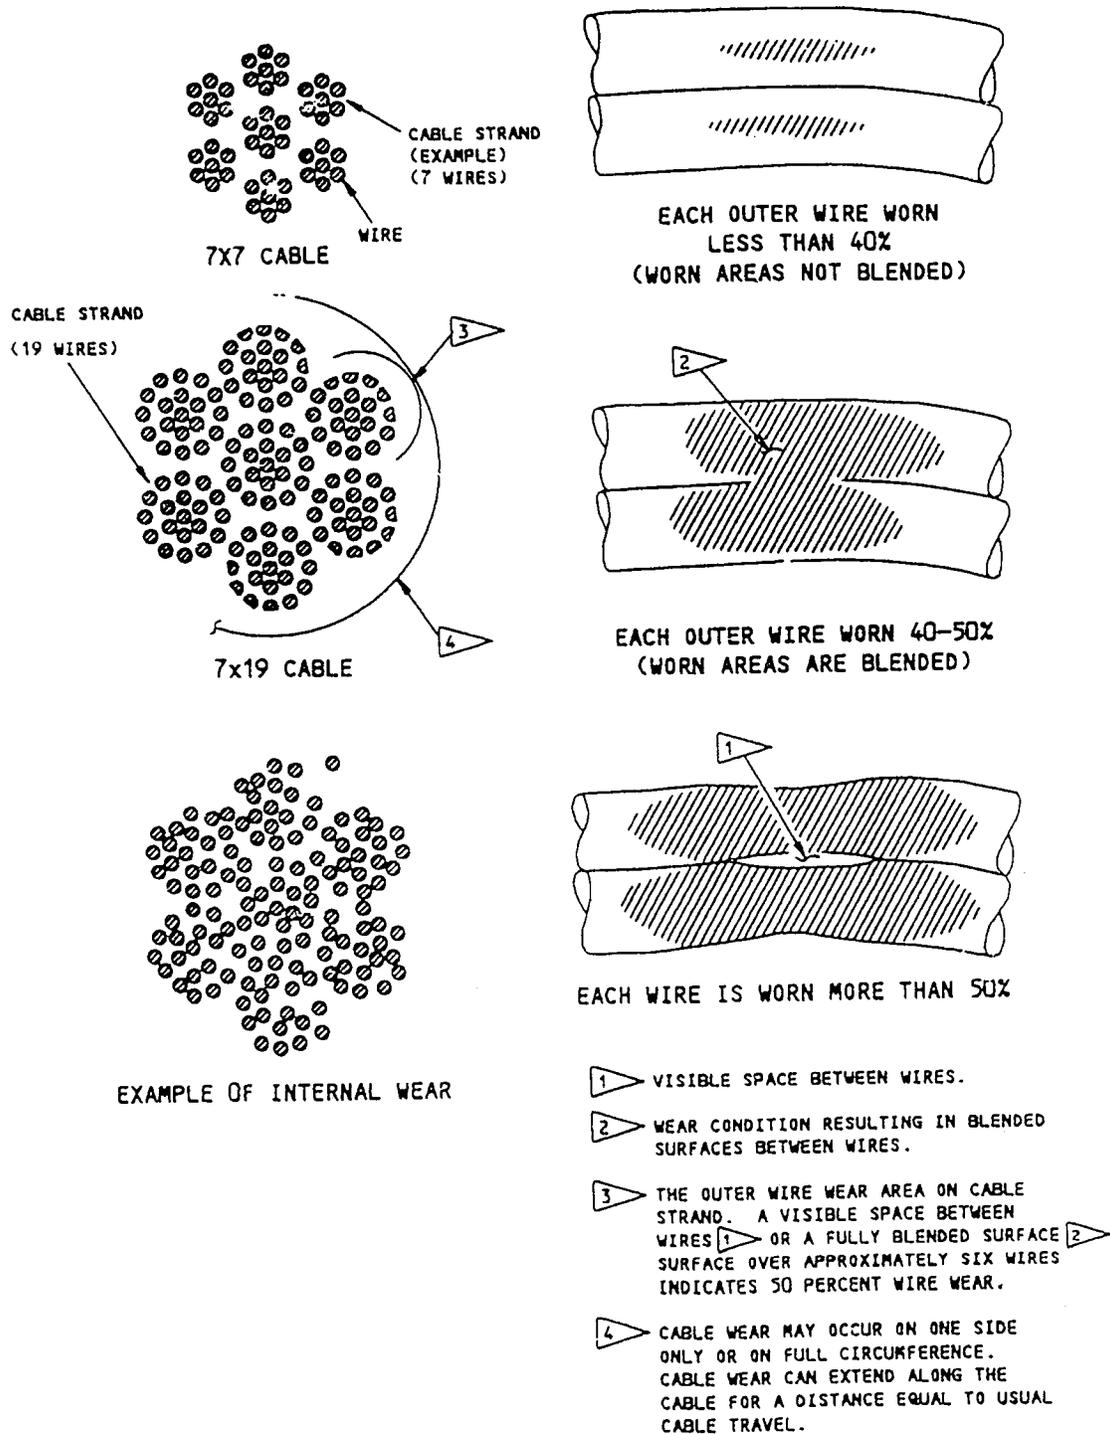
FIGURE 1

The FAA has revised Figure 1 of Appendix 1 in the final rule to correct the percentage of wear of each outer wire of the thrust control cables as illustrated. The correct percentage (40%) was specified in Appendix 1, Paragraph 2.B.(1) of the proposal. Figure 1 of Appendix 1 in the proposal illustrated, "Each outer wire worn less than 50%." Figure 1 of Appendix 1 in the final rule illustrates "Each outer wire worn less than 40%."

(1) One cable strand had worn wires where one wire cross section is decreased by more than 40 percent (see Figure 1),

B. Perform a detailed visual inspection of the cable runs to detect incorrect routing, kinks in the wire rope, or other damage. Replace the cable assembly if:
