[Docket No. 99-NM-22-AD; Amendment 39-11640; AD 2000-05-30]

Airworthiness Directives; Boeing Model 747 Series Airplanes

ACTION: Final rule.

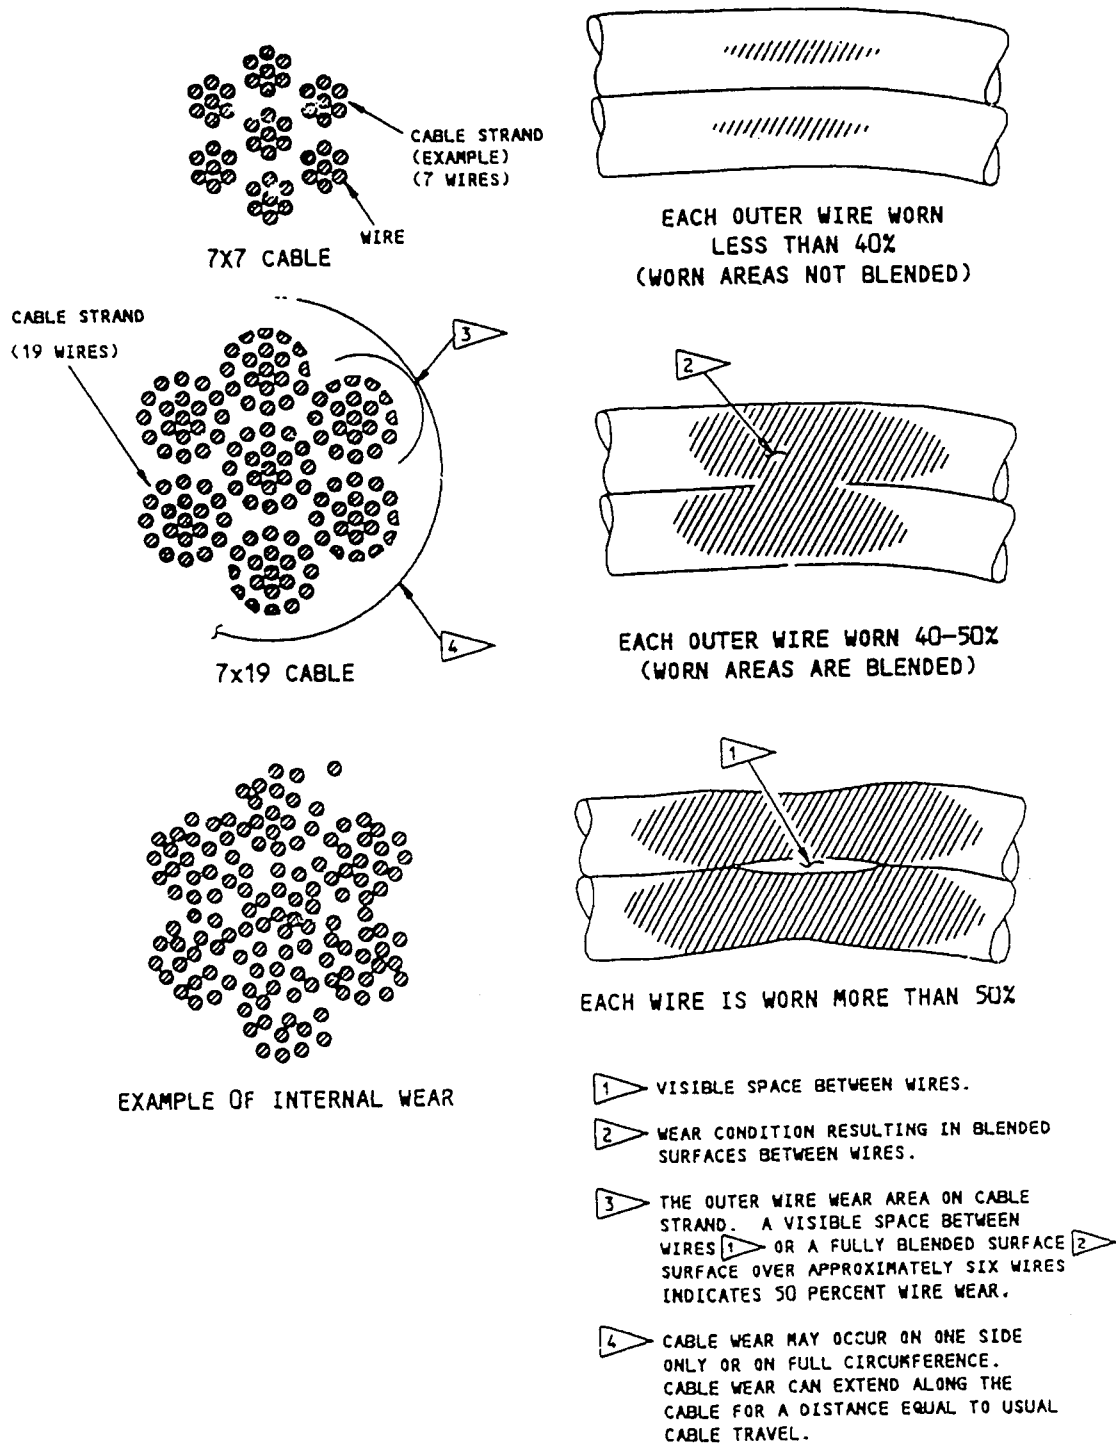
FIGURE 1

The FAA has revised Figure 1 of Appendix 1 in the final rule to correct the percentage of wear of each outer wire of the thrust control cables as illustrated. The correct percentage (40%) was specified in Appendix 1, Paragraph 2.B.(1) of the proposal. Figure 1 of Appendix 1 in the proposal illustrated, "Each outer wire worn less than 50%." Figure 1 of Appendix 1 in the final rule illustrates "Each outer wire worn less than 40%."

(1) One cable strand had worn wires where one wire cross section is decreased by more than 40 percent (see Figure 1),

B. Perform a detailed visual inspection of the cable runs to detect incorrect routing, kinks in the wire rope, or other damage. Replace the cable assembly if:
