Airworthiness Directives; Robinson Helicopter Company Model R44 Helicopters

AD 2000-07-03 Robinson Helicopter Company: Amendment 39-11657. Docket No. 99-SW-08-AD.

Applicability: Model R44 helicopters, serial numbers 0002 through 0462, certificated in any category.

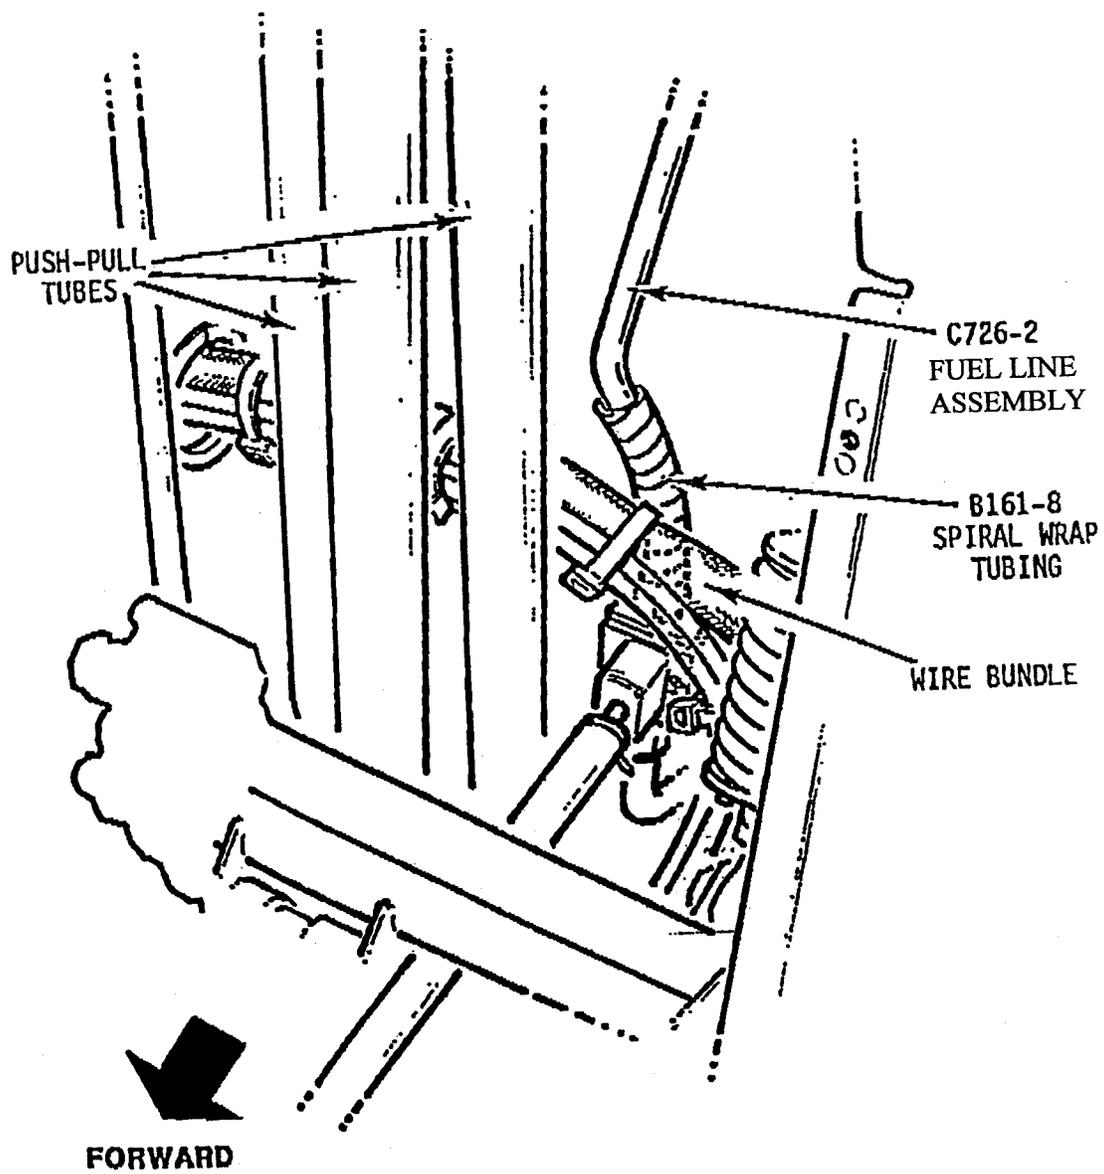
FIGURE 1

To prevent contact between the wire harness and the fuel line assembly, which could result in chafing of the wire harness and a potential fire hazard, accomplish the following:

(b) Inspect the wire harness, P/N C059, and the fuel line assembly, P/N C726-2, above the fuel shutoff valve for contact. If the wire harness contacts the fuel line assembly, inspect for chafing.

(c) If chafing has occurred between the wire harness and the fuel line assembly, replace the fuel line with an airworthy fuel line assembly. Torque the fuel line nuts to 110-130 in-lbs. Verify that clearance exists between the fuel line assembly and the wire harness.

(d) Install a 3-inch section of spiral wrap tubing, P/N B161-8, on the fuel line assembly as shown in Figure 1. Push the spiral wrap tubing down until it is against the fuel line fitting.
