[Docket No. 99-SW-80-AD]

Airworthiness Directives; Bell Helicopter Textron Canada Model 206L, L-1, L-3, and L-4 Helicopters

ACTION: Notice of proposed rulemaking (NPRM).

Bell Helicopter Textron Canada: Docket No. 99-SW-80-AD. Supersedes AD 99-13-12, Amendment 39-11207, Docket No. 99-SW-23-AD.

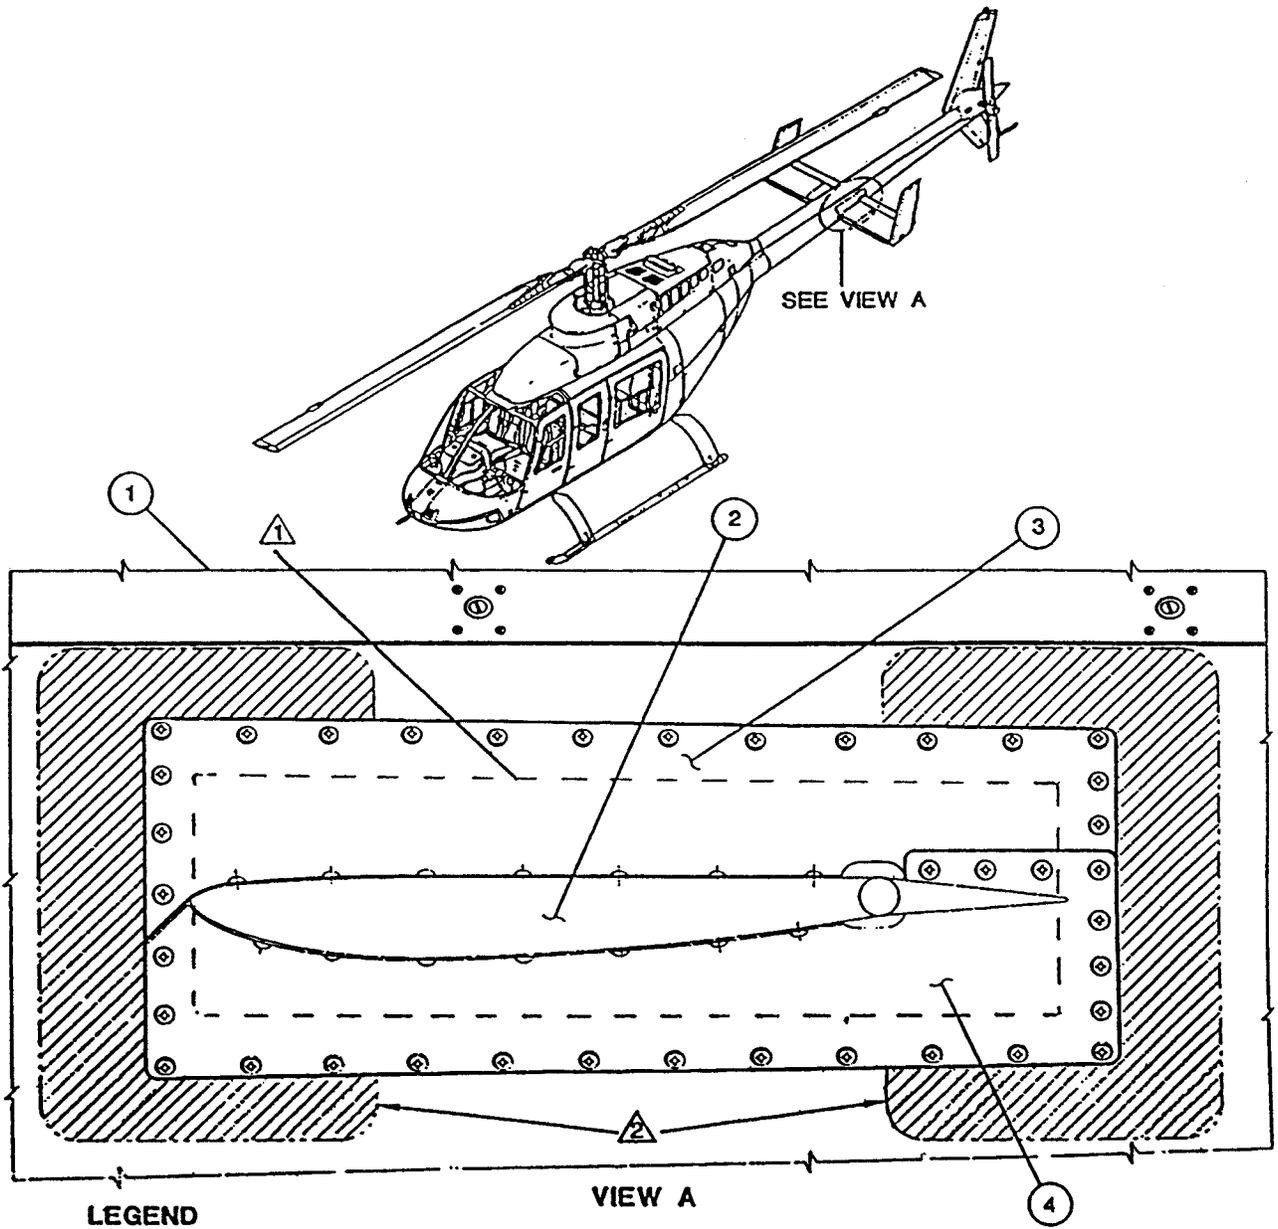
Figure 1

Transport Canada, which is the airworthiness authority for Canada, has notified the FAA that an unsafe condition may exist on BHTC Model 206L, L-1, L-3, and L-4 helicopters. Transport Canada advises that cracks were found on the tailboom skins in the area of the horizontal stabilizer.

(a) Before further flight and thereafter at intervals not to exceed 10 hours time-in-service (TIS) until accomplishing the one-time fluorescent-penetrant inspection (FPI) required by paragraph (c)(2) of this AD, visually inspect for any crack in the shaded areas shown in Figure 1. Use a 10-power or higher magnifying glass. If a crack is found, replace the tailboom with an airworthy

(b) At intervals not to exceed 5 hours TIS, visually check for any crack in the tailboom as depicted by the shaded areas shown in Figure 1. If any crack is found, replace the tailboom with an airworthy tailboom modified according to the requirements of paragraph (e) of this AD before further flight. The visual check may be performed by an owner/operator (pilot) holding at least a private pilot certificate and must be entered into the aircraft records showing compliance with paragraph (b) of this AD in accordance with sections 43.11 and 91.417 (a)(2)(v) of the Federal Aviation Regulations (14 CFR sections 43.11 and 91.417 (a)(2)(v)).

(2) Perform a one-time FPI of the edges of the tailboom skins for any crack around the left and right horizontal stabilizer openings (Figure 1). Remove paint and primer to inspect the edges and exterior skin surface in the skin area at least $\frac{3}{4}$ inch around the edges of the horizontal stabilizer openings.

- △ 2 Inspect for a crack in these two areas on both sides of the tailboom.
- △ 1 Inspect entire edge of stabilizer opening on both sides of the tailboom.

(2) Visually inspect the entire edge of the horizontal stabilizer opening on both sides of the tailboom for any crack using a 10-power or higher magnifying glass.

(3) If a crack is found, replace the tailboom with an airworthy tailboom modified according to the requirements of paragraph (e) of this AD before further flight.

(e) Within the next 300 hours TIS, inspect and modify the tailboom in accordance with Parts I, II, and III of Bell Helicopter Textron Canada (BHTC) Alert Service Bulletin 206L-99-115, Revision D, dated January 26, 2000 (ASB). If a crack is found while accomplishing Part I of the ASB, replace the tailboom with an airworthy tailboom modified as required by this paragraph before further flight. After accomplishing the modification, inspect the modified tailboom at intervals not to exceed 1200 hours TIS in accordance with Part IV of the ASB.
