[Docket No. 99-SW-81-AD]

Airworthiness Directives; Sikorsky Aircraft-manufactured Model CH-54A Helicopters

ACTION: Notice of proposed rulemaking (NPRM).

Siller Helicopters; Aviation International Rotors, Inc. (Air, Inc); Columbia Helicopters, Inc.; Chet Raspberry, Inc. (CRI); Silver Bay Logging, Inc.: Docket No. 99-SW-81-AD. Supersedes AD 99-07-16, Amendment 39-11102, Docket No. 97-SW-60-AD.

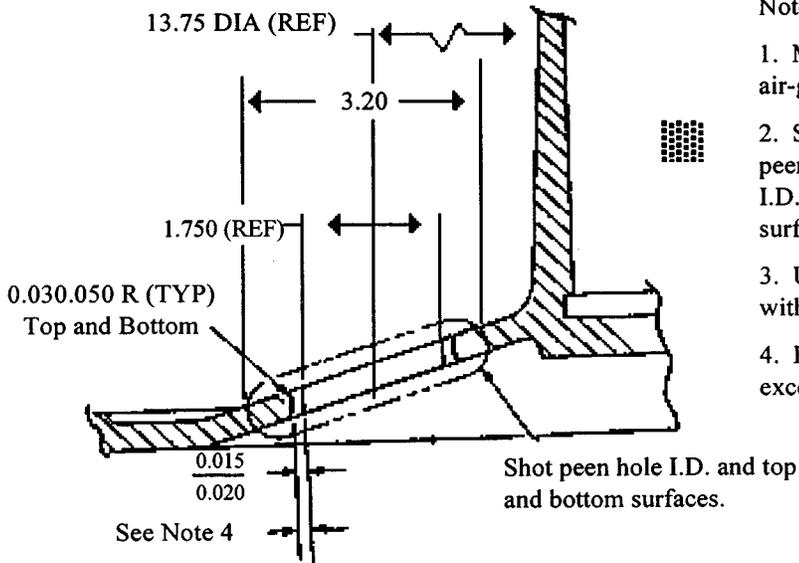
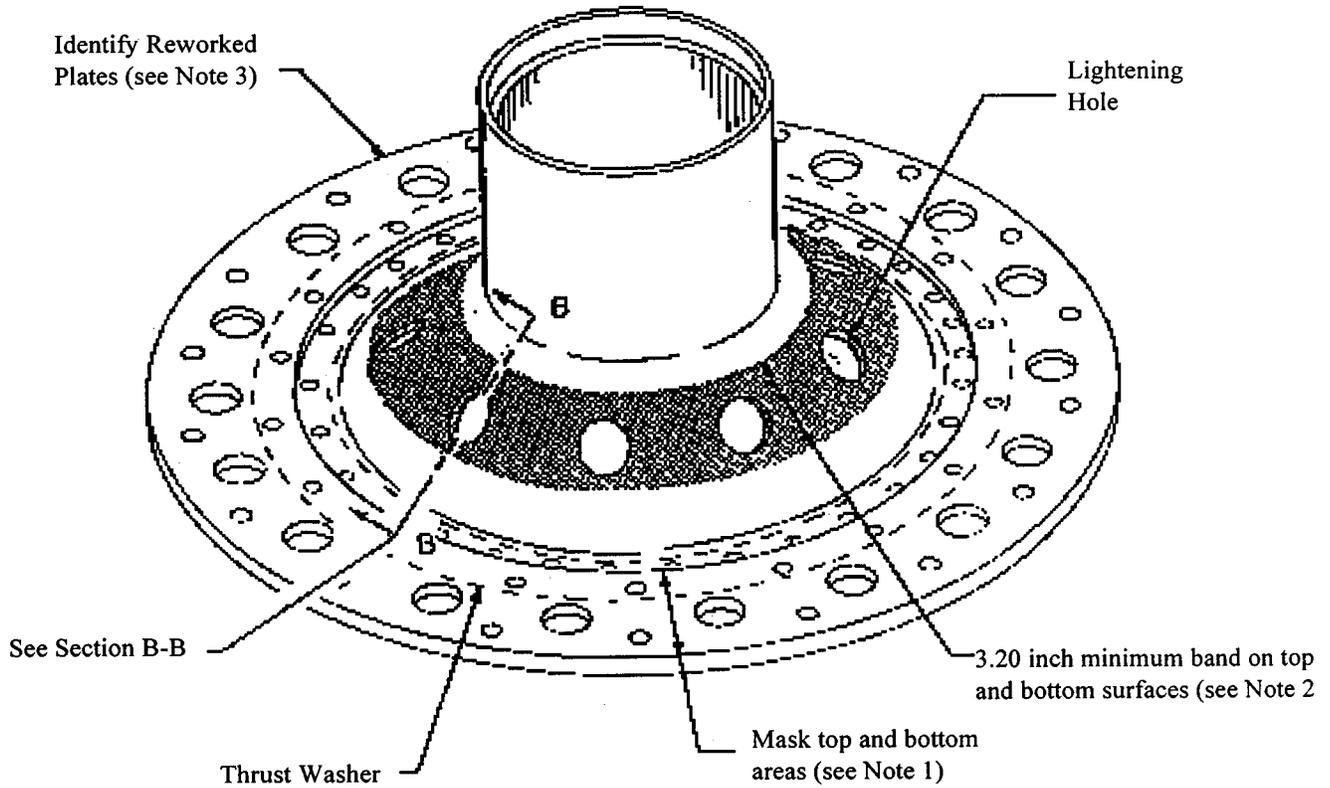
Rework of Second Stage
Lower Planetary Plate (6435-20229-102)
Figure 1

Section B-B
(Typical Nine Places)

1. Mask top and bottom areas to protect from liquid air-grit and shot peen.
2. Shaded area to be liquid air-grit blasted and shot peened includes plate top and bottom surfaces and I.D. of all lightening holes. Feather shot peened surface edges.
3. Use low-stress depth controlled impression-stamp with full fillet depth of no more than 0.003 inch.
4. Reworked machined surface roughness shall not exceed 63 microinches AA rating.

(i) Locate the center of each 1.750 inch-diameter lightening hole and machine holes 0.015 to 0.020 oversize on a side (0.030 to 0.040 diameter oversize). Machined surface roughness must not exceed 63 microinches AA rating (see Figure 1).

(ii) Radius each hole 0.030 to 0.050 inches on each edge as shown in Figure 1.

(iii) Mask the top and bottom surfaces of the plate to expose 3.20 inch minimum width circumferential band as shown in Figure 1.

(viii) Identify the reworked plate by adding "TS-107" after the part number using a low-stress depth-controlled impression-stamp with a full fillet depth of not more than 0.003 inch (see Figure 1).
